## **The Industrial Heritage of the North Isles Orkney**

## **Research and Interpretation Project Data Structure Report**

February 2025

**Project No: 996**

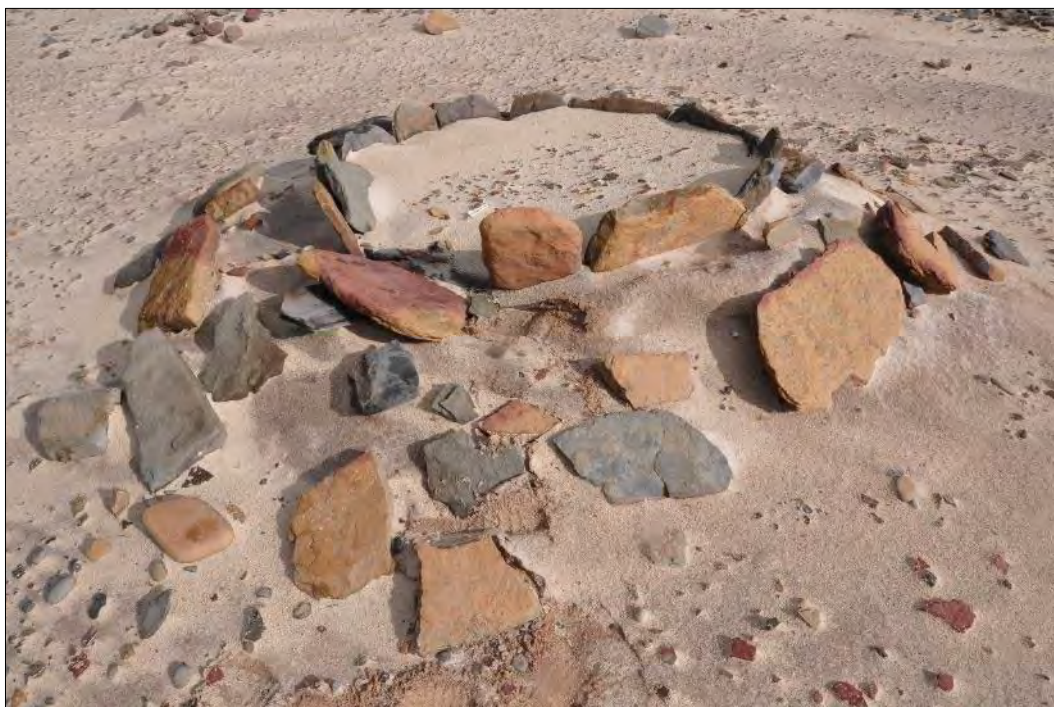
**Plate 13:** A collapsed and eroded kelp pit on the beach at the Links of Noltland, Westray. The stones that originally lined the pit still remain form a ring in the centre of the mound.

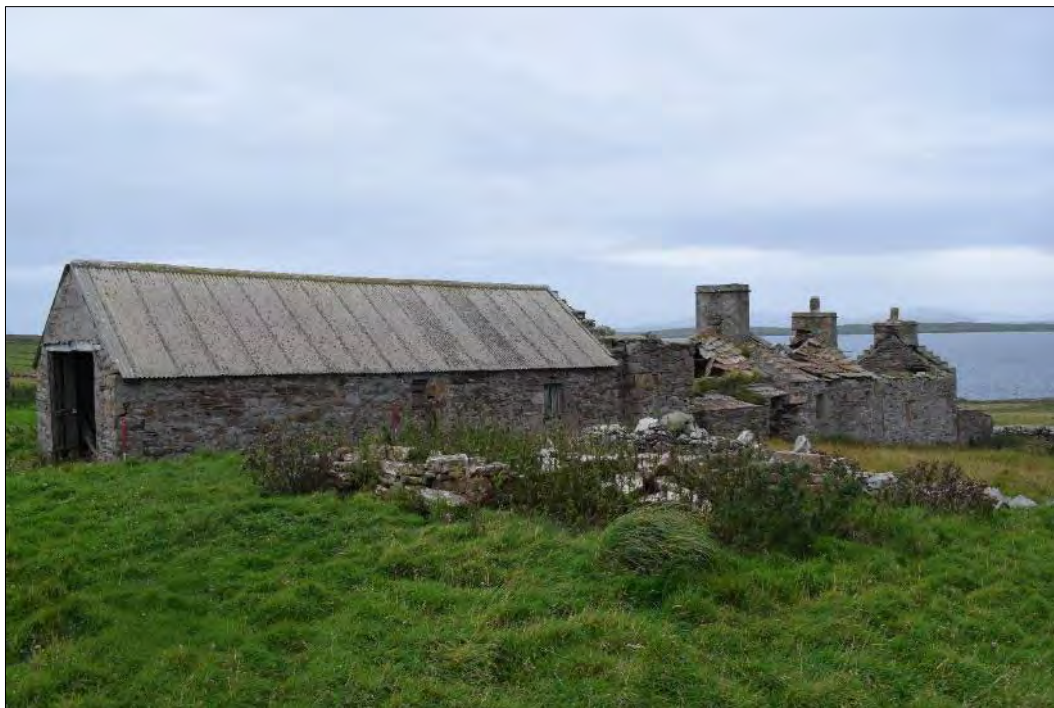
*Plate 21: North range of Redhouse, looking southwest.*

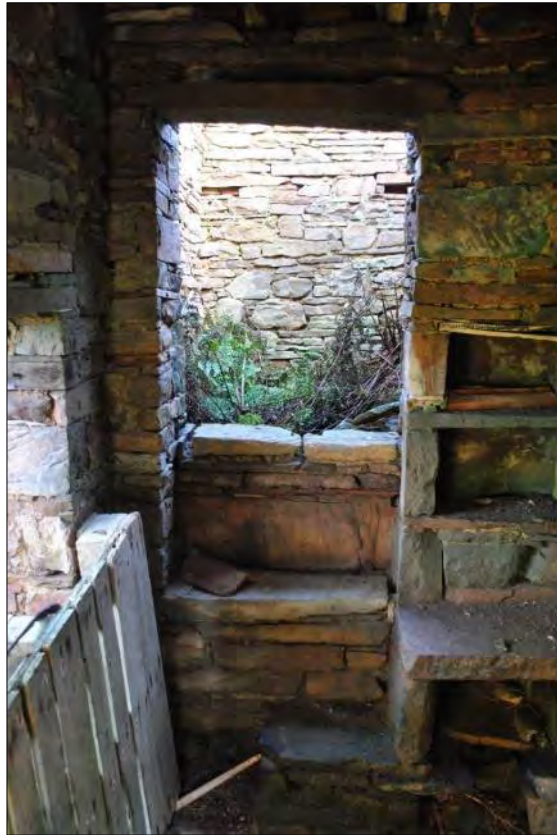
*Plate 28: Corn drying-kiln, Building 4, looking north, showing the steps leading to the kiln floor and the fire hole (bottom right).*

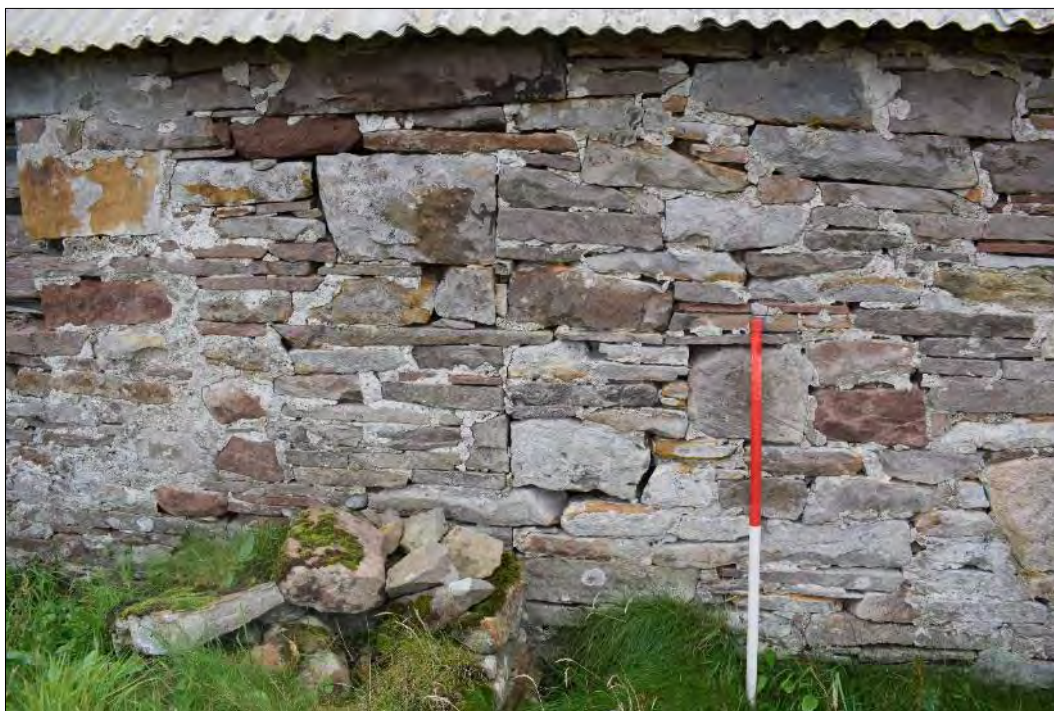
**Plate 30:** North-facing elevation showing the wall scarring which marks the former division between Building 5 and 6. The remains of the former enclosure wall at the base are keyed into the elevation.

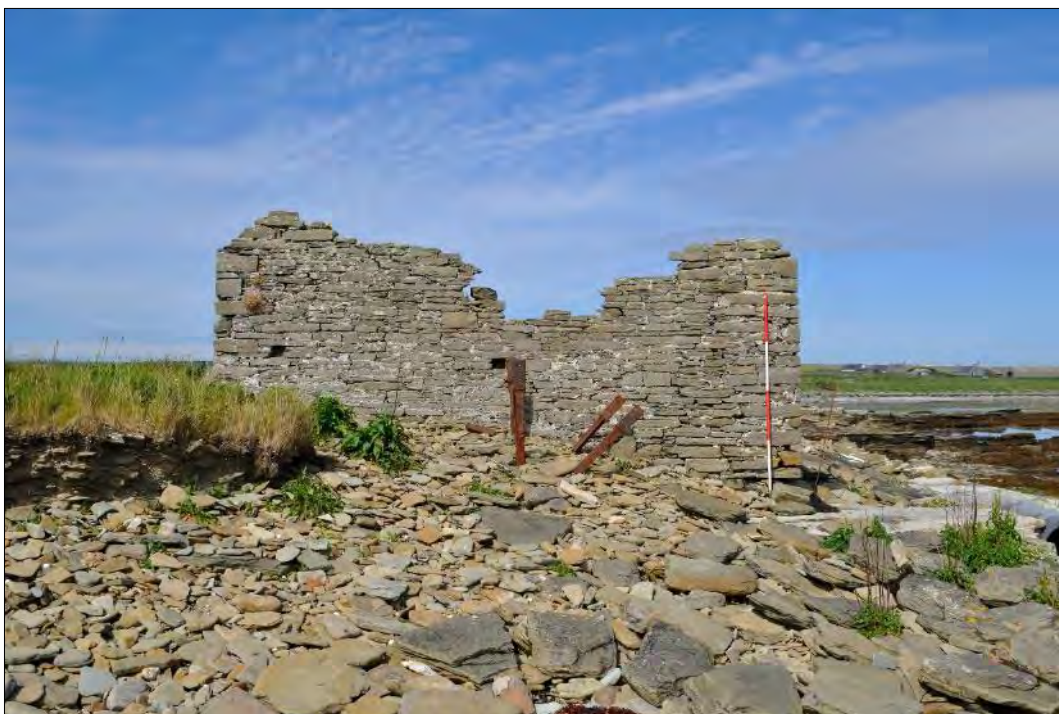
**Plate 58:** East-facing gable of Hookin Mill (June 2016) with the spokes of the mill-wheel protruding from the pebbled stones filling the wheel pit.

The east-facing gable measures 5.96m in length and is preserved to a maximum height of 2.5m (**Plate 58**). The wheel pit butts against the base of the elevation. Much of the detail, however, of the pit is obscured by infilling from pebbled beach stones, and the north end of the pit has been replaced by a modern culvert to allow water to continue to overflow from the loch and into the sea. Two pairs of the water wheel's spokes are visible above the infilling pebbled stones. These are of cast iron and indicate that the wheel's axle lies below both the current ground level and the visible base of each of the four elevations.

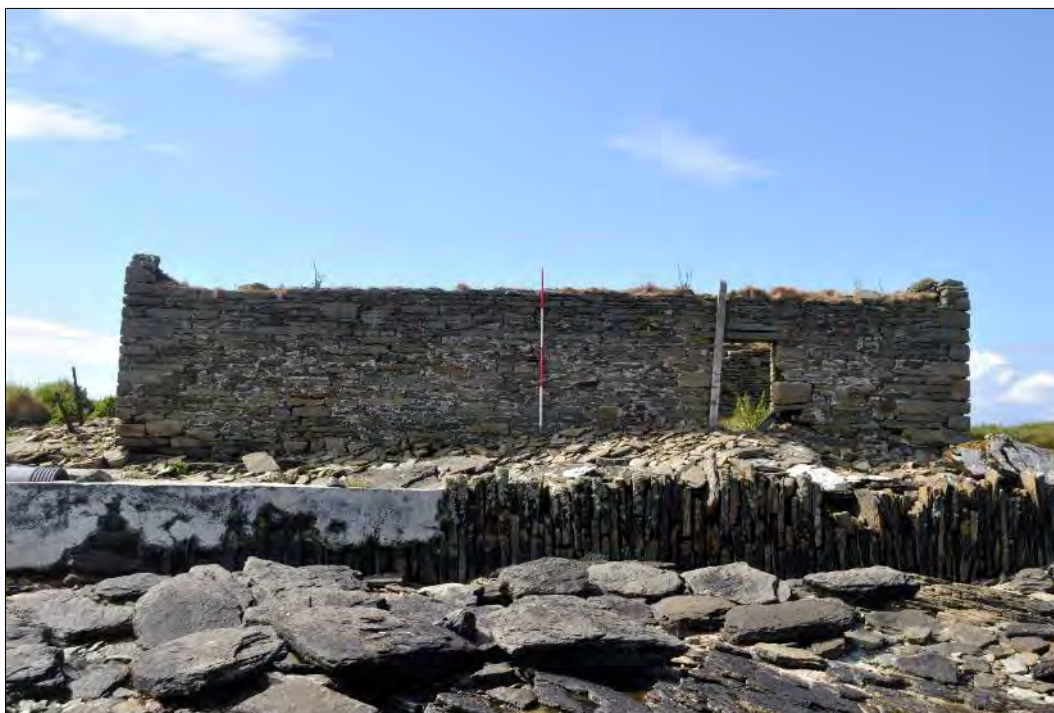
*Plate 59: North-facing elevation of Hookin Mill (June 2016) with the vertical flagstones forming the sea wall in the foreground.*

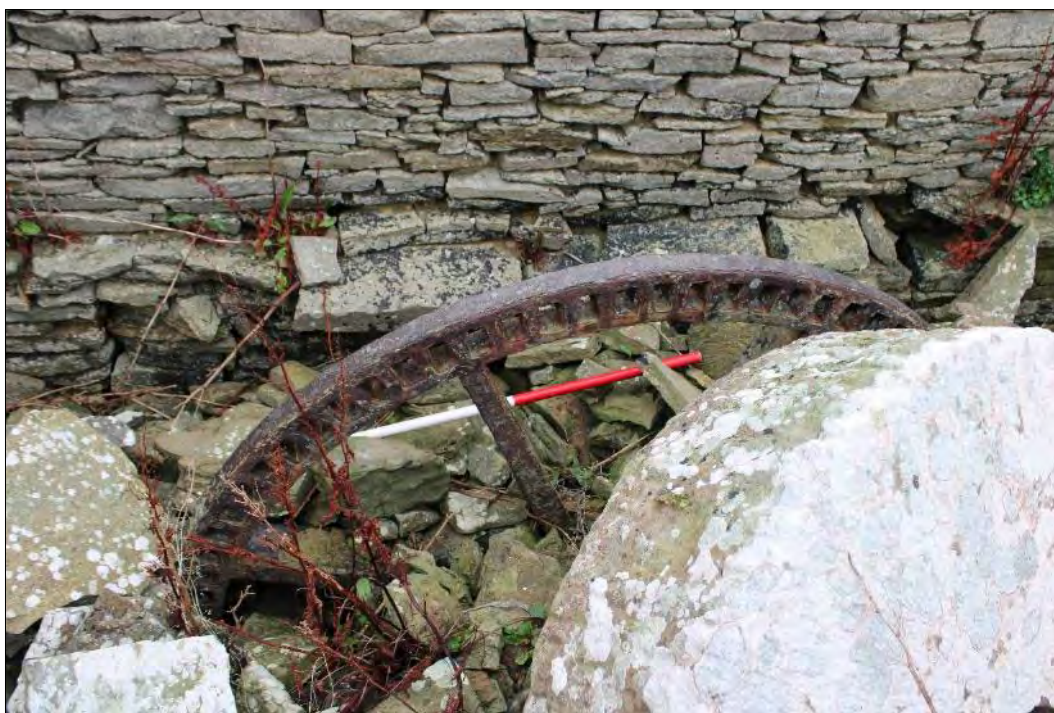
**Plate 62:** Mill machinery at Hookin Mill. The wheel appears to be in-situ within the demolition rubble and is probably connect to the external mill wheel by a shaft passing through the centre of both.

Fragments of mill machinery remain visible within the scrub vegetation at the east end of the building. These include a cast iron wheel with square holes through the rim (**Plate 62**). This would probably have been utilised to turn a horizontal wheel with pegs or lugs around its circumference that fit into the square holes. The wheel had a diameter of at least 1.8m and this may be connected directly to the axle of the water wheel. Beside this was a gritstone, 1.36m in diameter. No features or grooves were noted in the exposed surfaces. A second grindstone was partially visible with the stone rubble and was also entirely earth-fast so could not be extensively examined.

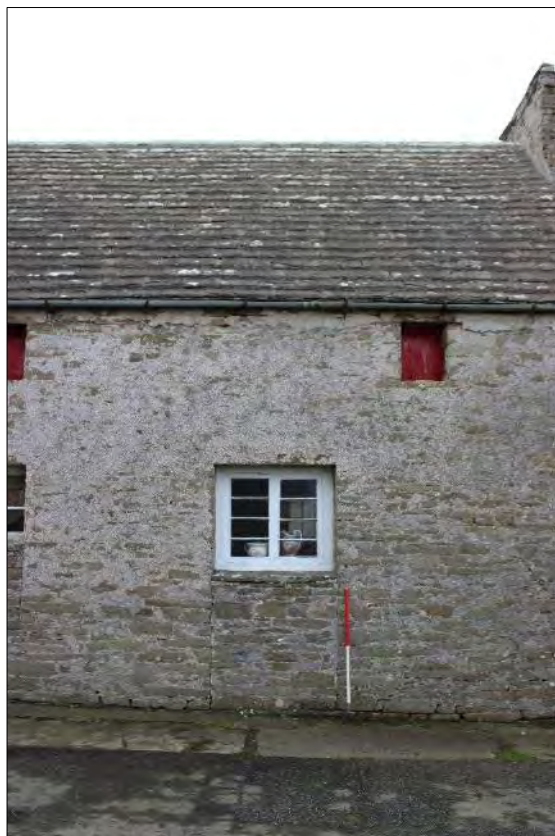
**Plate 74:** Detail of the west-facing elevation, Building 3.2 showing the former external doorway partially blocked to form a ground-floor window.

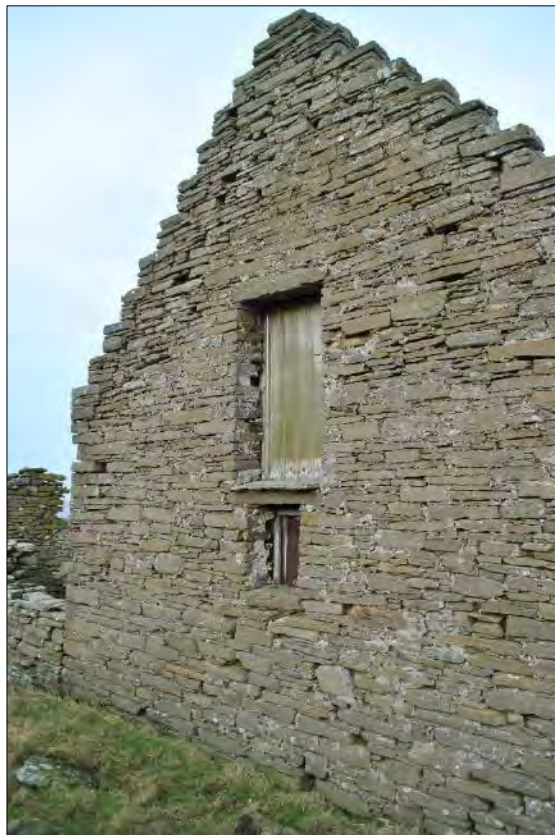
**Plate 97:** South gable of the old threshing barn (Building 10) with doorway at loft height and window below. The blocking between Building 10 and Building 11.1 can be seen on the extreme left of the photograph.

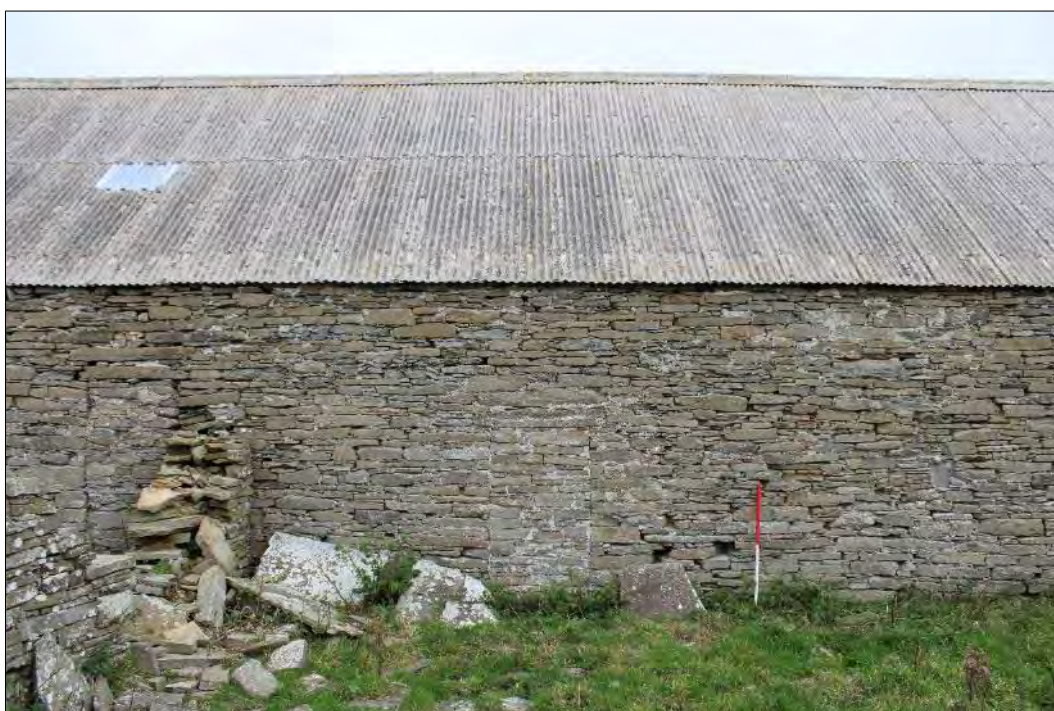
**Plate 98:** Detail of the west-facing elevation of the old threshing barn showing two blocked doorways. The wall butting against the elevation next to the left doorway is the south elevation of Building 12.1.

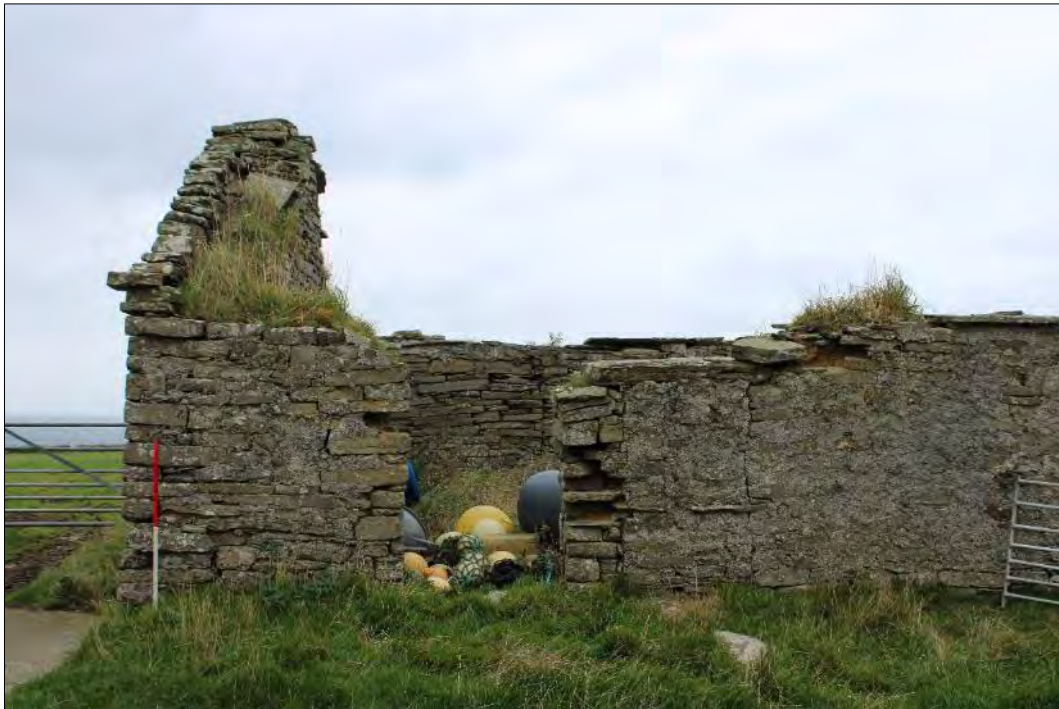
**Plate 106:** South-facing elevation of Building 13 showing the external doorway with the blocked window to the right.

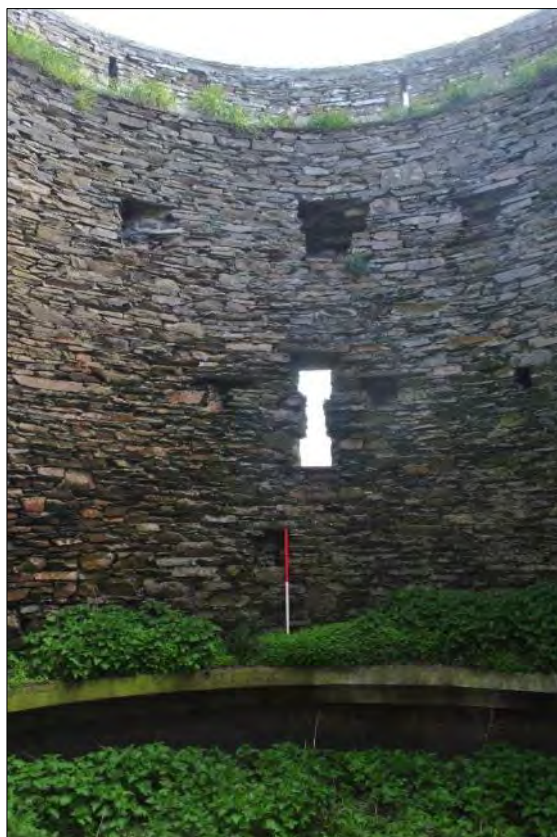
**Plate 141:** Interior of the gasometer tower showing the two lines of apertures/damaged stonework running round the interior wall surface.

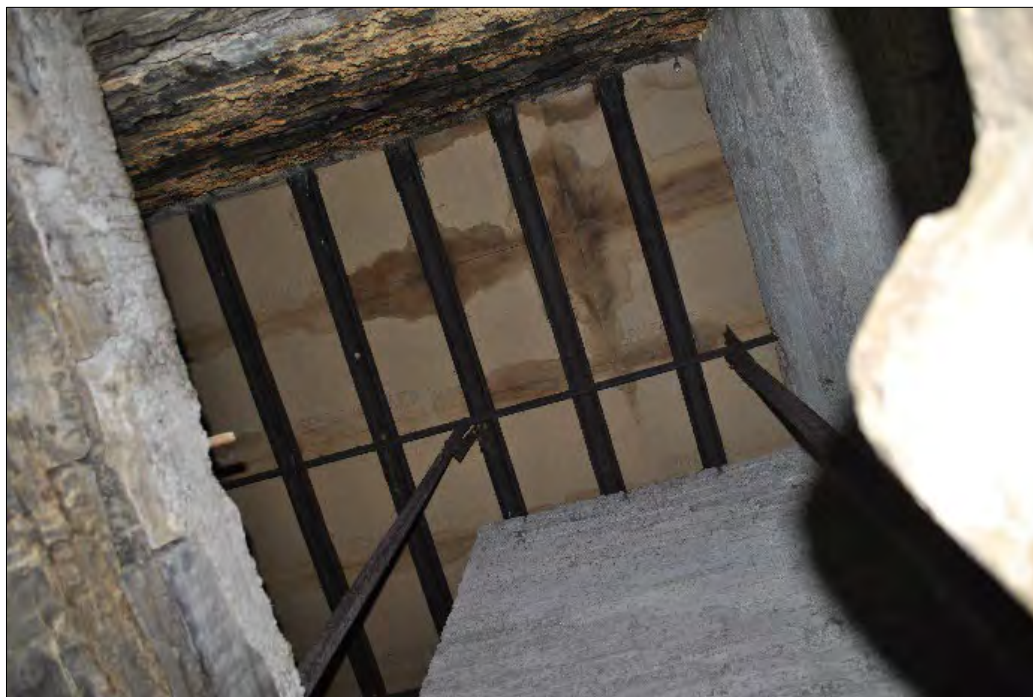
had been modified at first floor level with the addition of, or replacement of the original structure with, concrete blocks (see **Plate 151**).

**Plate 151:** View looking up from the ground floor of the corn-drying kiln at the underside of the replacement flooring of the second floor. The cross-beams appear to be iron and are probably the original fittings that formed part of the drying floor. Also visible are modern alterations to the upper structure of the kiln itself.

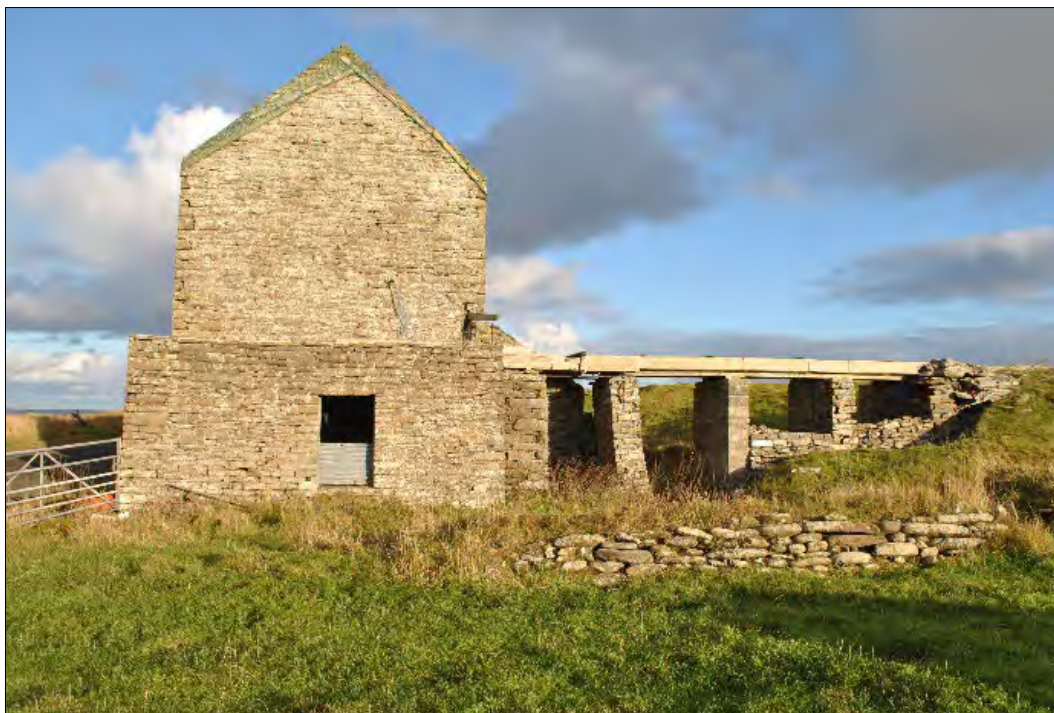
**Plate 156:** Southwest gable of the mill showing the timber trough supported by four pillars and the roofless water wheel house. The timber beam operating the sluice above the water wheel is visible protruding from the gable. The dry-stone walling in the foreground marks the approximate south edge of the overflow ditch.

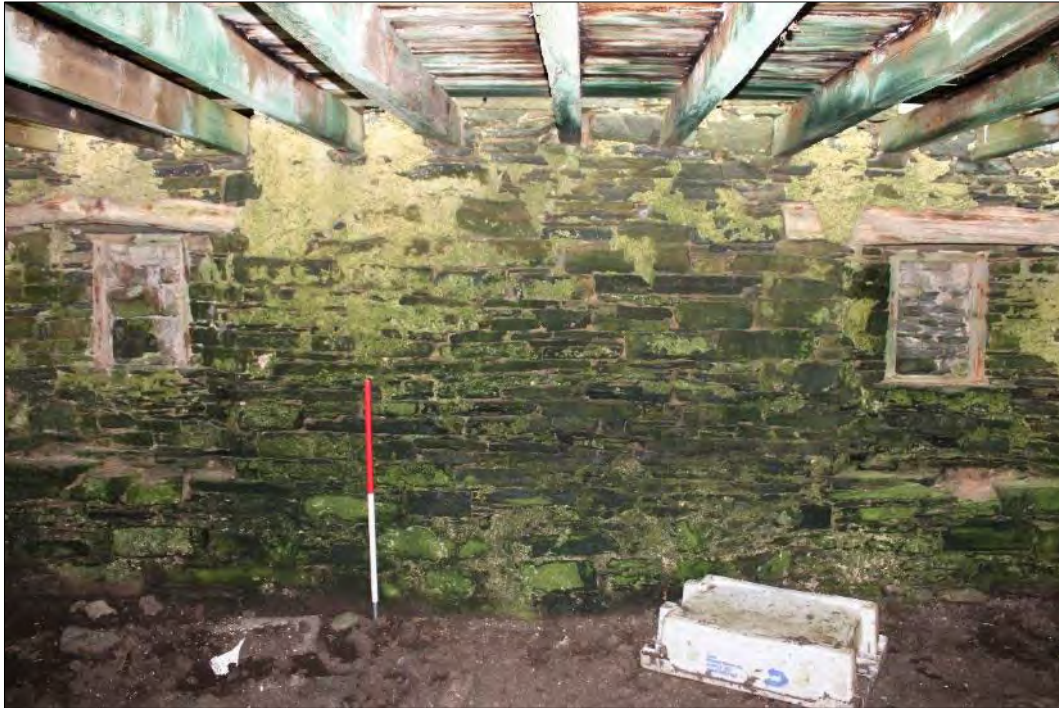
**Plate 163:** South elevation with blocked windows.

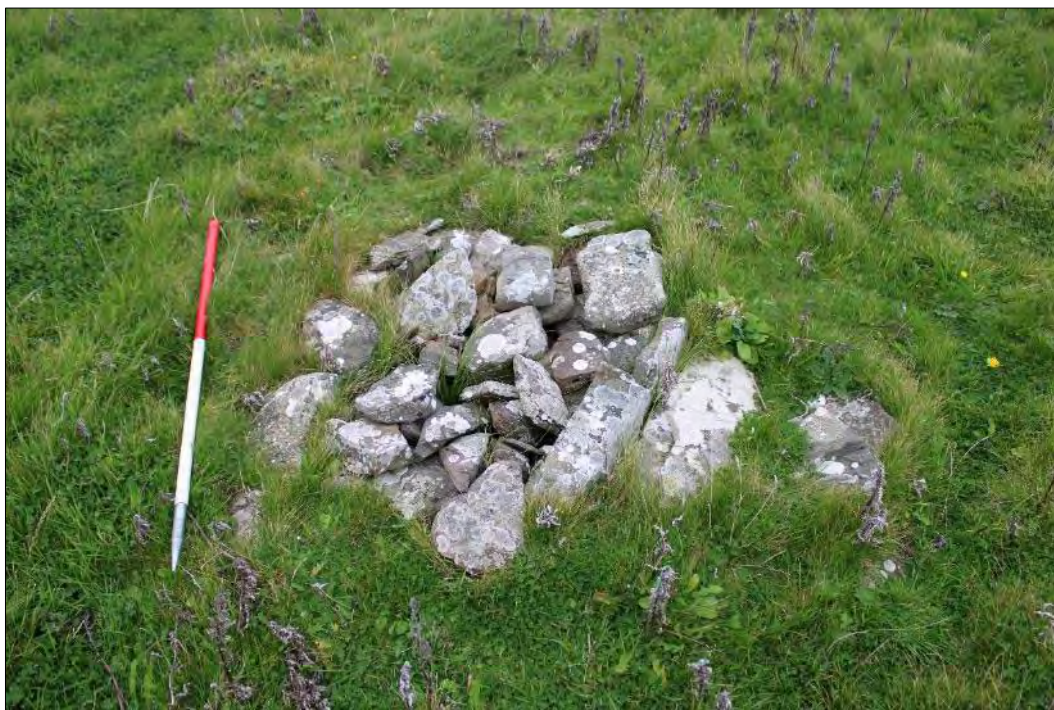
**Plate 210:** Former kelp pit (Feature 51) filled with loose stone at Aikerness, Westray.
