Tres Ness chambered tomb, Sanday:
Excavations in 2017
Data Structure Report

Grid ref: HY 711 375

Scheduled monument number: SM1330

Vicki Cummings, Jane Downes, Chris Gee and Colin Richards

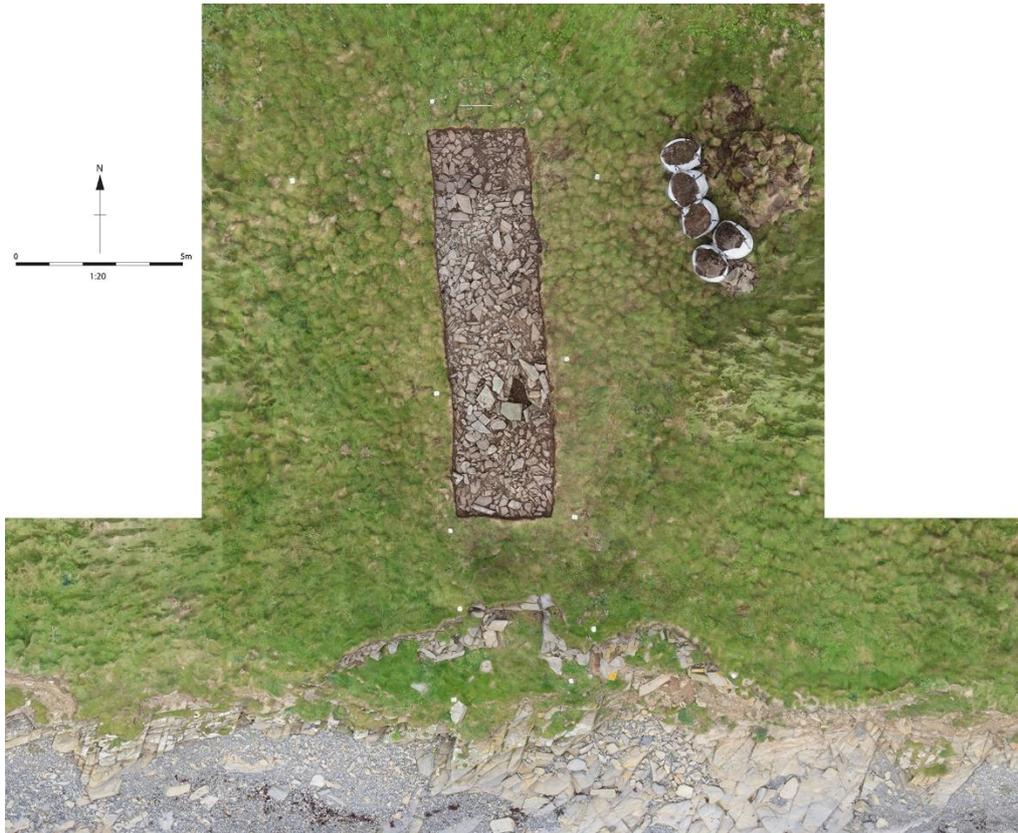
Figure 3. Vertical view of the trench through the cairn

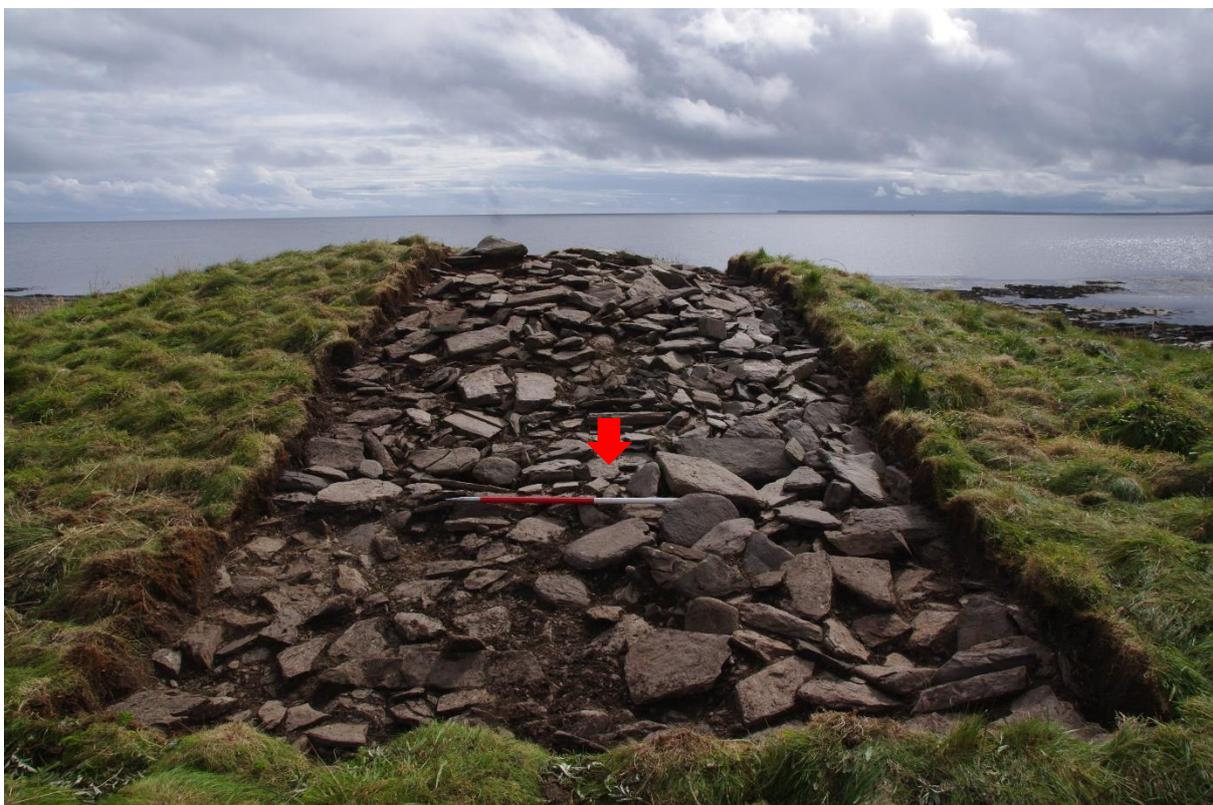
Once the turf was removed we encountered a fairly thick layer of silt (001 - topsoil). This cleaned off to reveal the uppermost layer of cairn material (002) with a matrix of silt and small eroded pieces of sandstone (003). On the northernmost side of the cairn we uncovered what appeared to be an *in situ* kerbstone (006) and beyond this was displaced cairn material which had slipped off the main body of the cairn (007). Within the mound we revealed a stretch of dry-stone walling (004) which had previously been visible on the surface (see Davidson and Henshall 1989) and is presumed to be the upper portion of the western wall of the chamber. It was supported by an orthostat (005) which may be one side of a stall within the chamber.

Figure 5. The exposed cairn, looking south towards Stronsay. The *in situ* kerbstone (006) is marked by an arrow

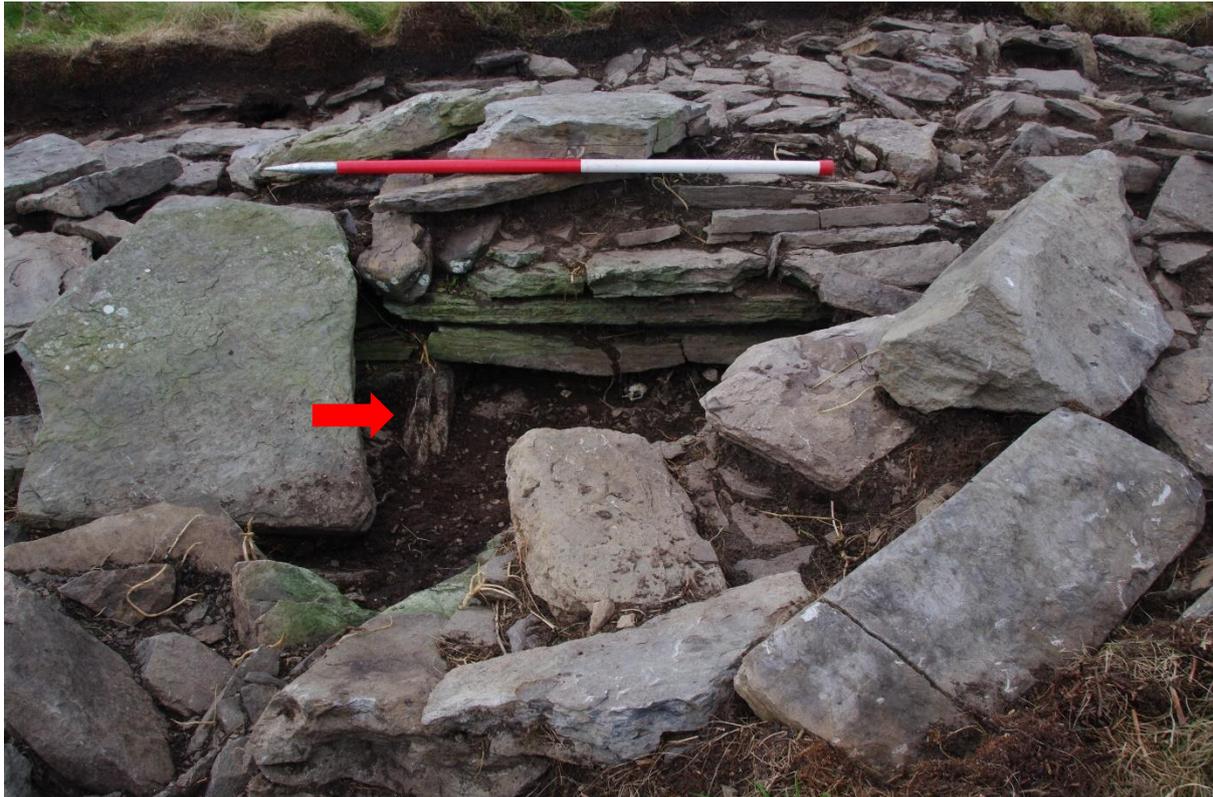
These excavations did not disturb any archaeological layers bar revealing the cairn. It is possible to suggest, however, that the cairn is well-preserved, although the earlier investigation of the chamber in one area is apparent from the quantity of very loose large slabs strewn around this area. It was not possible to assess how far these earlier investigations had gone without more extensive excavation which was beyond the remit of the Scheduled Monument Consent.

Figure 6. Dry-stone walling on the western extent of the exposed chamber sitting on top of another orthostatic stall indicated by an arrow. The other slabs have been displaced, presumably in antiquity, by someone investigating the chamber

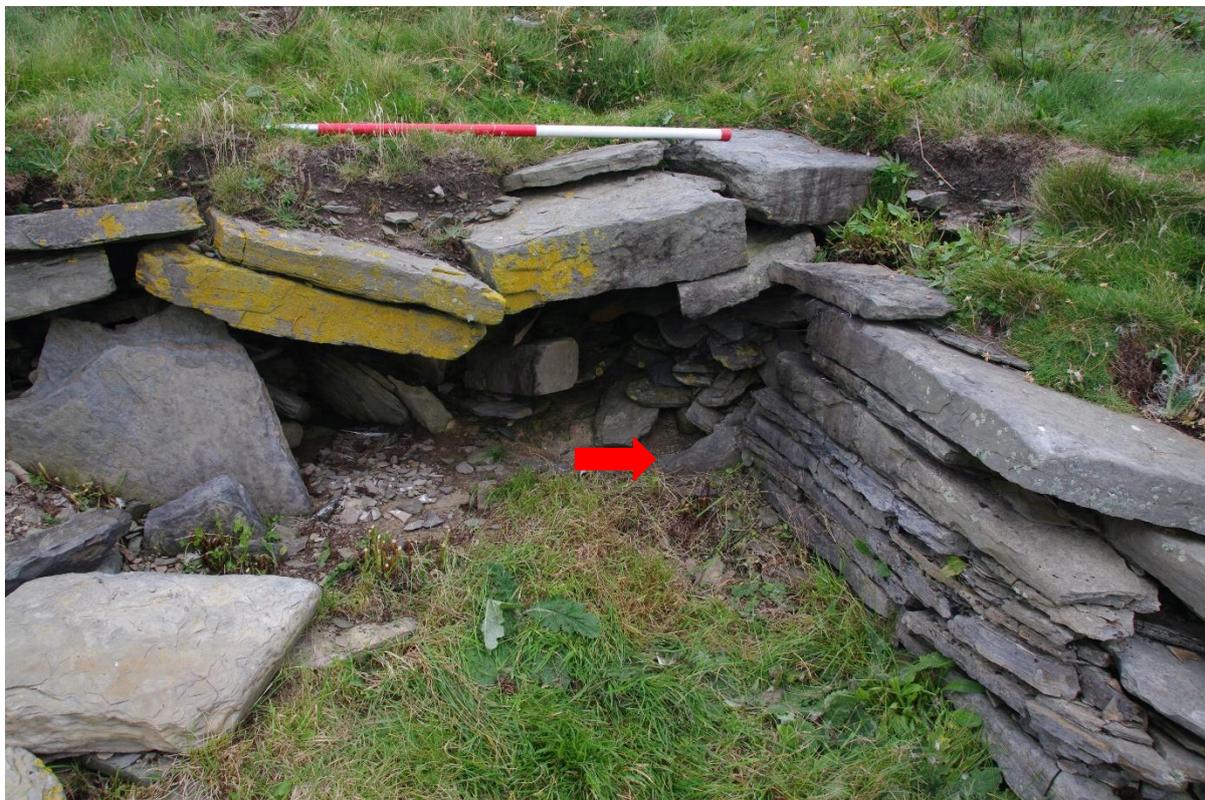
Figure 9. The masonry visible in the section. To the right is dry-stone walling which is the eastern extent of the chamber or passage walling in this area. To the left one of the orthostatic stalls is visible, although it has been shattered on its upper surface. The horizontal slabs have slumped inwards since being recorded by Smith in 1983. The broken right orthostatic stall stone is indicated by an arrow

The section has eroded significantly since recorded by Smith in 1983. Some stones in her drawing are still clearly visible in the section, particularly those for substantial features such as walls. There are many patches, however, which have obviously eroded since 1983. The fact that we were unable to record sections of this by hand indicates the wider erosion of the site, discussed in more detail below.

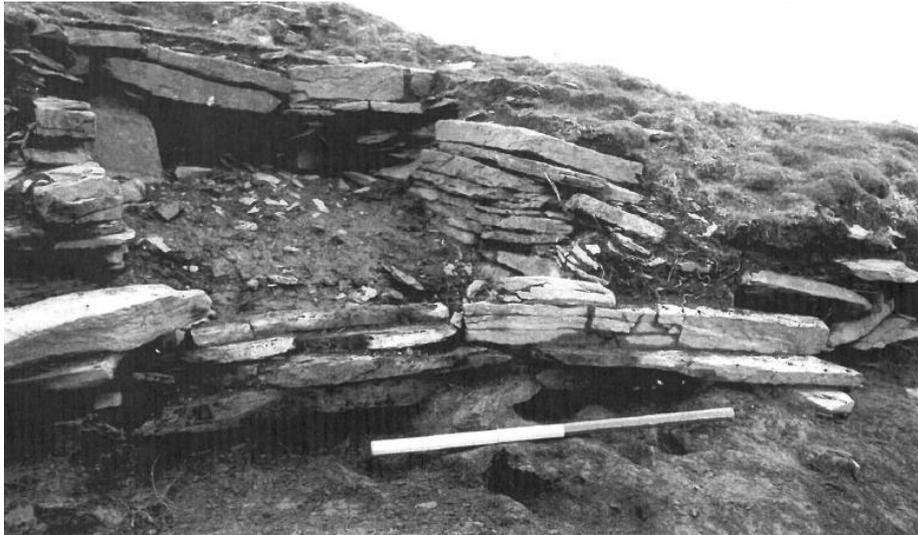
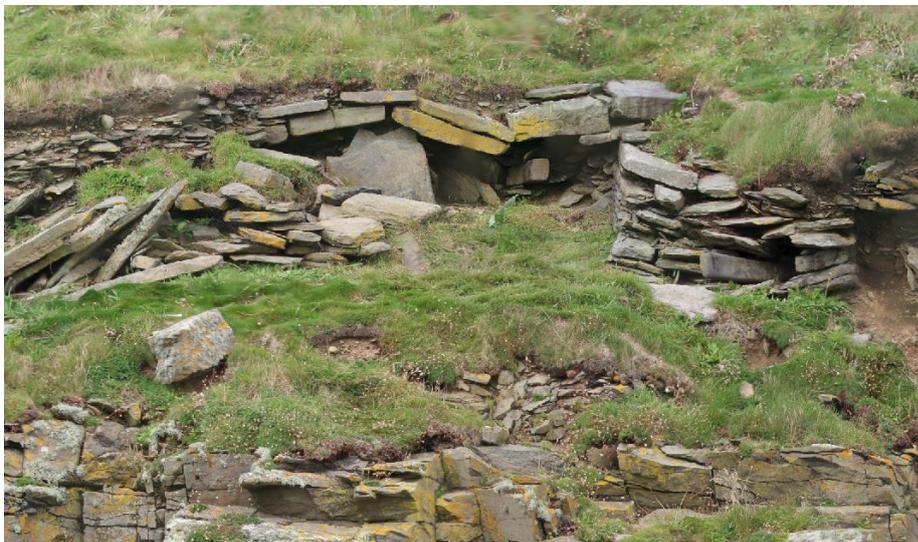
It is clear that the site is suffering from ongoing and significant coastal erosion. Some of the archaeology recorded by Smith in 1983 has gone or deteriorated, and the site has further eroded into the sea. The key changes since Smith's 1983 assessment are:

- the curving wall recorded to the south of the section has gone completely
- the slabs overlying the passage or chamber visible in the section (possibly from a later round cairn and associated kerbing) have collapsed inwards
- the western dry-stone walling of the entrance or chamber has collapsed, with some slabs no longer *in situ*
- much of the cliff which she has drawn in her plan of the site is now gone. She was able to stand on and record an area to the south-east of the section and her plan shows masonry sticking out over land – this land is no longer present and the masonry sticks out directly over the cliff edge. This means that up to 1.5m of archaeology has disappeared since 1983. This is the most pronounced on the eastern extent of the site.

Figure 9. The top image is taken from Smith's 1983 assessment of the site. Below is the chamber today. The wall at the front of the monument has completely gone, and some of the supporting slabs have slumped in

The site is actively eroding into the sea and remains very vulnerable to further erosion. This is currently most pronounced on the eastern side of the section. There is no obvious solution to this problem, since the site is located on the edge of a steep cliff. If Historic Environment Scotland wished to support the research excavation of a stalled cairn in Northern Scotland, however, this would be excellent choice since, ultimately, it will be destroyed by coastal erosion.
