## **The Industrial Heritage of the North Isles Orkney**

## **Research and Interpretation Project Data Structure Report**

February 2025

**Project No: 996**

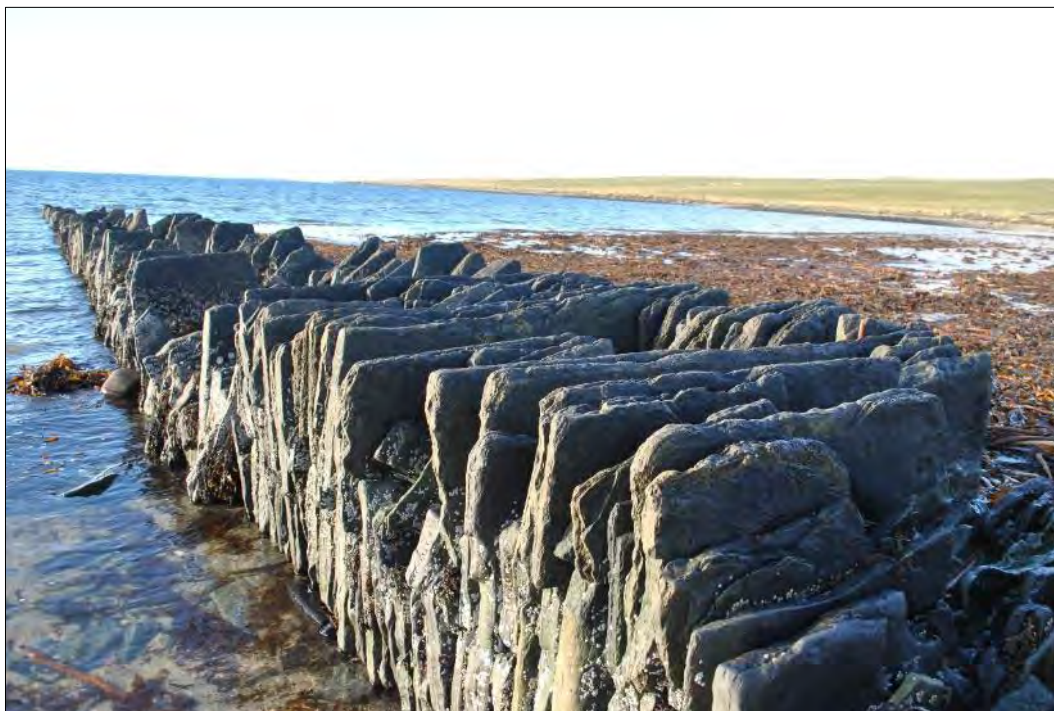
*Plate 16: Remains of kelp pier at Bay of Greentoft, Eday. A kelp store stood close at the landward end of the pier, above the coastal edge.*

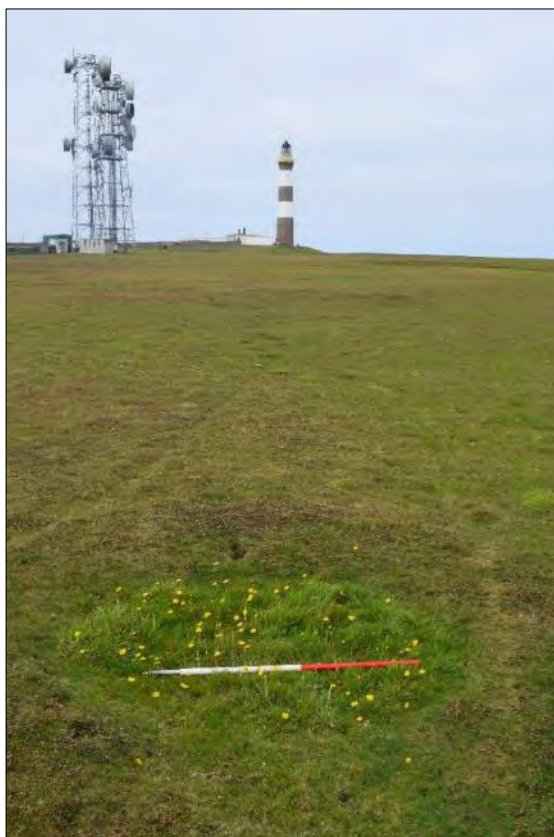
**Plate 17:** *The remains of a kelp pit at Dennis Head, North Ronaldsay with the lighthouse in the background.*

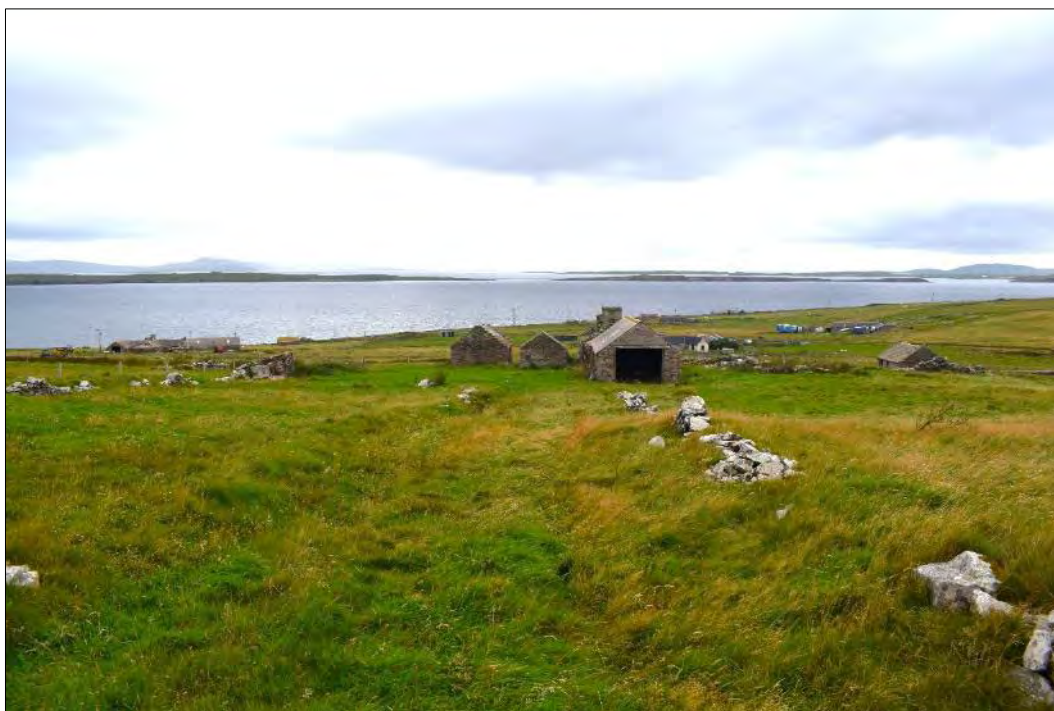
*Plate 20: General view of Redhouse looking west towards the Sound of Faray. The view shows the three ranges comprising the main farmstead complex along with remains of enclosure walls (foreground)*

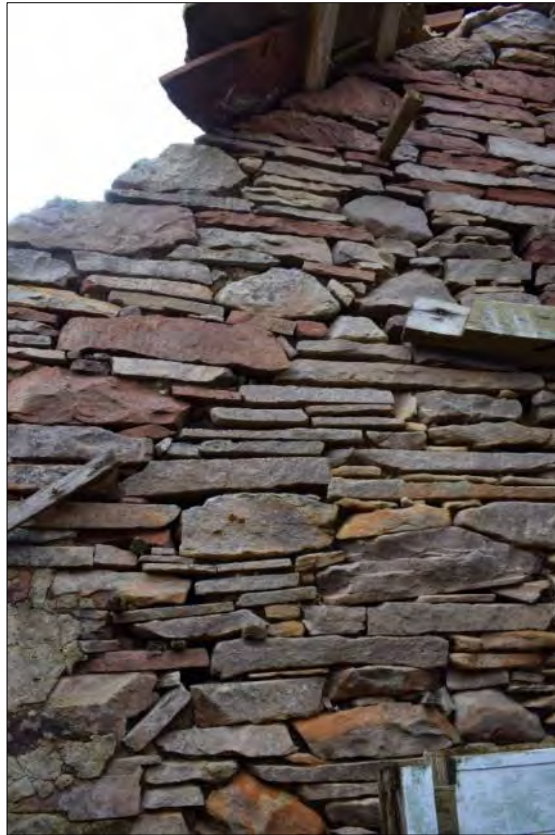
**Plate 22:** Detail of dividing wall (east elevation) viewed from Building 2 showing construction scar which appears to demarcate the original line of the gable roof line with the lumb rising from it.

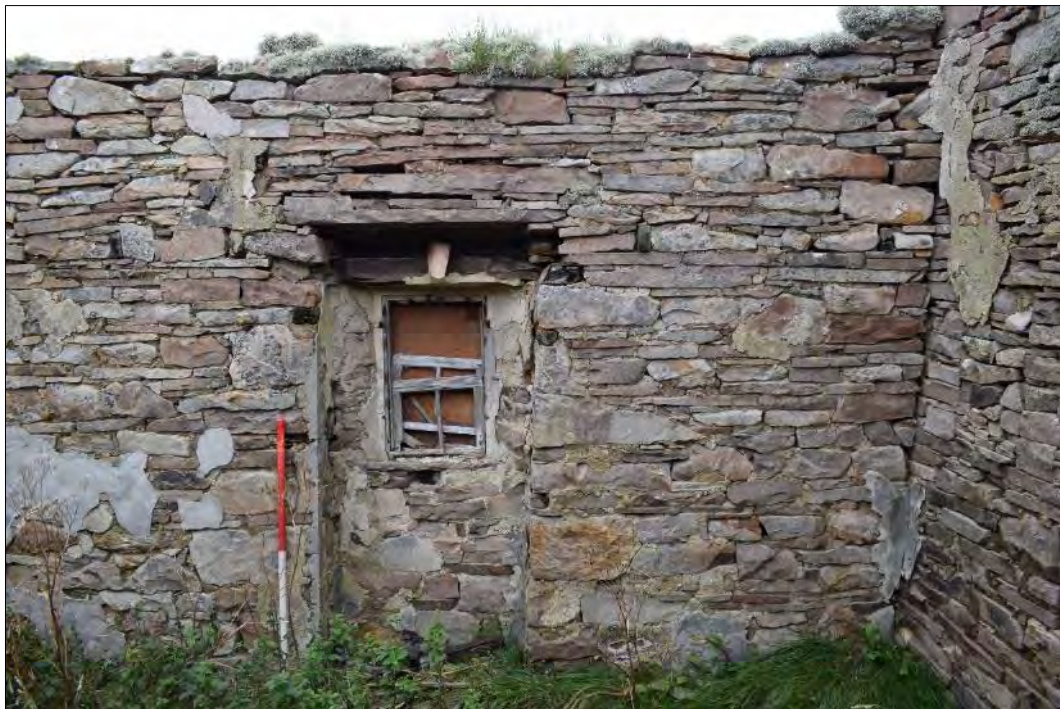
**Plate 23:** East end of north elevation, Building 1 (North Range) showing former exterior doorway blocked up to form a small window.

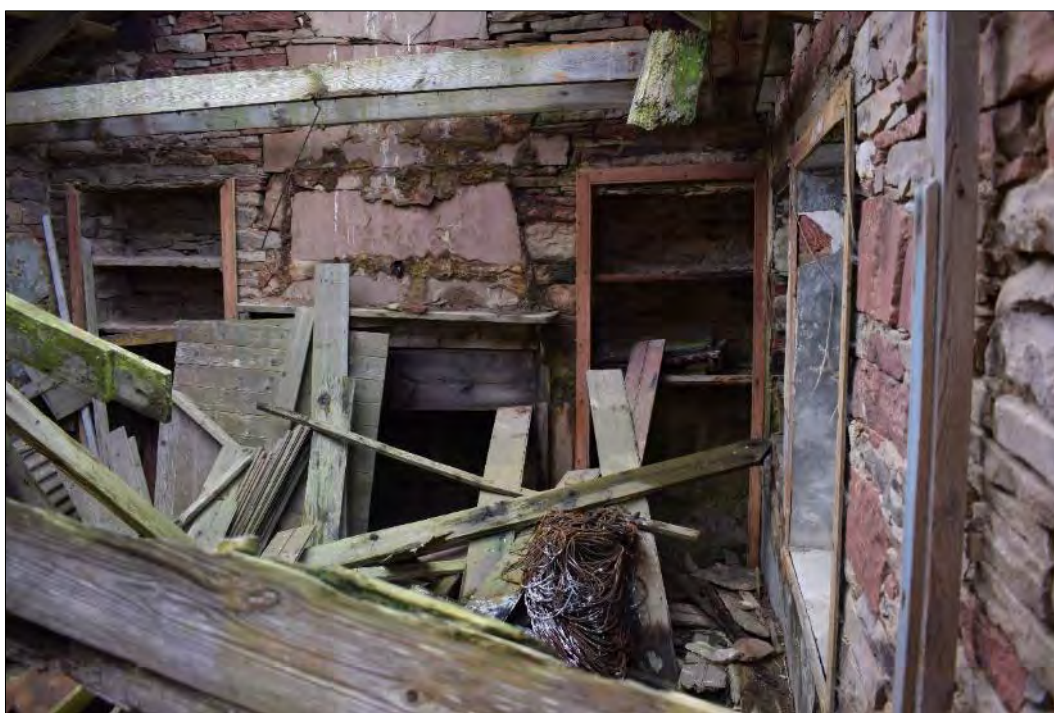
**Plate 24:** *Building 2, east elevation with central fireplace flanked by integral cupboards.*

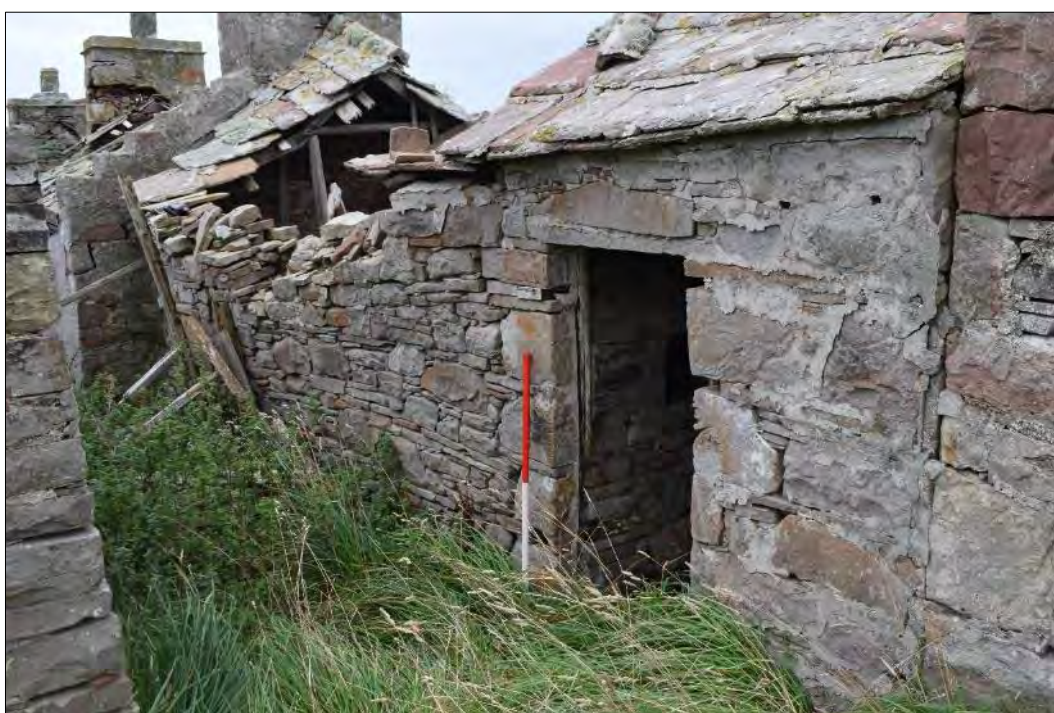
**Plate 25:** South-facing elevation of Building 3 (left of centre) with collapsed roof and bowing wall butting against the gable end of Building 2, and Building 4 (right), looking northwest.

Exterior access to Building 2 is provided by a doorway positioned left (west) of centre in the south-facing elevation. This has a timber frame with a three-fan light above the door, a feature not seen on any other external doorway in the north range. There is a large window to the right (east) of the centre-line with the frame intact. This has two panes, divided horizontally. There are two windows in the north-facing elevation both slightly larger than that in the south though the window towards the west end has been partially blocked. The timber frame divides the window into four panes. Internally, Building 2 has a fireplace in the east elevation. The fireplace has a large stone lintel, a timber surround and mantle, flanked by two cupboards integral to the wall fabric and which extend from the floor level to the height lintel stone top (**Plate 24**). Both recesses have two flagstone shelves in the upper half. A similar cupboard is also present in the south elevation between the east wall edge and the window. The west elevation is obscured by the debris and demolished fittings. A number of the timber roof

trusses have collapsed and a small number of flagstone roof slabs have fallen but the majority of the roof is still *in-situ*, though further, extensive loss of the roof is likely.

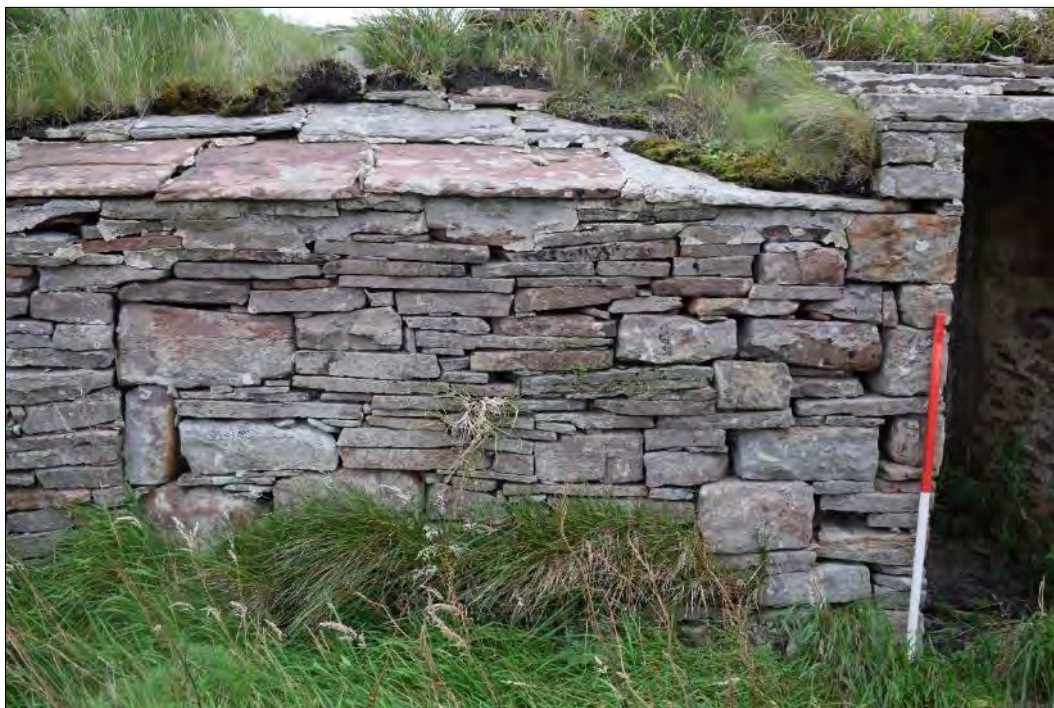
**Plate 26:** Detail of north-facing elevation showing construction break (extreme left) between Building 3 (centre and right) and Building 4.

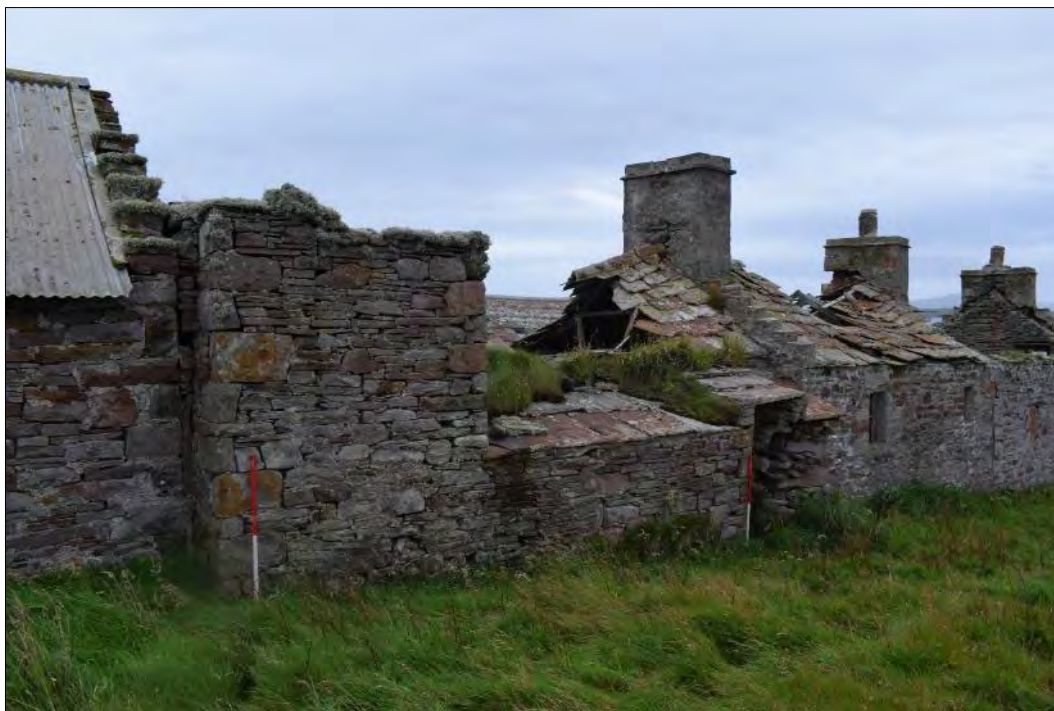
*Plate 27: North-facing elevation of north range showing Building 4 comprising a square-plan corn drying-kiln (centre left), looking southwest.*

Building 4 is the shortest of the buildings in the north range and comprises a corn drying-kiln, square in plan (**Plate 27**). Access to Building 4 is provided by an external doorway in the south elevation. The kiln body itself forms the northern-half of Building 4 and scrub vegetation fills the interior of the kiln, obscuring much of the interior detail. A flight of stone steps provide access to the kiln floor, where the grain would be spread out for drying, and the fire hole is located to the right (east) of the steps (**Plate 28**). The area between the exterior doorway and the kiln steps is an open, working area with a flagstone floor set slightly lower than the external ground surface. Access to Building 3 is provided by an internal doorway in the west elevation of Building 4. It is likely that Building 3 acted as a storage area for the corn-drying kiln. There is a small, rectangular aperture in the west-facing elevation of building 4 to the left(north) of the internal doorway and set below the level of the kiln floor. It is possible that this is part of the flue for the kiln. The flagstone roof outwith the kiln is complete.

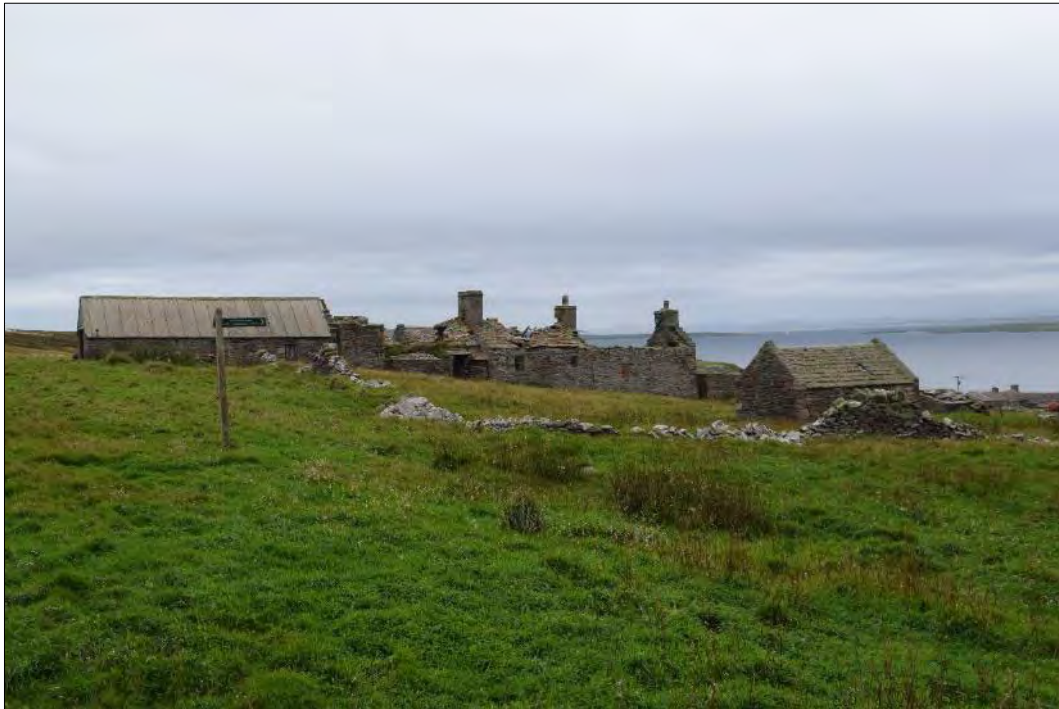
**Plate 29:** General view of Redhouse looking southwest from close to Building 17 showing Building 1-6, 15 and 16, and the enclosure wall which originally extended up to the north wall of Building 5 and 6.

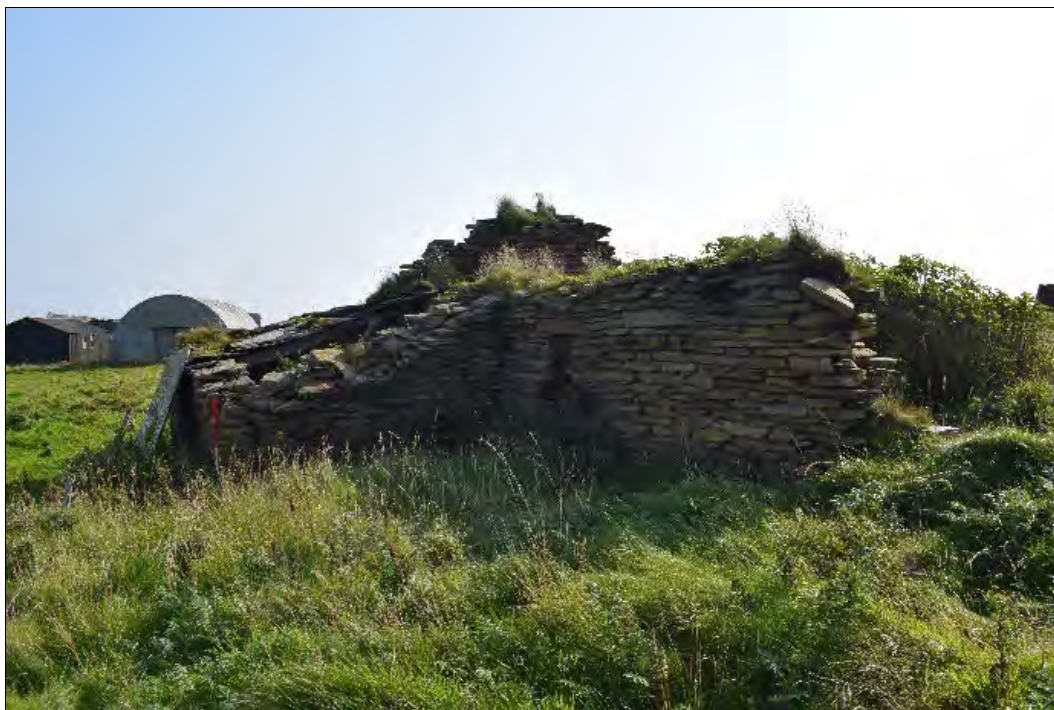
*Plate 56: North-facing elevation of Millhouse, looking southeast, showing blocked doorway (centre) and the largely intact northeast annex.*

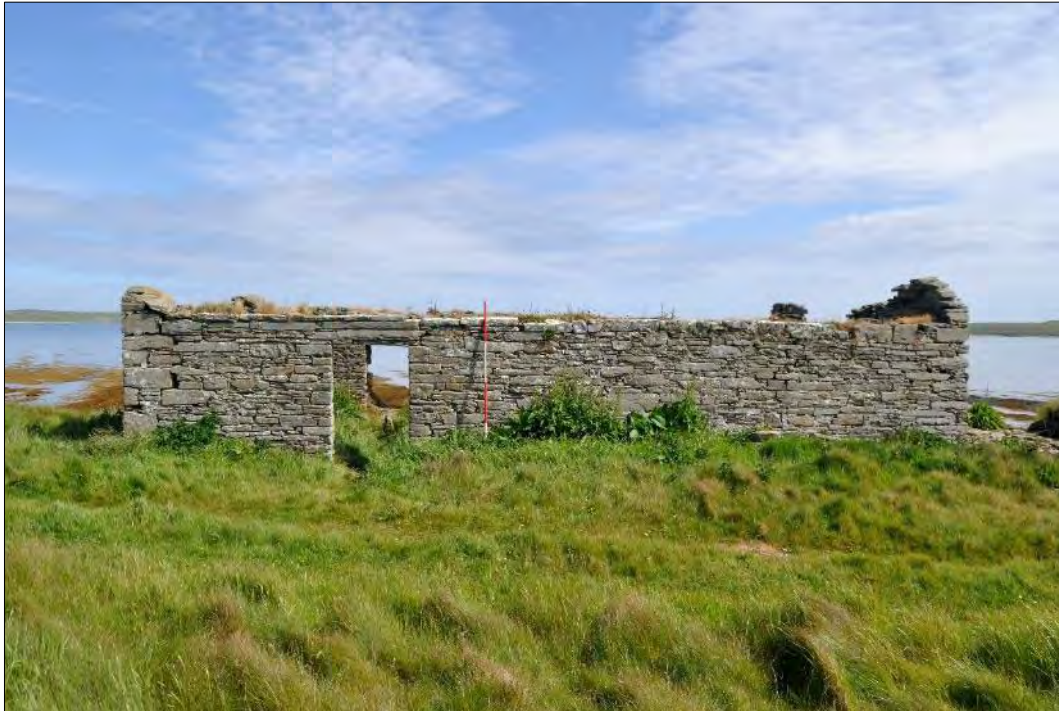
The mill is a stone rubble-built structure, rectangular in plan, with large corner quoins. The south-facing elevation measures 11.05m in length and is preserved to a height of 1.8m (**Plate 57**). The elevation bows outwards noticeably. The elevation has an external doorway, with a

stone lintel and threshold, centrally-placed in the west-half. There is an aperture measuring 0.26m by 0.28m at the base of the elevation close to the east end.

**Plate 57:** South-facing elevation of Hookin Mill, Papa Westray (June 2016).

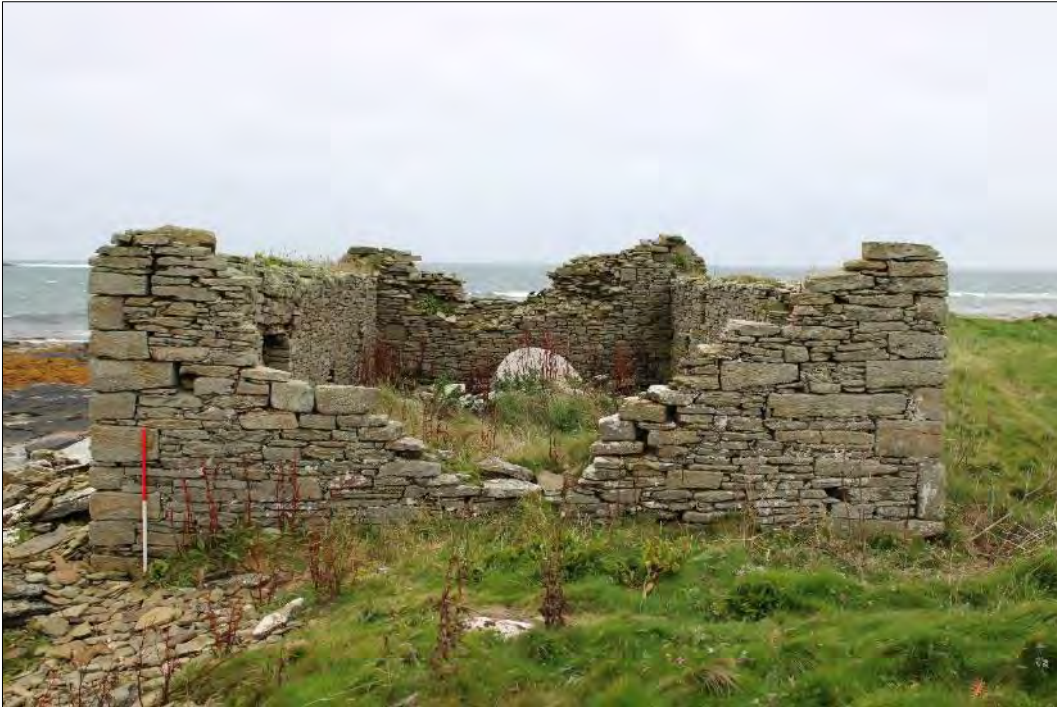
The west-facing gable measures 5.92m in length and is preserved to a maximum height of 2.18m (**Plate 60**). This elevation has collapsed to the greatest degree with the centre of the elevation being reduced almost to the current ground level.

**Plate 60:** West-facing gable of Hookin Mill with a grindstone visible in the interior of the building.

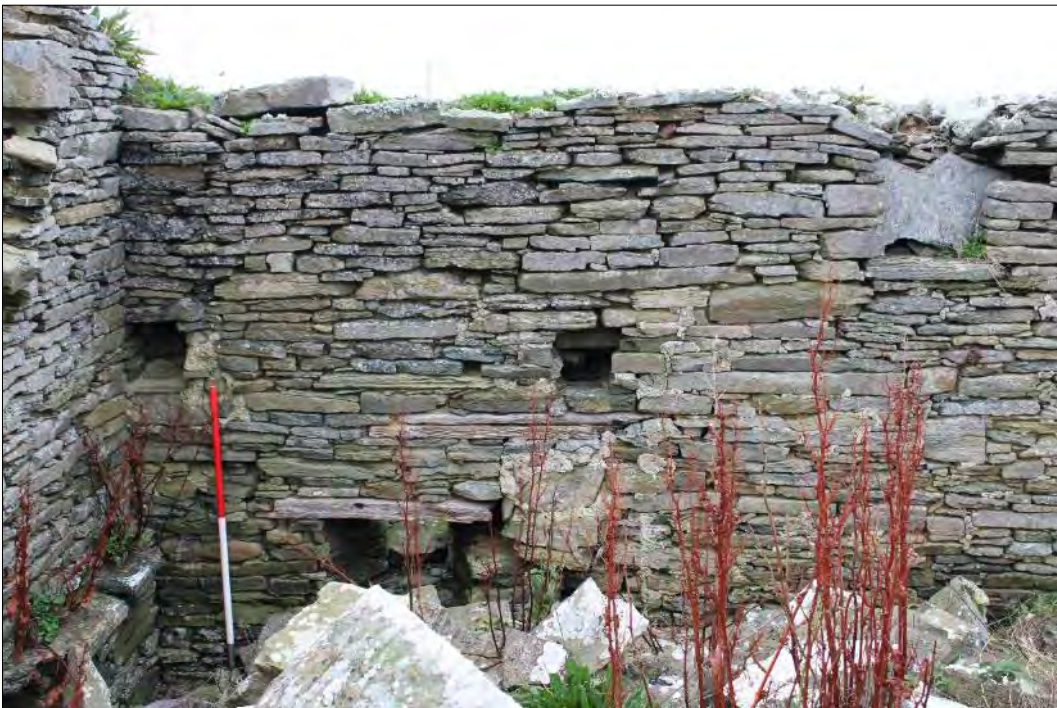
The small aperture identified externally at ground level is clearly visible in the south elevation (**Plate 61**) and is wider (0.58m), with a timber lintel internally. There is a second aperture, possibly a window, at the top of the south elevation slightly left (east) of the centre line. This has a stone sill, is 0.38m wide and has a height of 0.43m though the top of the aperture is clearly truncated. This feature was not visible in the external elevation.

**Plate 61:** South elevation of Hookin Mill with one aperture at the base of the wall, a possible window (top right) and two beam slots (centre and centre left).

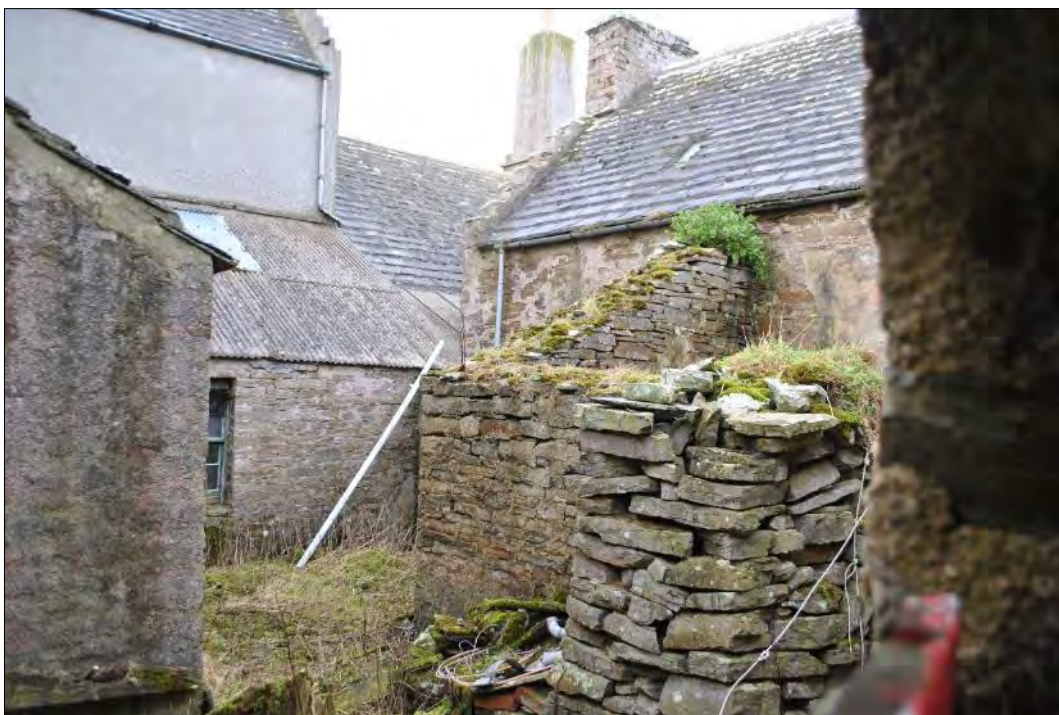
**Plate 72:** The courtyard at Holland House looking southwest through the partially blocked courtyard entrance. The north-facing elevations of the south wing and the service wing with a lean-to structure obscuring the ground floor level are in the right and centre background. On the right is the earlier structure, Building 3.2, with the roofless remains of another lean-to structure butting against its east-facing elevation.

The east-facing elevation of Building 3.2 was only observed through the partially blocked entranceway in the north courtyard wall. The extension in the angle of the building's original L-shape was seen to be a separate lean-to structure. This is stone rubble-built and is now roofless (see **Plate 72**). There are two small skylights in the roof above the east-facing elevation. Again, these are in the form of a single pane of glass replacing one or two stone slates.

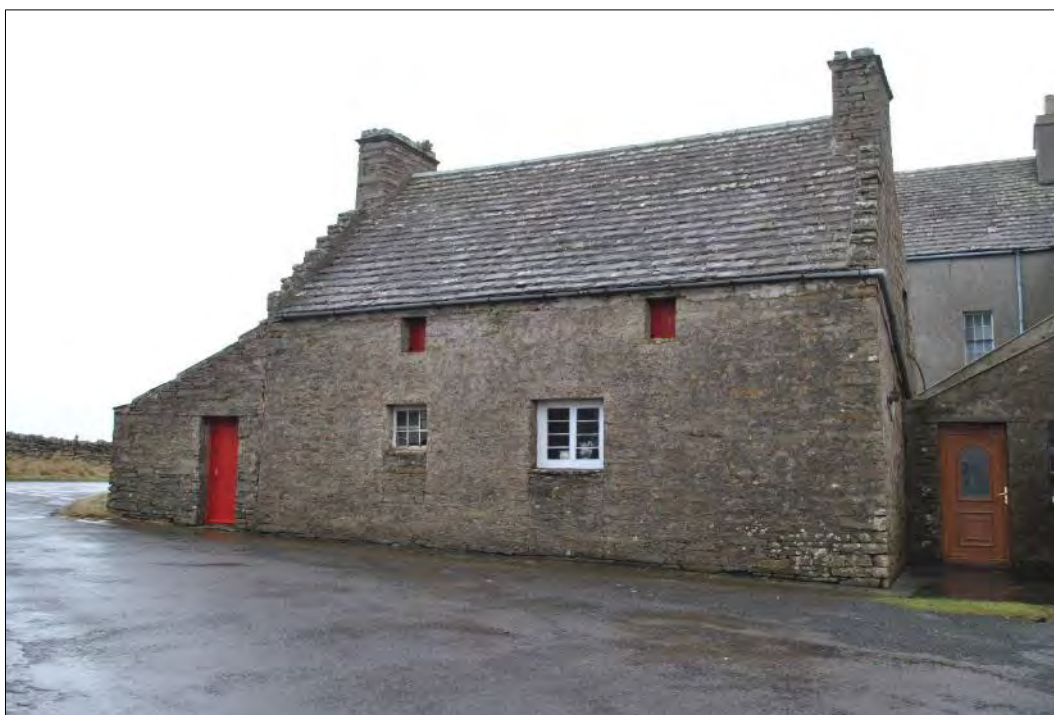
**Plate 73:** General view of Building 3.2 looking northeast from Central Road. The construction scar below the left ground-floor window is clearly visible, as is the construction break between this structure and the lean-to (Building 3.3) at the north end. The lean-to structure on the right with the modern door butts against the south wing and service wing of Holland House (Building 3.1)

**Building 3.2** stands at the northwest corner of the courtyard and is a stone rubble-built structure with a double-pitched stone slate roof (**Plate 73**). The current structure is rectangular in plan but the First and Second Edition Ordnance Survey maps depicted a slightly more complex plan comprising a longer north edge to create a more L-shaped style with a shorter extension to the plan in the angle of the 'L'.

The west-facing elevation shows a clear construction break with Building 3.2 (see **Plate 73**). There is an external doorway in this elevation with a stone lintel and threshold. It has an internal timber frame with a timber plank door. There are some patches of render which is particularly heavy around the butting join with Building 3.2 and the join with the roof stones.

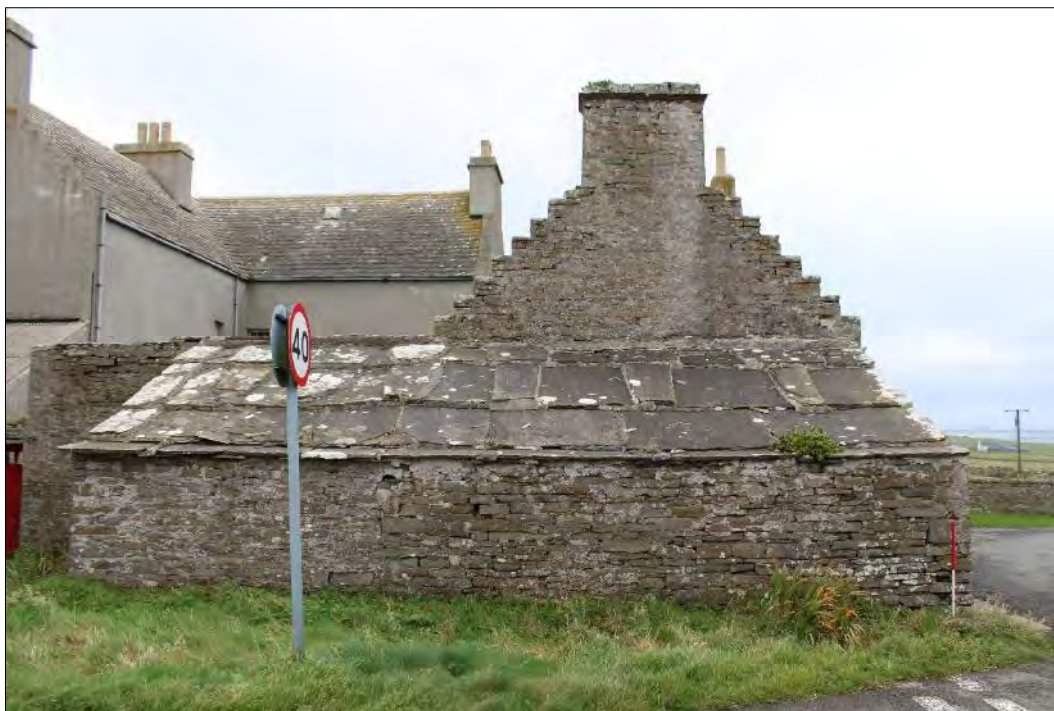
**Plate 75:** The north-facing elevation of Building 3.2 viewed from School Road showing how the wall extends beyond the gable end reflecting the original plan of the structure. Much of the elevation is obscured by a lean-to structure (Building 3.3).

**Building 3.3** is a lean-to structure butting against the north-facing elevation of Building 3.2. The First and Second Edition Ordnance Survey maps show the structure as only partially roofed with the east-third being roofless. The current structure has a flagstone roof throughout (see **Plate 75**) with stone rubble-built walls.

The north-facing elevation has no architectural features but there is one clear, and one probable, wall scar (see **Plate 75**). These are positioned quite close together and correspond roughly to the position of the boundary between the roofed and unroofed sections shown on the historic maps. The clear break shows a distinct change in the build quality of the wall with the constituents being less uniform, slightly smaller and a heavier use of mortar render. The probable break appears as a slight widening of the gap between constituents which is frequent, but not continuous, along a vertical plane. Neither of the scars is continued in the roof. These probably reflect partial rebuilding of the structure, possibly as part of modifications to extend the roof.

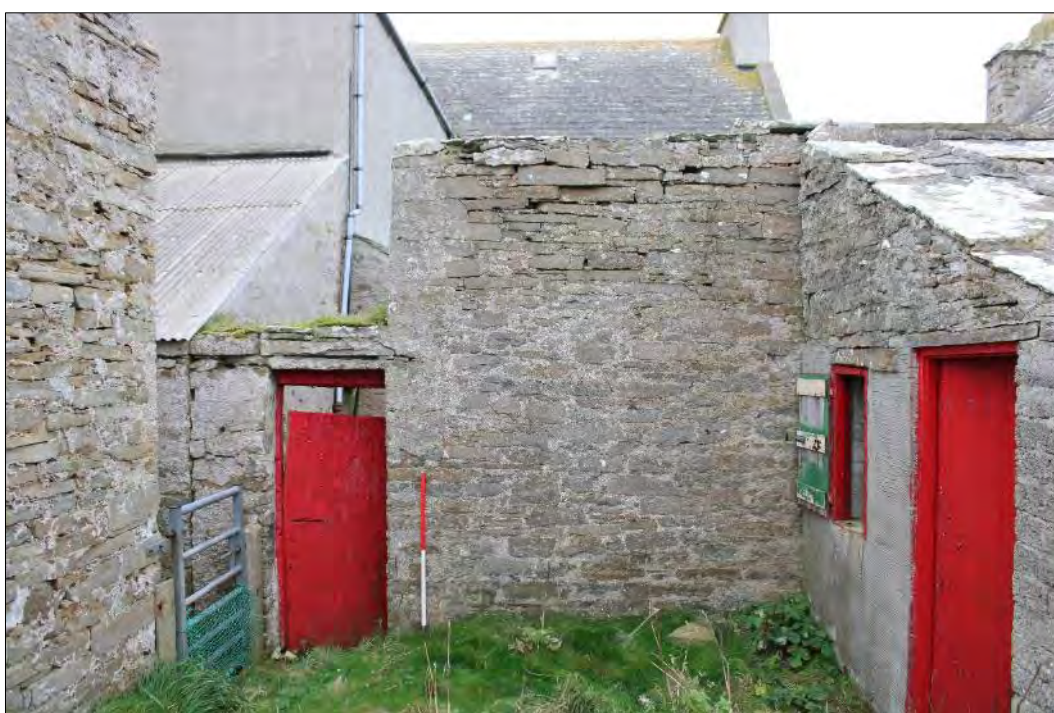
**Plate 76:** Detail of the east end of the north-facing elevation (Building 3.3) and the short north wall of the courtyard with the courtyard entrance.

The east-facing elevation contains an external doorway with a stone lintel and threshold, and an internal timber frame with a plank door (see **Plate 76**). To the left (south) is a window with a stone lintel and an external plank shutter which opens horizontally to the left. The right side of the doorway is built of brick-sized cement blocks and the whole of the elevation between the doorway, the window and the left edge of the elevation is rendered in cement mortar up to the line of the doorway top, with the stonework above this line and the butt end of the north elevation stands slightly proud of the cement render. This may indicate that the east elevation of the building originally had a much wider external doorway that included the area of both the current doorway and the window.

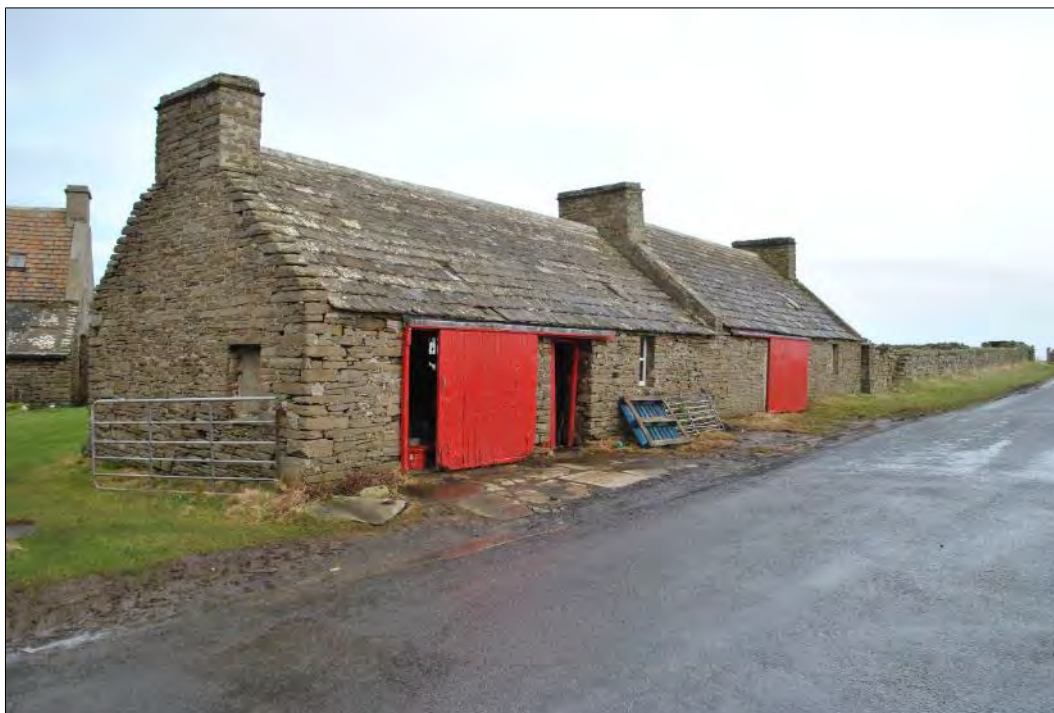
the east pitch and is clearly visible in exterior views of the building (**Plate 77**). There are chimney stacks in the gable ends of Building 4 and one in the centre above the dividing wall.

*Plate 77: General view of Building 4 looking northwest from Central Road.*

The south-facing gable end of Building 4.1 is crudely crow-stepped and has a large window on the right (east) side with a stone lintel and sill. This has been blocked by a single stone slab placed on end (see **Plate 77**).

The east-facing elevation of Building 4.2 contains a single, window with a stone lintel and sill and an internal timber frame divided into four panes, on the right (north); and a large external doorway on the left (see **Plate 77**). The doorway has a sliding, timber door within a metal runner fitted to the exterior elevation, below the eaves. Both this doorway, and the sliding doorway in Building 4.1, were considered to be later modifications. There is a single skylight in the east roof pitch of Building 4.2 comprising two panes of glass within a metal frame.

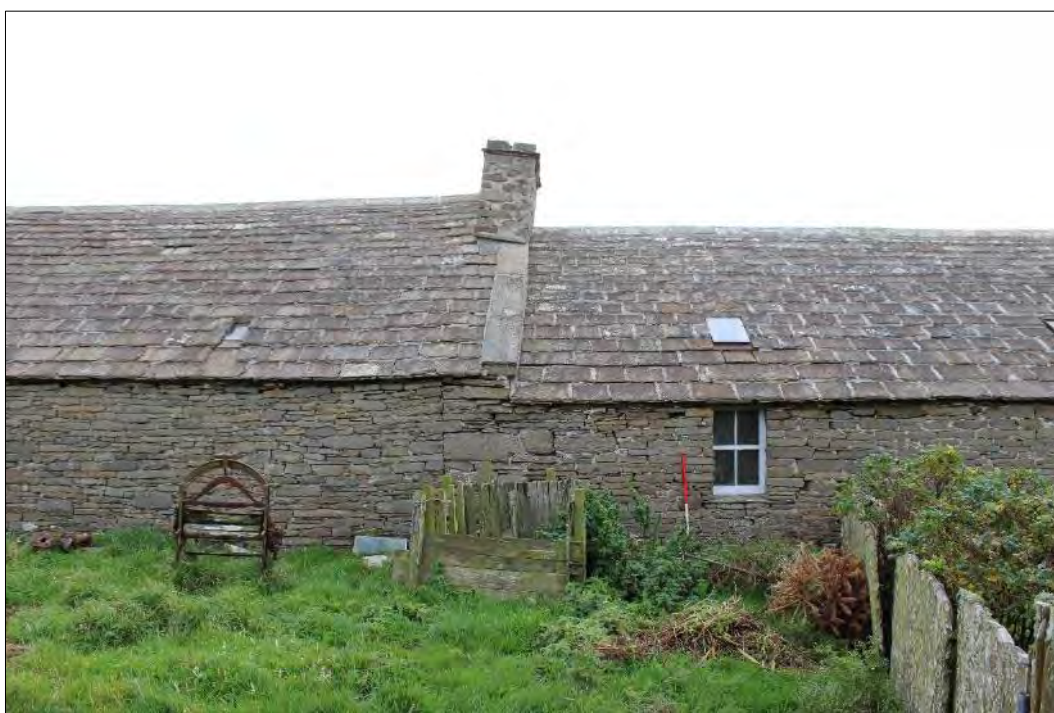
The west-facing elevation of **Building 4.1** contains a single window with a stone lintel and sill and an internal timber frame divided into four panes. There is a clear construction break between Building 4.1 and Building 4.2 which is seen as a vertical seam that is bridged by two stone constituents (**Plate 78**). The roof overseamers of Building 4.2 partially overlap the north elevation of Building 4.1, with the seam between the two walls being in line with the north edge of the centre dividing wall and chimney. This indicates that the dividing wall and chimney are part of the build of Building 4.1. There are two skylights in the west roof pitch of Building 4.1, both with metal frames.

**Plate 78:** The west-facing elevation of Building 4 showing the construction break between Building 4.1 (right) and Building 4.2 (left). The view also shows how the wall of Building 4.1 aligns with the chimney and the overlapping roof of Building 4.2.

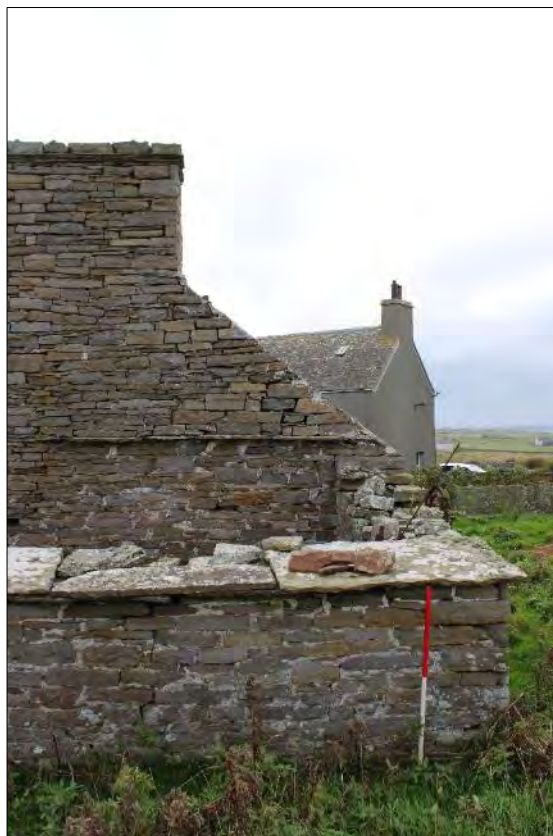
**Building 4.3** is a ruinous lean-to structure at the north end of the range. The structure is now roofless but historic map evidence and the remains of roof flagstones along the top of the north elevation show that the structure was originally roofed (**Plate 79**). The west-facing elevation shows that the structure butts against the north end of Building 4.2 with no interlocking of the stone constituents across the construction break. Both the west- and north-facing elevations are plain. The east-facing elevation contains the access doorway to the structure. The south

edge of the doorway is formed by the northeast corner of Building 4.2. The stone lintel of the doorway has been inserted into the stonework of Building 4.2. Only one fragment of Building 4.3's stonework survives *in-situ* above the lintel and this appears to confirm that the lean-to structure as a whole butts against Building 4.2's north gable and is probably, therefore, a later addition.

**Plate 79:** The northwest corner of Building 4.3 looking south, showing the remnants of the flagged roof and the north elevation of Building 4.2 with the line of mortar indicating the former roof line of Building 4.3.

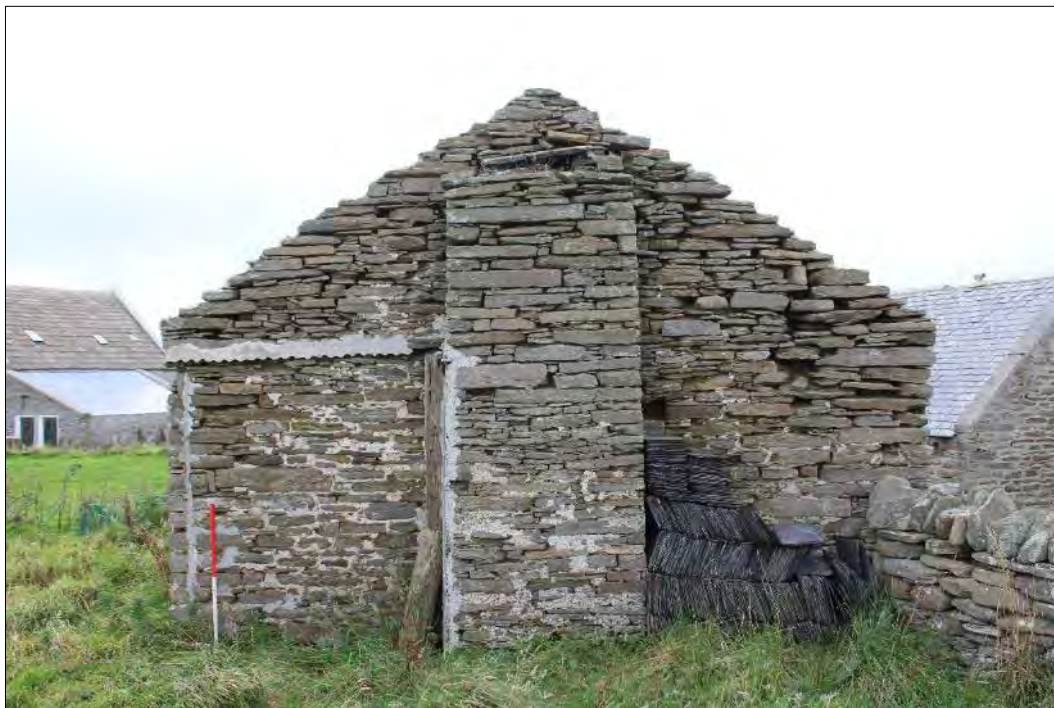
The north-facing gable end has a centrally-placed, outstanding chimney lumb which is truncated below the level of the gable top (**Plate 82**). Cement mortar deposits to the left (east) of the chimney and on the chimney stonework indicate that a flat-roofed structure had

previously butted against the north gable. An upright timber in the angle of the join between the chimney and the gable wall is probably a remnant of this structure. The horizontal line of mortar on the gable end also shows that the structure had a corrugated roof.

*Plate 82: North-facing elevation of Building 5 showing the outstanding chimney lumb and the mortar deposits indicating the former presence of a lean-to with a roof of corrugated material.*

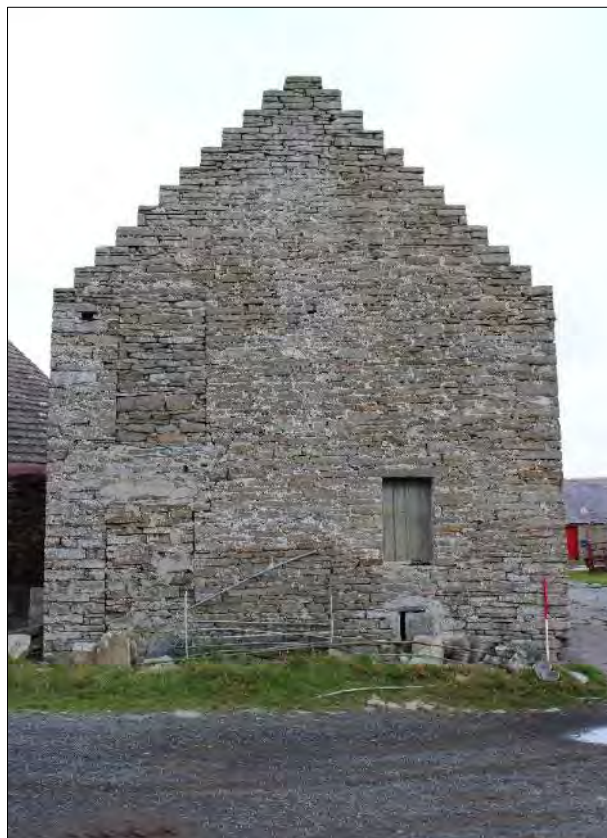
**Plate 89:** West gable of the threshing mill (Building 6.3) showing the blocked doorways (left) and window (right) with an opening below.

The west-facing gable is crow-stepped and has two external doorways on the left at ground and attic level (**Plate 89**). Both have stone lintels and have been blocked using stone rubble constituents. To the right is a ground floor window, similar in size to those of Building 6.2, with a stone lintel and sill. This has been blocked by a corrugated metal sheet. Below this is a smaller opening, centred on the window, with a stone lintel. Much of the surrounding stonework is covered by a cement mortar, particularly the sides and interior of the aperture. The opening resembles an oddle hole, possibly related to the original use of the structure but the form of the opening in the interior elevation, with its appearance of being cut into the

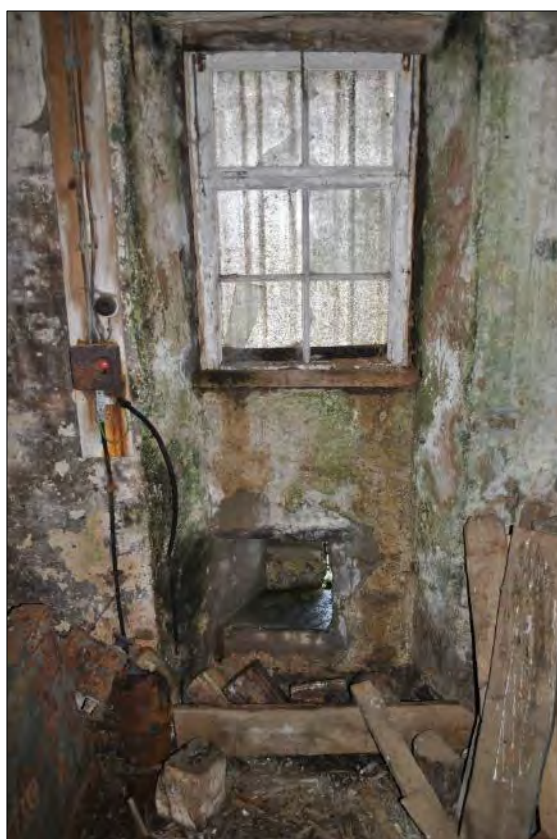
**Plate 90:** Detail of the west gable of the threshing mill showing the opening cut into the wall below the window.

window bay and the positioning of machinery in the ground floor room would seem to indicate that this opening is a later modification as part of the use of the structure as a powered threshing mill (**Plate 90**).

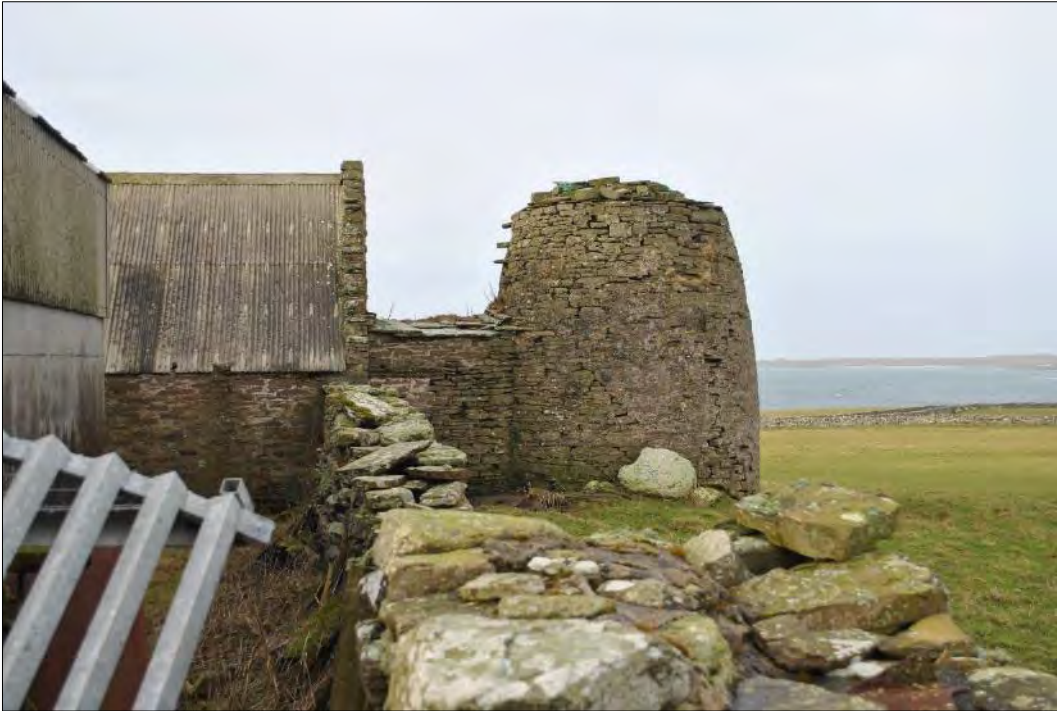
Building 10 stands at the northwest corner of the Holland Farm buildings. It is a single storey structure, with a loft, and stone rubble-built. Rectangular in plan with a circular corn drying-kiln attached to the north end (**Plate 96**). The double pitched roof comprises large, corrugated sheets, probably of asbestos.

**Plate 96:** General view of the corn drying-kiln at the north end of the old threshing barn (Building 10), and linked by a short, roofed passage.

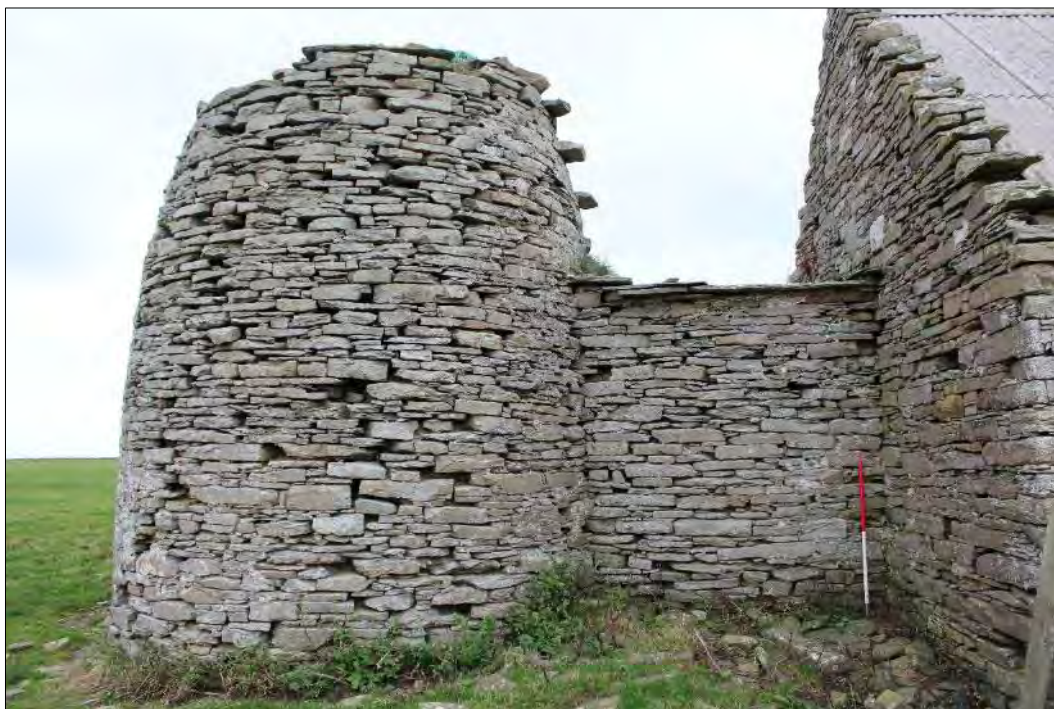
**Plate 99:** Detail of the corn drying-kiln (Building 10) showing the short linking passage with flagged roof and the outstanding stones forming a staircase leading to the top of the kiln.

The north-facing gable end is crow-stepped. Much of the lower left quarter of the elevation is occupied by the short passage which links the barn with the kiln (see **Plate 96**). The passage has a flat roof of stone flags. There are also some remaining flagstones on the roof of the kiln. The kiln is circular in plan with a slight beehive profile. A series of stone constituents outstanding from the south side appear to form a rough line of step to the top of the kiln (**Plate 99**).
