## **The Industrial Heritage of the North Isles Orkney**

## **Research and Interpretation Project Data Structure Report**

February 2025

**Project No: 996**

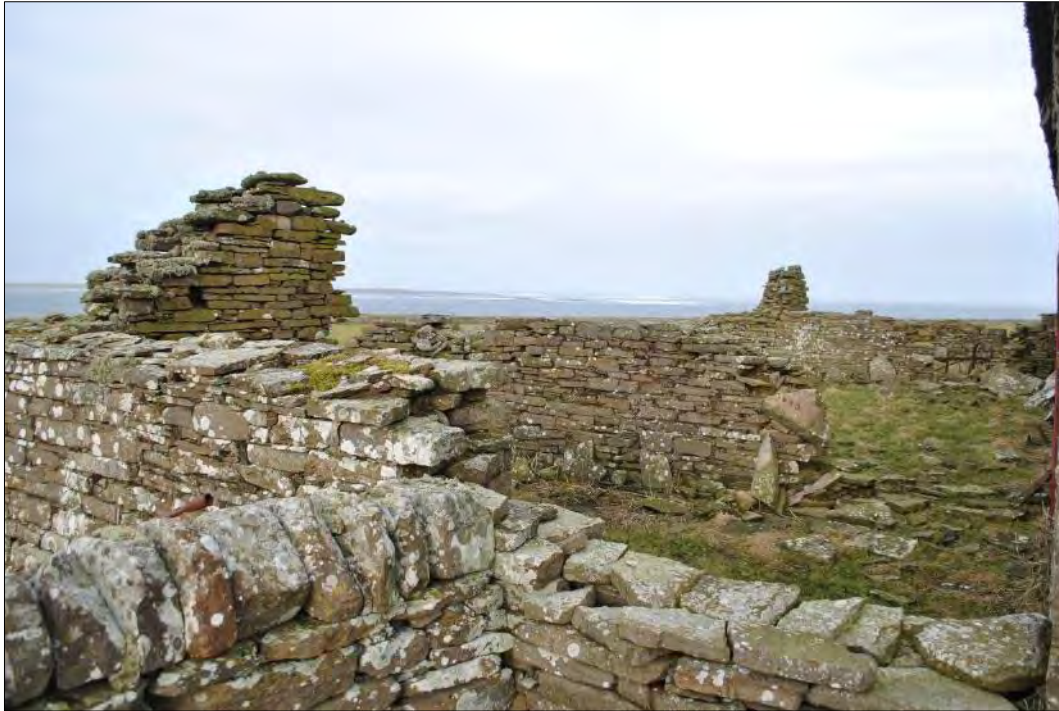
Buildings 11 and 12 and a pair of parallel structures running perpendicular to Building 10. Both structures are stone rubble-built, roofless and ruinous (**Plate 100**).

*Plate 100: General view of the sheep sheds, Buildings 11 and 12, looking northwest from the southwest corner of the old threshing barn.*

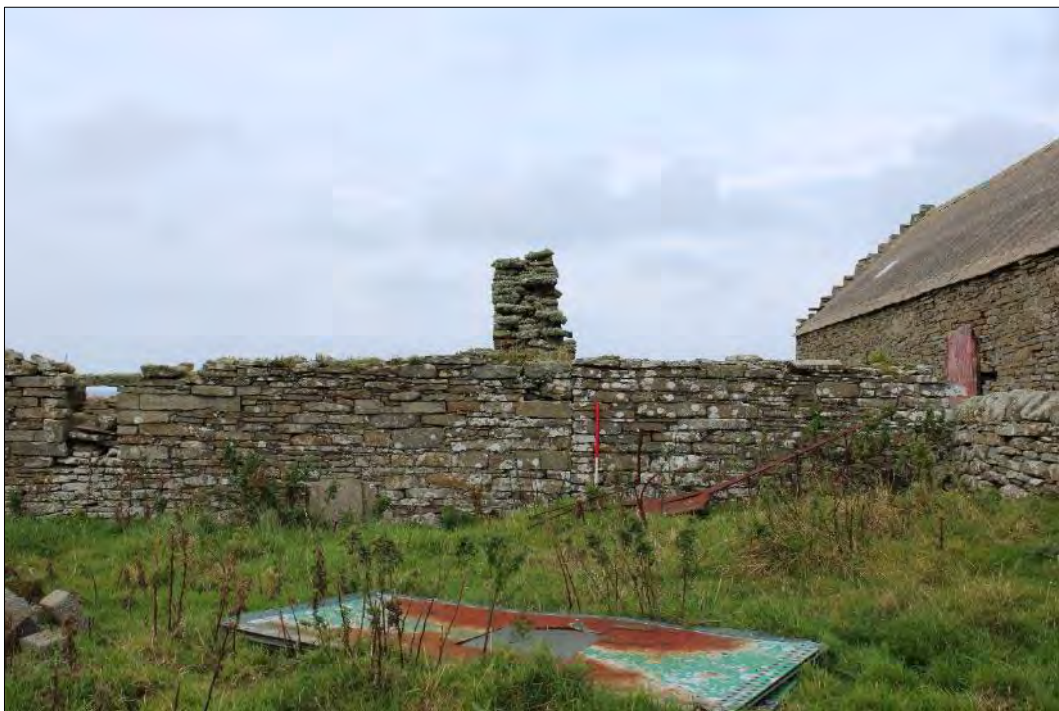
*Plate 101: The east end of the south-facing elevation, Building 11, showing the upstanding east gable and the construction break with the annex (Building 11.1).*

Butting against the east end of Building 11 are walls associated with its later extension, **Building 11.1**, as shown on the Second Edition Ordnance Survey map. There is a clear construction break in both the north- and south-facing elevations (**Plate 101**), and the build characteristics of the north elevation are noticeably different. The OS map depicts both walls

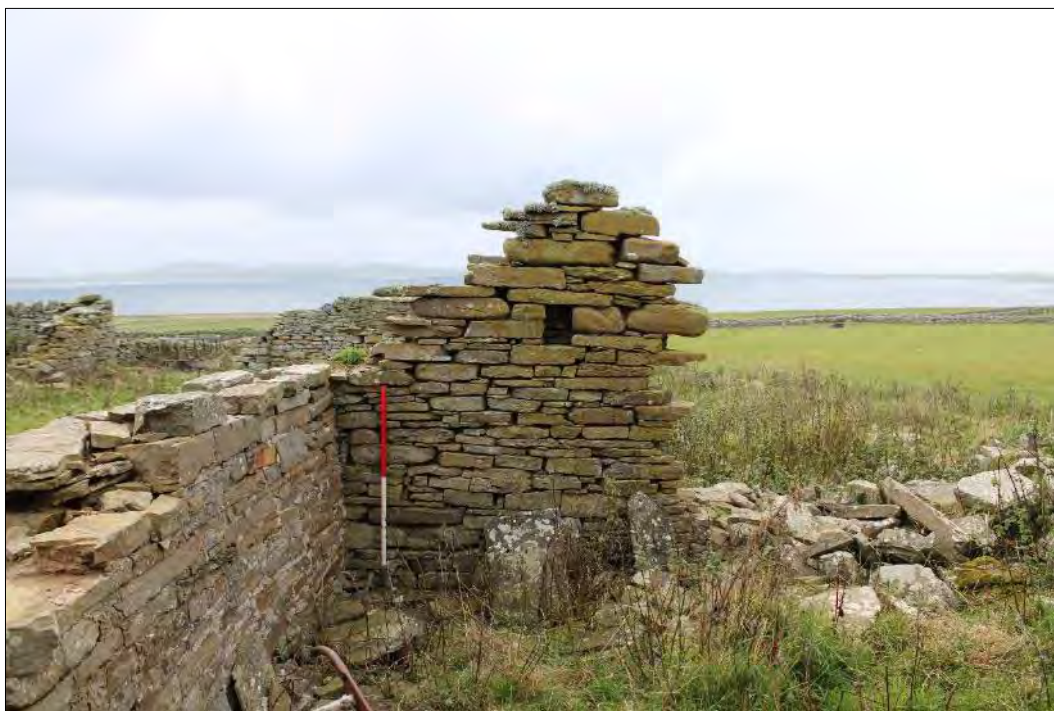
**Plate 102:** The east-facing gable of Building 12 with the south wall of Building 12.1 (left) butting against it. Behind the gable, to the left, is the enclosure wall between Building 12 and Building 11 and, on the extreme left, is the northwest corner of Building 11.

**Building 12** is the northern building of the pair and its size and form are identical to that of Building 11. The south elevation is poorly preserved. There is a c.2.5m long section surviving to full height at the southeast corner, and a c.3m long section, six courses high, at the southwest corner. The section at the west end preserves the west, lower side of an external doorway, the position of which matches the west doorway in the north elevation of Building 11. The east-facing gable end is partially preserved (**Plate 102**) and it appears to be identical to that of Building 11. The west gable and the north elevation exist as linear spreads of stone rubble with occasional earth-fast constituents remaining *in-situ*.

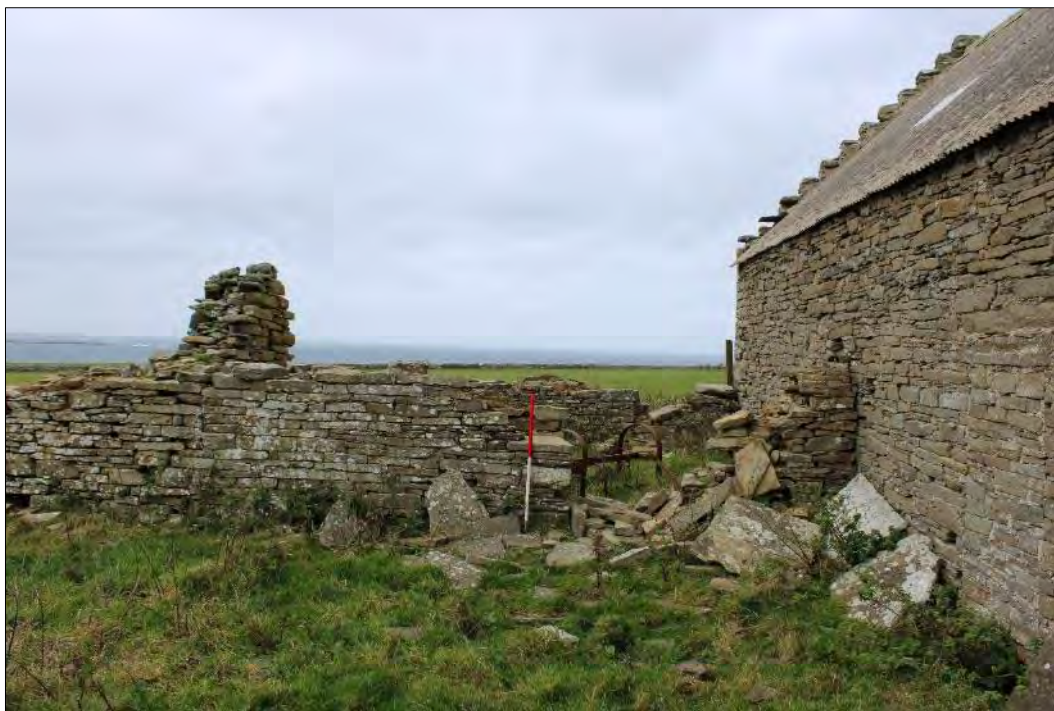
The walls forming the extension, **Building 12.1**, are preserved to a greater extent (**Plate 103**). Almost the full length of the south elevation is preserved with only some constituents missing around the east side of an external doorway. The wall butts against the west elevation of Building 10 with mortar or other bonding material visible at the join. The south elevation appears to have originally stood to the same height as that of Building 12 itself. The north elevation is preserved to approximately half of its original height with most of the north-facing elevation obscured by wall collapse. Again, the elevation butts against the west elevation of Building 10 with no evidence for mortar bonding. There is a window in the north elevation directly opposite the external doorway in the south elevation. There was no visible evidence identified for a roof on Building 12.1.

**Plate 103:** *The annex to Building 12, looking north. The doorway is visible to the right of the upright scale and the left side window in the wall beyond is also discernible. The walls of the annex can clearly be seen to butt against both Building 10 (right) and Building 12.*

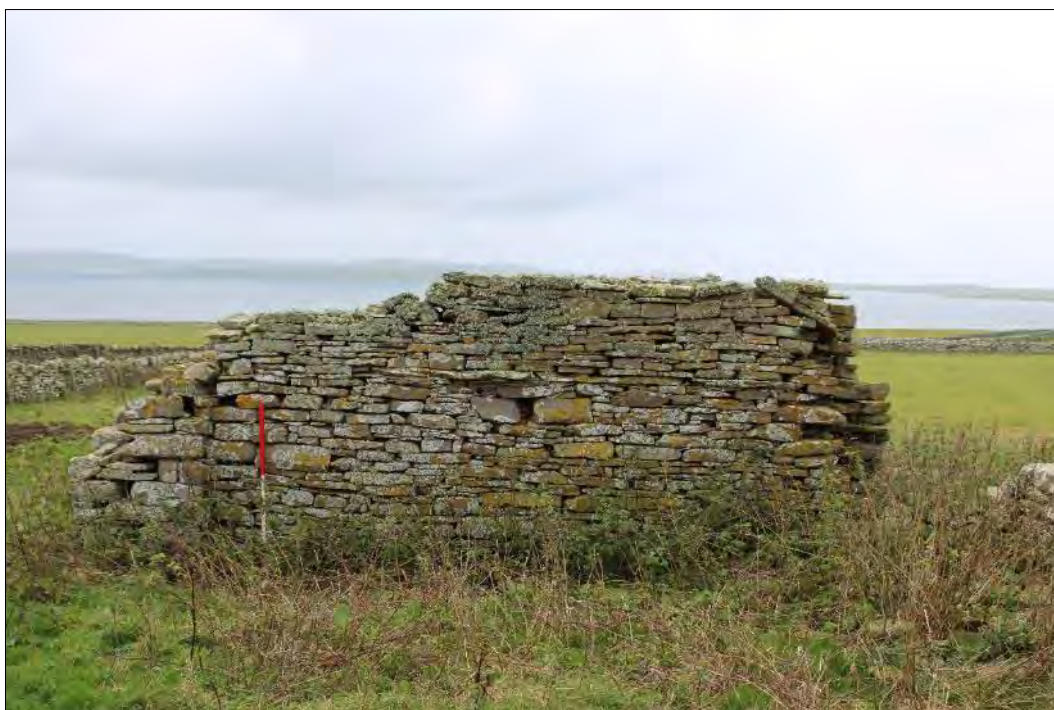
**Plate 104:** *The east-facing (interior) elevation of the enclosure wall between Building 11 and Building 12 showing the short return at the south end (left).*

An enclosure wall linking Building 11 and Building 12 is upstanding at the west end of these structures (**Plate 104**). This is stone rubble-built, preserved to a height of approximately 2.5m which is higher than the north and south elevations of Buildings 11 and 12, and similar to the

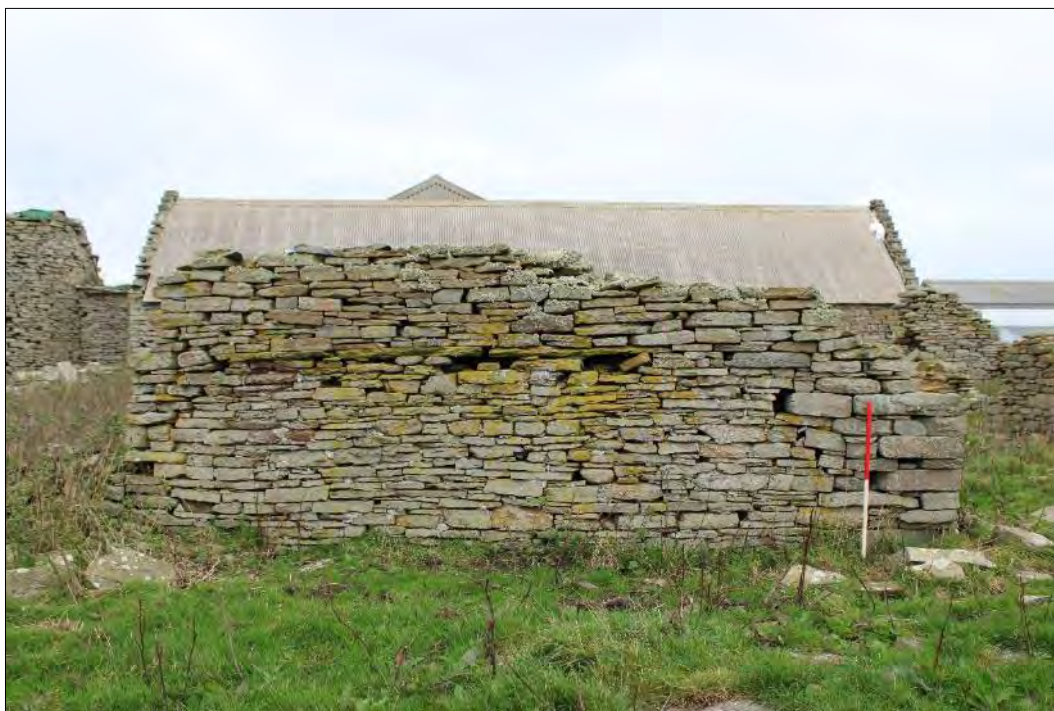
full height of the gables. The north end of the enclosure west wall has been truncated and the nature of the building join with Building 12 could not be determined, though at the base of the west-facing section there are a number of constituents that may butt against the southwest corner of Building 12. The wall had a short, east return at the north end, creating the north side of an opening/entrance with the northwest corner of Building 11 (see **Plate 102**). This opening is not shown in any of the historic Ordnance Survey maps. The south end of the west-facing elevation contains much larger stone constituents which may be indicative of this end of the wall, and hence the return, being re-built or modified (**Plate 105**).

**Plate 105:** *The west-facing (exterior) elevation of the enclosure wall between Building 11 and Building 12 showing the possible re-build at the south end (right). Also visible at the base of the north end are the four course of stonework which appear to butt against the southwest corner of Building 12.*

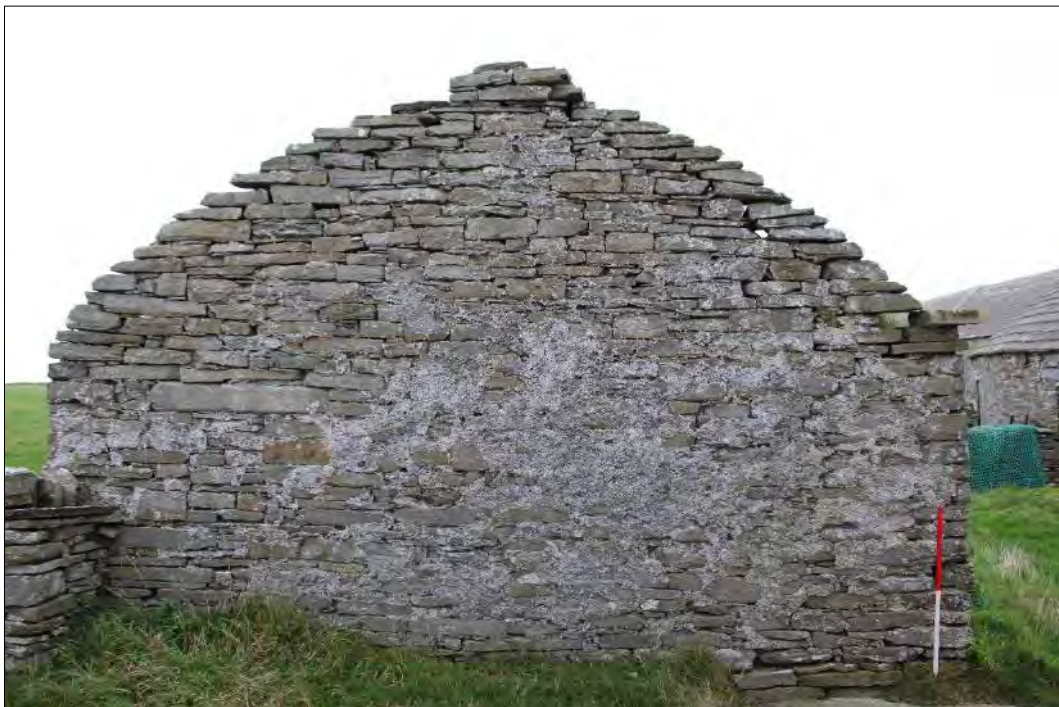
**Plate 107:** West-facing gable end of Building 13 illustrating the slightly convex nature of the gable. The blocked small window is visible towards the north end (left).

The west-facing gable end has a slightly convex nature (**Plate 107**). This is a small window on the left (north) side with a relatively thick lintel. There is no discrete sill and the window has been blocked with stone rubble constituents. There are the remains of a chimney stack at the apex of the gable and a lumb is visible on the interior elevation. The east-facing gable is completely obscured by vegetation though a chimney lumb is visible within the interior elevation.

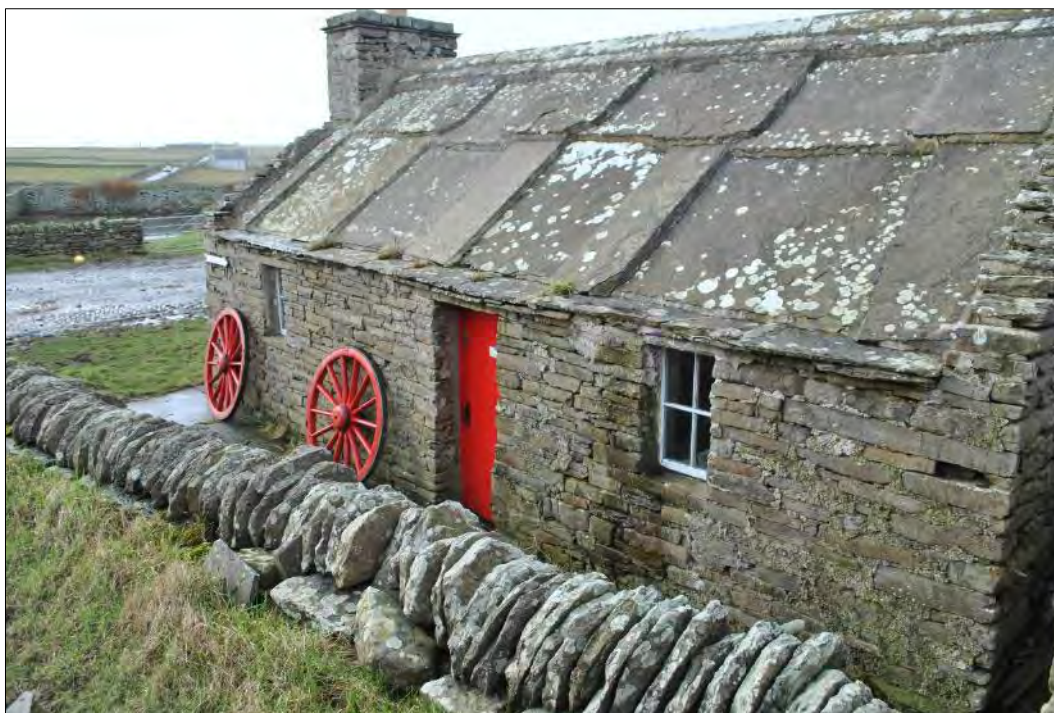
**Plate 108:** General view of the east-facing elevation of Building 14, looking southwest.

Building 14 is a detached, single storey structure running northwest-southeast and located close to the southwest corner of Kye's Byre (Building 8) (**Plate 108**). It is stone rubble-built with a double-pitched, stone flag roof.

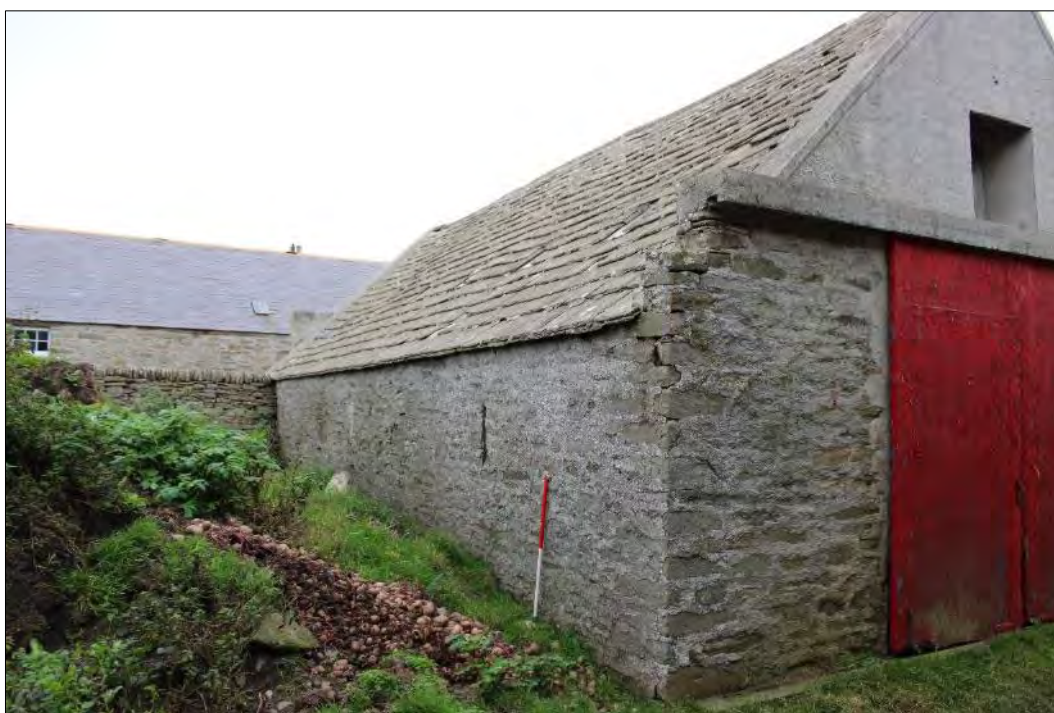
Building 15 stands immediately north of Building 14. It is flagstone rubble-built structure, single storey with a loft section at the east end. The building is partially cut into a bank at the east end (**Plate 109**). The double pitched roof comprises stone slates with skylights in each pitch.

**Plate 109:** General view of Building 15, looking southeast, showing the differing ground surface levels at the west (foreground) and east ends (background).

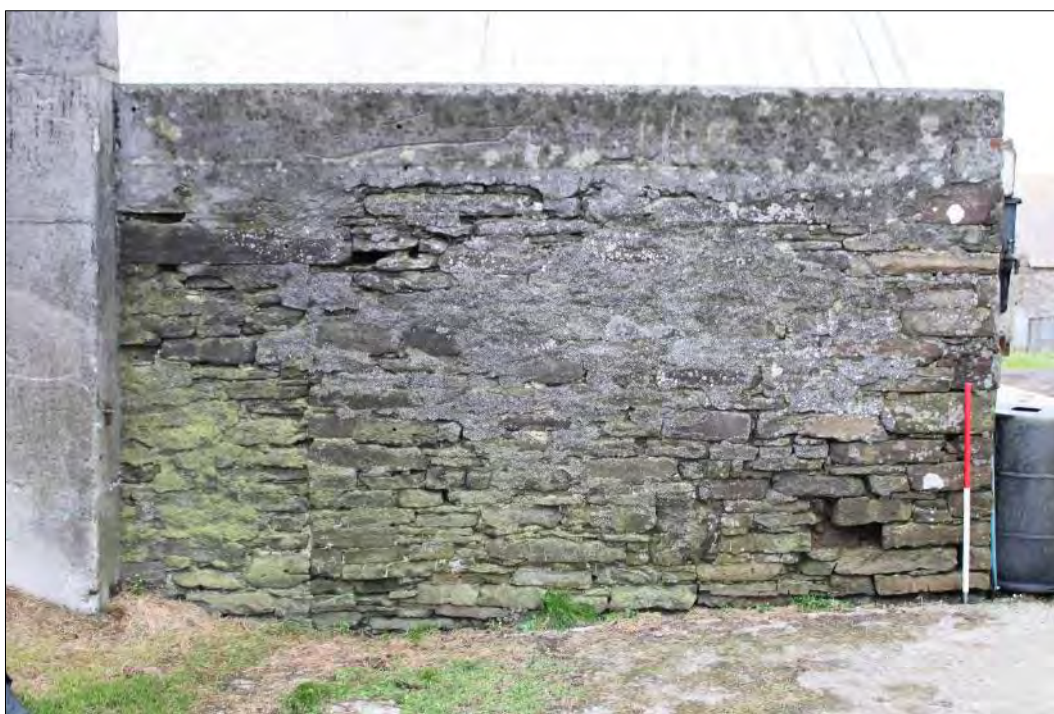
**Plate 110:** Length of upstanding wall (Building 17) incorporated into a modern agricultural shed, looking southwest. It is possible that this was originally part of a byre shown on the 1844 plan. A blocked doorway or window is visible at the south (left) end.

A length of stone rubble walling, **Building 17**, was identified in the exterior wall of the modern byres west of Building 14 and Building 15 (**Plate 110**). This was interpreted as a remnant of an earlier structure which has been incorporated into a more recent structure and, on the basis of historic map evidence, the walling was considered to have been part of a byre which ran

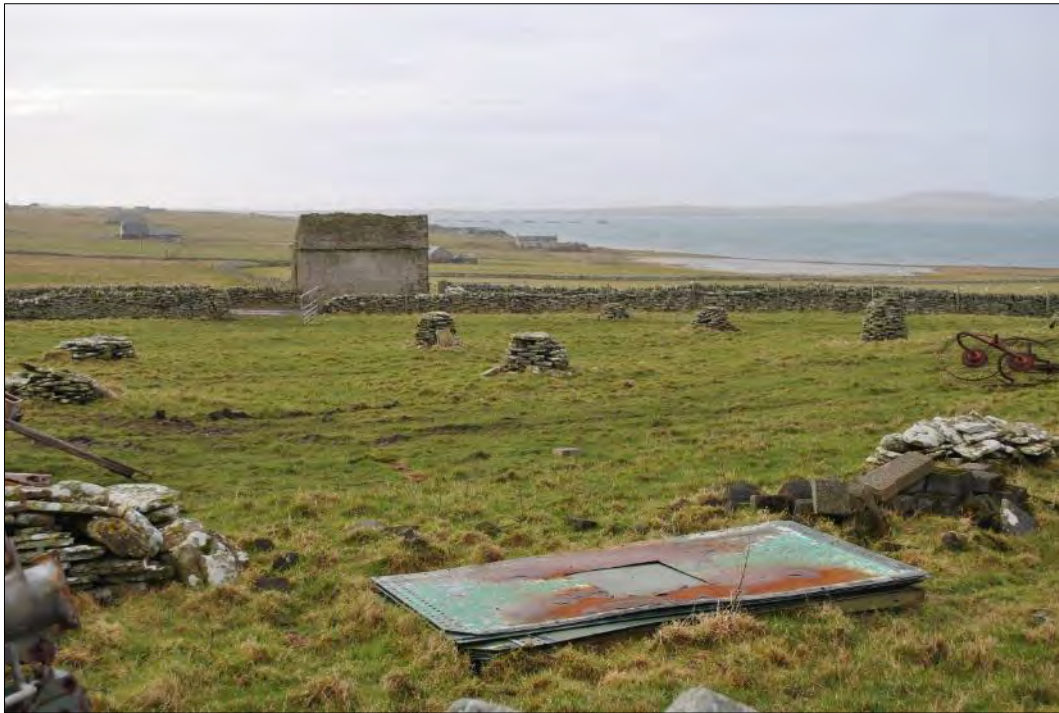
*Plate 111: General view of the stackyard, looking south.*

The enclosure to the southwest of the Holland farm buildings is the stackyard (**Plate 111**). Circular dry stone-built platforms (steethes) are used to raise cornstacks off the ground. A total of seventeen platforms were identified during the fieldwork and these were surveyed using a Lecia (**Figure 12**). These were circular in plan with a conical or beehive profile (**Plate 112**) having an average height of 1.2m and diameter of 1.4m. A short section of enclosure walling, **Structure 16**, located to the west of the modern byres and north of the modern silage tank, was considered to be an upstanding remnant of the former east wall of the stackyard. The stackyard also forms part of the general listing (LB 18600, Stackyard) for the site area to the west of Central Road, and is designated as Category B.

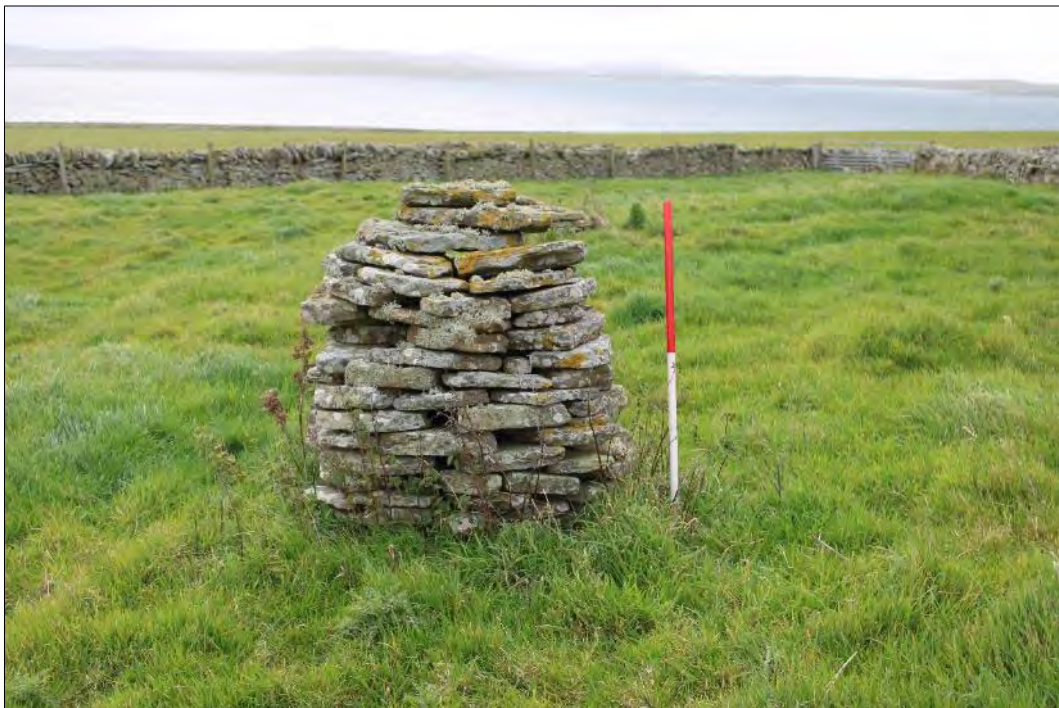
*Plate 112: An example of a stone platform (steethe) in the stackyard.*

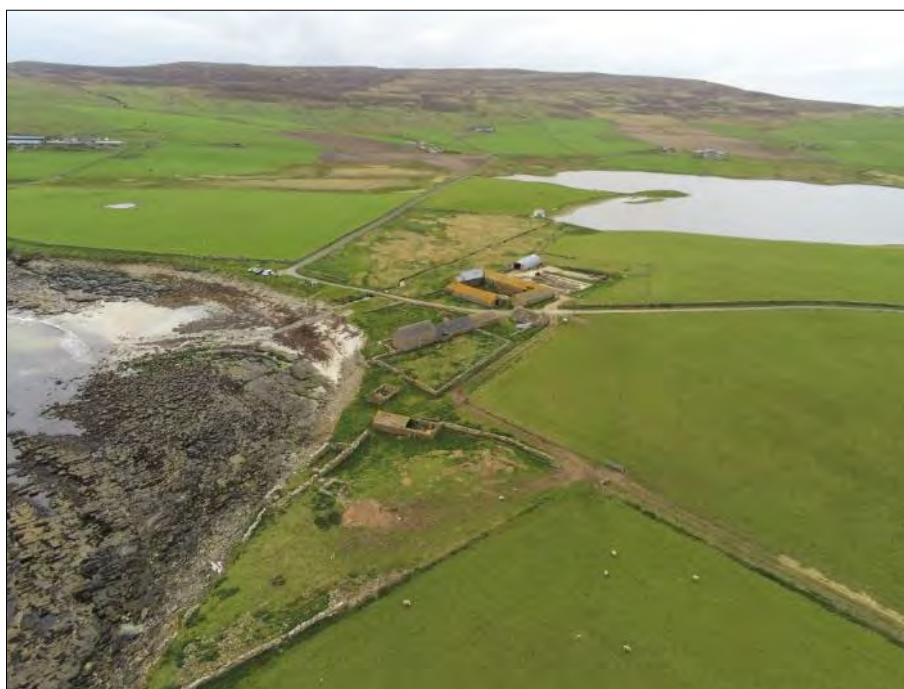
Saviskaill is located at NGR HY 40030 33502 in the northwest of Rousay and stands between the Loch of Wasbister and the beach at Saviskaill Bay. The site comprises a series of ruinous structures, unoccupied domestic buildings, and farm buildings which are still in use (**Figure 13; Plate 113**).

**Plate 113:** Aerial view of Saviskaill Farm, looking southwest, showing Saviskaill Bay (left) and Loch of Wasbister (right). The ruinous, and partially eroded, structures are in the foreground with the unoccupied domestic buildings behind. On the far side of the roadway are the nineteenth-century agricultural and mill buildings with a modern agricultural shed furthest away (© Robert Friel).

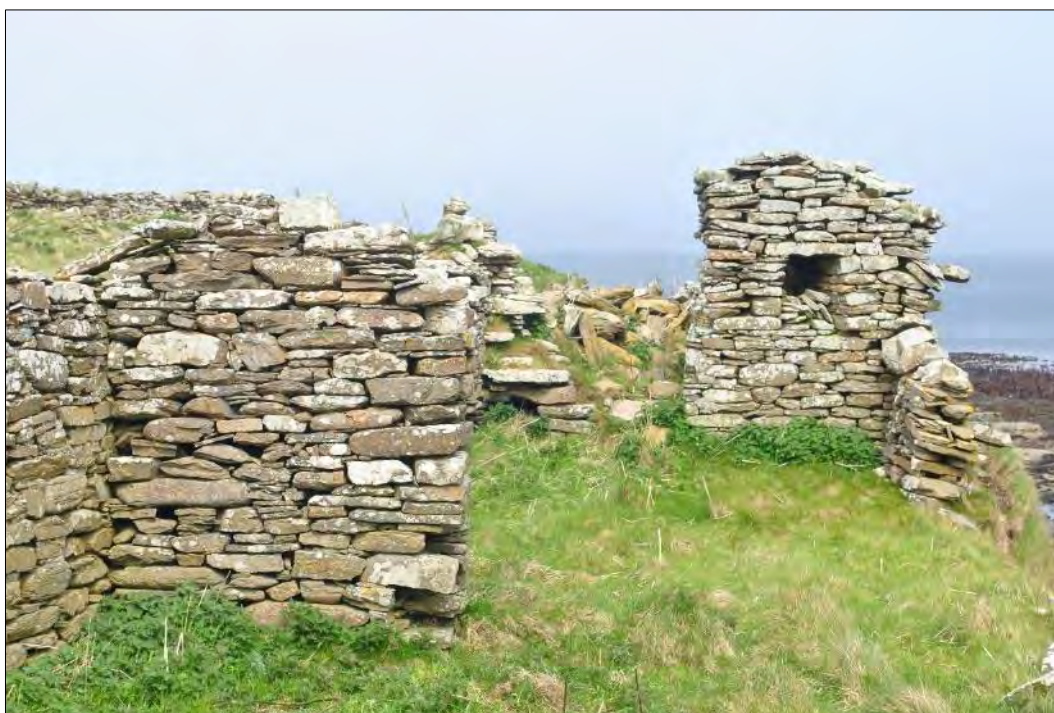
*Plate 114: View from FB 2 of FB, looking northeast, showing loss of the east wall (right) and the upstanding remains of a corn drying-kiln (background centre and right).*

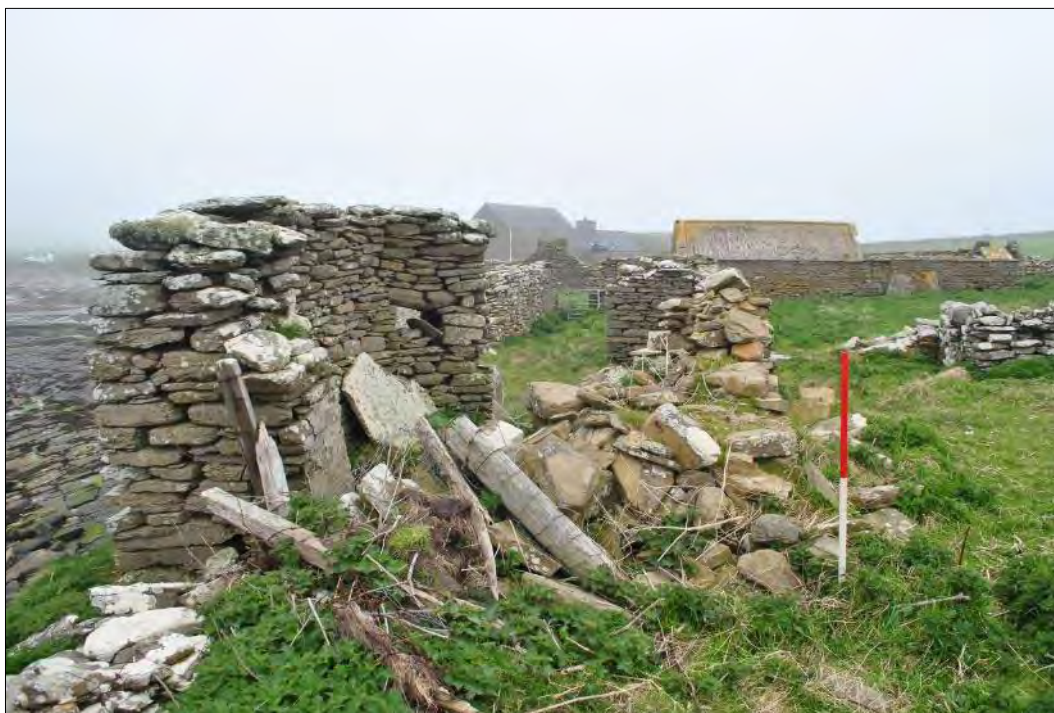
south elevation in FB 1.2. The north annex has a raised, stone-built floor standing approximately 0.3m above the interior ground surface. The east elevation of the annex, and the connecting east ends of the north and south elevations, are preserved to a height of approximately 1.75m. These show that the interior elevations were concave and that the interior space of the annex was very probably circular in plan (**Plate 115**). There is a rectangular aperture in the remaining fragment of the annex's south elevation. The annex was interpreted as the remains of a corn drying-kiln.

**Plate 115:** View of the annex at the north corner of FB 1, looking southwest, showing the concave shape of the interior elevation and the aperture in the south elevation. The second annex is visible to the west (right) of FB 1 and FB 3 is visible southwest of FB 1 (right background).

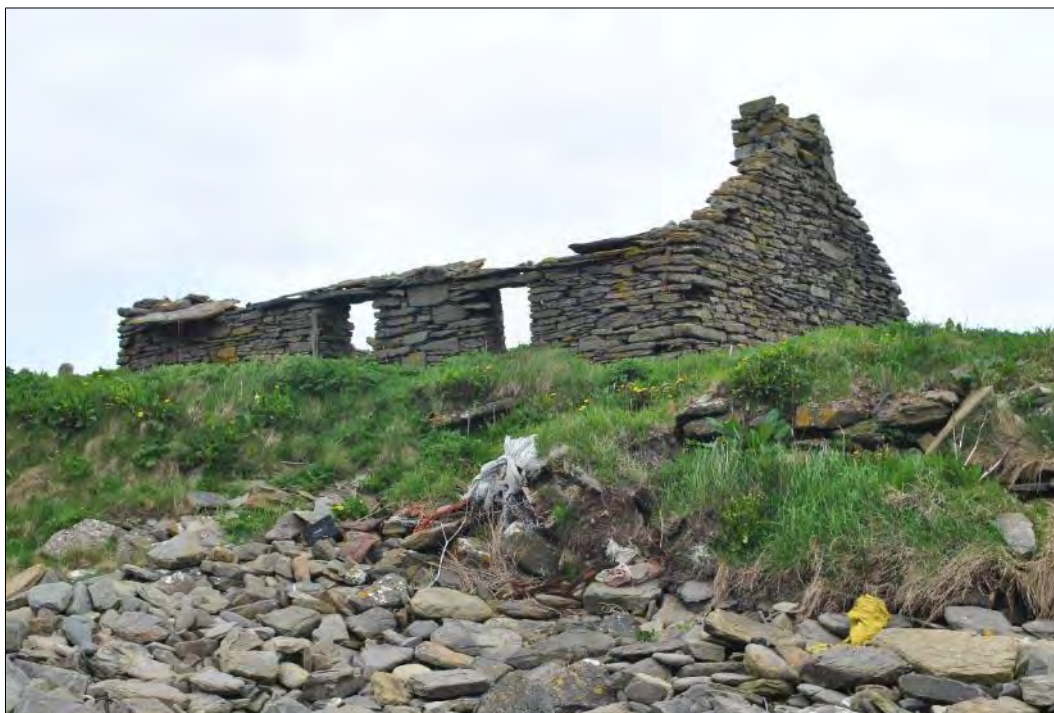
**Plate 116:** General view of FB 4, looking west from the beach at Saviskail Bay.

FB 4 is a former domestic structure, now ruinous, located south of FB 3 (**Plate 116**). Most of the walls survive to the height of the eaves, including the southeast-facing gable, though the northeast-facing gable survives to full height. There is a centrally-placed external doorway, with a stone lintel, in the southeast-facing elevation and a window, with stone lintel and sill, to its right (north). In the corresponding position to the left (south) of the doorway is a vertical construction break which may be indicative of a window originally being present in the elevation. There is, however, no construction break marking the other side of the window aperture, and no lintel or sill could be identified. The southwest-facing gable has collapsed above the level of the eaves and no features were identified in the elevation. The northwest-facing elevation stands to the same height and, again, no features were identified in the elevation. The northeast-facing gable is almost complete with the chimney stack showing minimal signs of collapse though it leans considerably towards the interior of the building. A small section of roof survives in the north corner with three or four large flagstone slabs remaining *in-situ*. The interior of FB 4 is filled with dumped spoil and timber window frames, and collapsed roof materials, all covered by scrub vegetation. The interior of the building was inaccessible and unsafe but the northeast and southeast were examined from an external position. The fireplace, with a large stone lintel, was clearly visible in the northeast elevation (**Plate 117**). To the left (west) was an integral storage cupboard divided by a stone shelf. No additional features were identified in the southeast elevation though it was noted that the construction break seen in the exterior elevation was also visible internally.

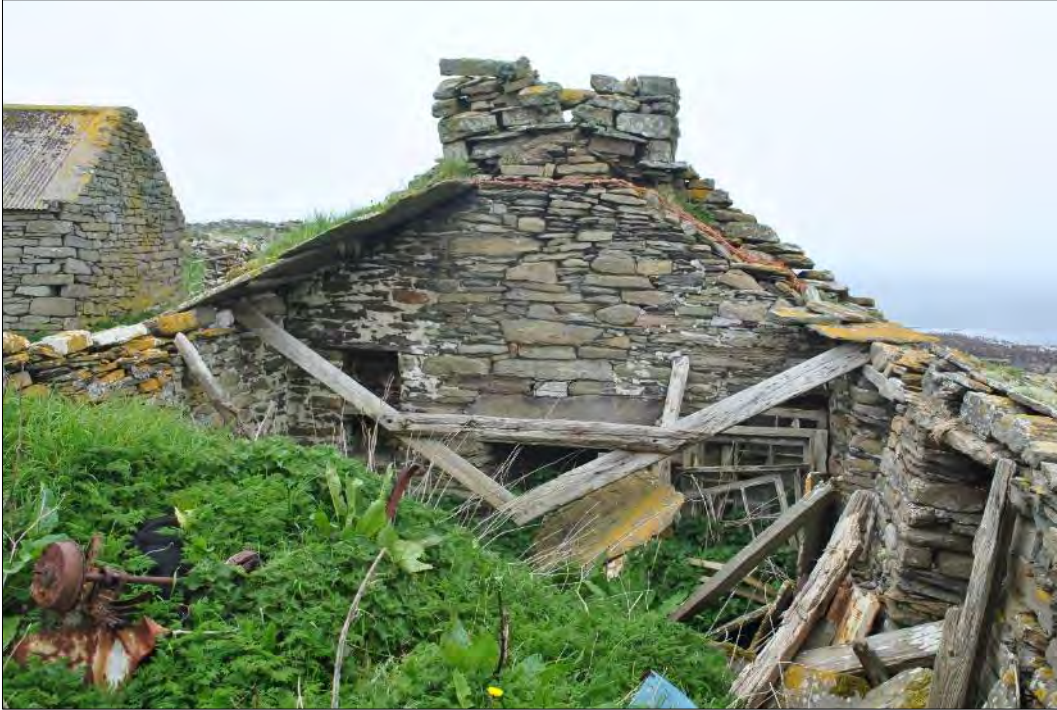
**Plate 117:** Northeast elevation of FB 4 showing fireplace, lumb, integral cupboard and remains of the flagstone roof.

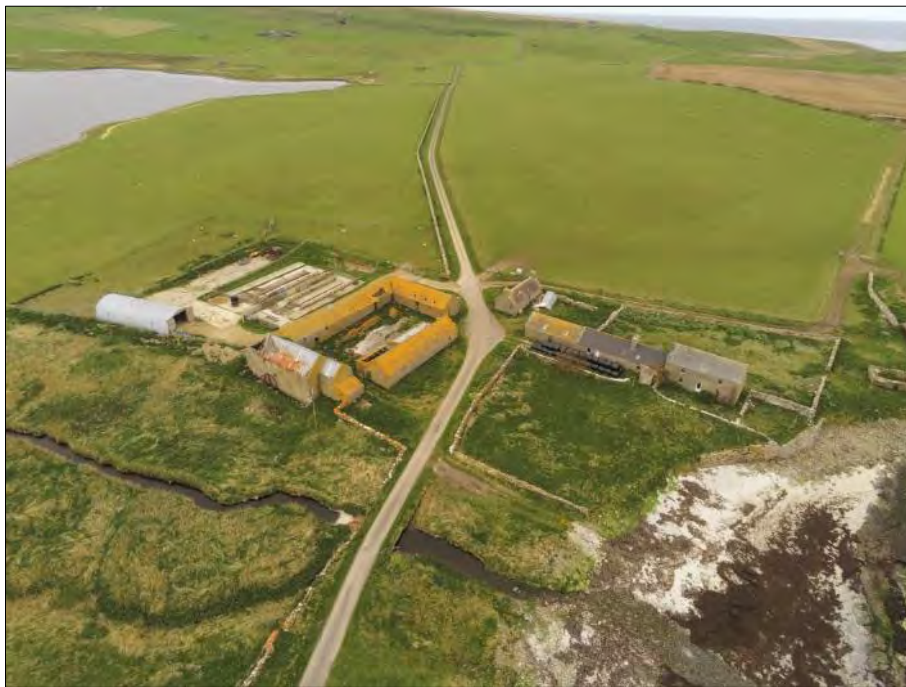
**Plate 118:** Aerial view of Saviskail Farm, looking northwest, showing the domestic range (FB 5, 6, 7) and the single dwelling (FB 8) to the east of the road (right). To the west of the road are the free-standing byre (FB 9) and the complex containing the water-powered mill (FB 10) and the attached byres (FB 11, 12) (© Robert Friel).

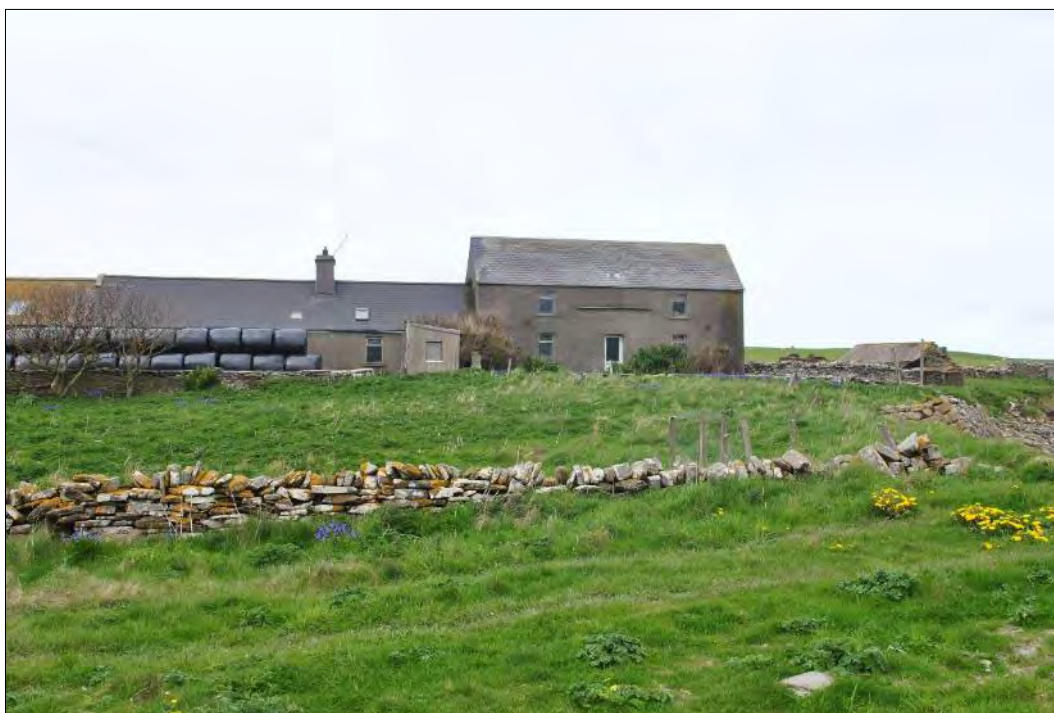
**Plate 119:** South-facing elevation of FB 5 (right centre) and FB 6. The chimney stack in FB 6 probably marks the division between the centre and west (left) structure shown on the First Edition 25-inch OS map.

FB 6, a single storey structure, stands against the west-facing gable of FB 5 and comprises the two structures (FB 6.1, centre; FB 6.2, west) shown on the First edition map forming the centre and west parts of the range. The location of this internal division is probably marked externally by the chimney stack (**Plate 119**). Both the north- and south-facing elevations of FB 6.1 were covered in the same thick render as FB 5. This is seen to be continuous in the north-facing elevation. The external doorway is placed right (east) of the centre line in the south-facing elevation but this is obscured by a modern porch structure comprising a timber frame with corrugated concrete sheets forming the sides and roof. There is a window to the left (west) of the doorway with a modern frame in the same style as those in FB 5. There is a similar window at the east end of the north-facing elevation. Much of the remainder of this elevation is obscured by a large, concrete structure standing as tall as the elevation and supporting a modern, plastic oil tank. The roof comprises modern roofing tiles with plastic guttering along the north and south edges, and there are modern roof windows in both sides.

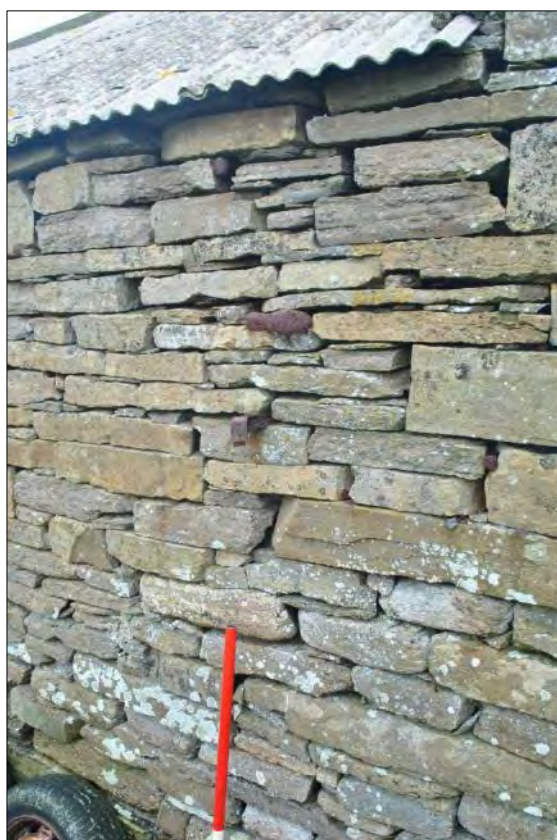
FB 7 is the extension to the range which was erected, on the basis of historic mapping, sometime after 1902 and prior to the 1970s. This is of stone rubble construction and there is a clear construction break in the north-facing elevation. This was not evident in the south-facing elevation due to extensive re-pointing of the stonework and the positioning of an external doorway in the position where the construction break was likely to be present. The west-facing gable contained a centrally-placed, large external doorway with sliding timber doors. The stonework around the doorway could not be examined so it was not possible to determine if this doorway was a later addition. One interesting feature was the presence of a shoe-last inserted into the north-facing elevation between the stonework (**Plate 120**).

**Plate 120:** Shoe-last inserted into the stonework of FB 7, north-facing elevation.

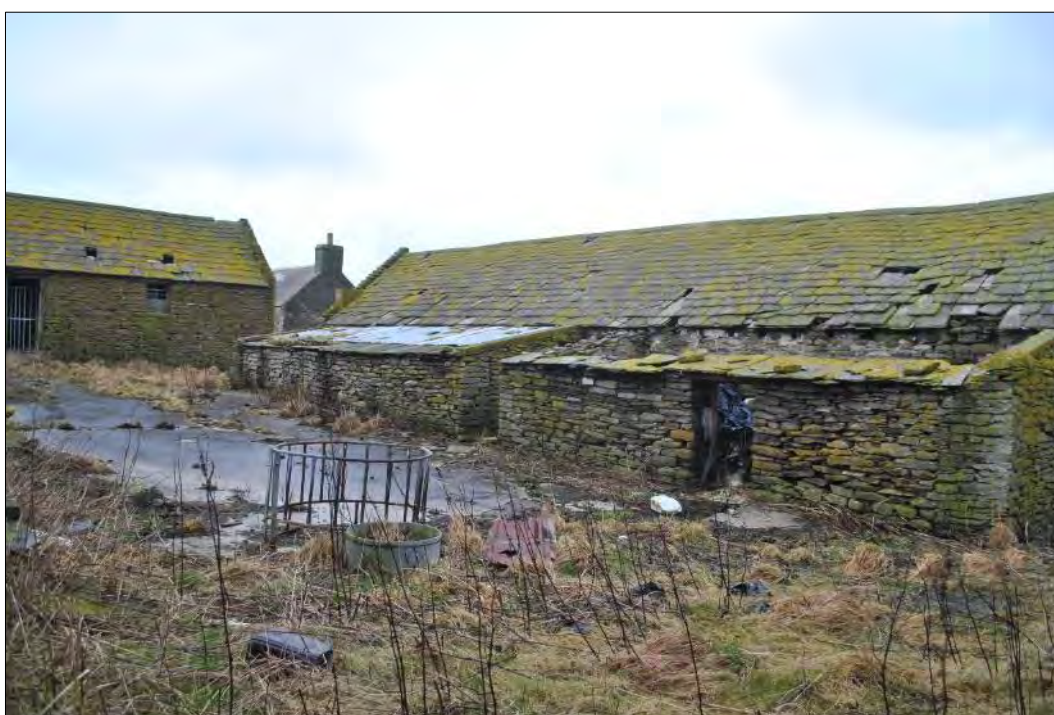
**Plate 121:** General view from the southwest corner of the quadrangle looking north towards FB 12 (left) and the lean-to structures built against the west-facing elevation of FB 9.

FB 9 is located to the southwest of Wasbister Road and forms the east edge of a quadrangle along with FB 10, 11 and 12. Unlike these three other structures, however, FB 9 is free-standing and does not form part of a range of buildings (**Plate 121**). All four of these buildings are shown on the First Edition map.

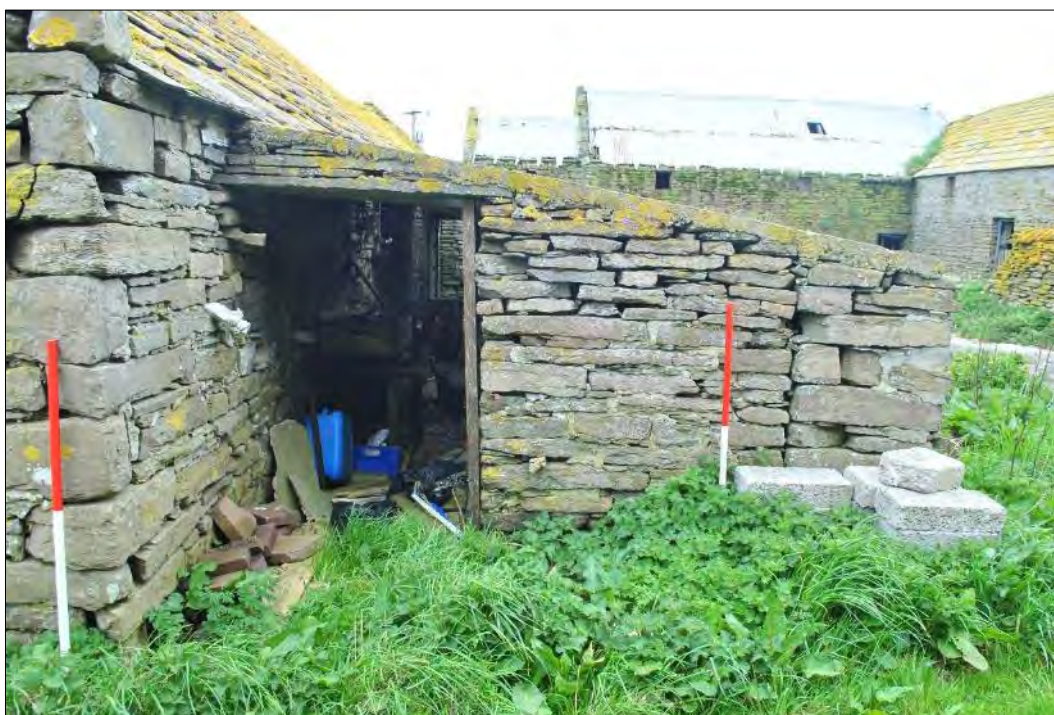
Much of the west-facing elevation is obscured by two lean-to structures. These flank a centrally-placed external doorway, with a timber frame and door, in the main structure. The north lean-to (FB 9.1) extends from this external doorway and along the west-facing elevation to a point approximately 1m short of the northwest corner of FB 9. There are external doorways against the FB 9 elevation in both the north- and south-facing elevations of FB 9.1. There is also a vertical construction break close to the west side in both these elevations which indicate that the lean-to may have originally been open-sided (**Plate 122**). There is a blocked external doorway in the west-facing elevation with the blocking material also containing an aperture, similar to an oddle hole, which was later itself blocked. FB 9.1 has a roof comprising the original flagstone roof patched with corrugated metal sheeting. The south lean-to (FB 9.2) extends from the FB 9 doorway and along the west-facing elevation to a point approximately 1m short of the southwest corner of FB 9. The north-facing elevation contains the same construction break seen in FB 9.1, but this is absent from the south-facing elevation of FB 9.2. This elevation is continuous and butts against the west-facing elevation of FB 9. The line of coping stones below the upper edge incline of the elevation indicates the lean-to roof is a later addition. There is an external doorway in the west-facing elevation of FB 9.2. There is a construction break close to the south end of this elevation and this may indicate that the south elevation was an earlier construction and the lean-to structure was added to it at a later date. Some constituents of the flagstone roof remain *in-situ* along the west edge of FB 9.2.

**Plate 122:** North-facing elevation of lean-to structure FB 9.1 showing external doorway and construction break which may indicate the structure was originally open-sided.

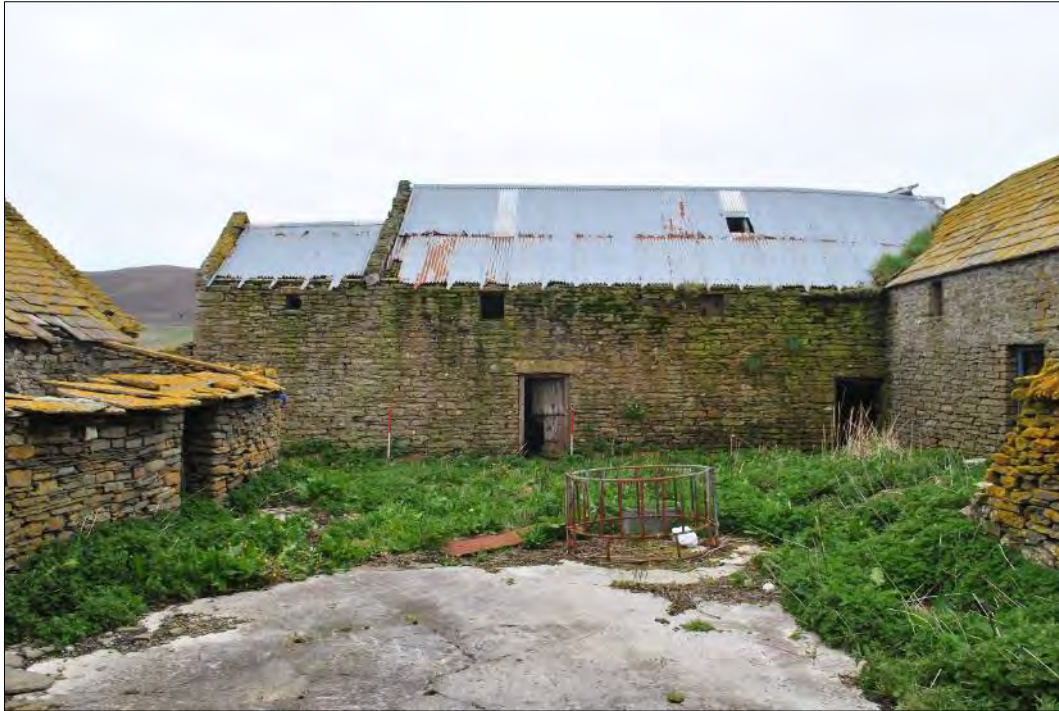
**Plate 123:** North-facing elevation of FB 10, with FB 9 (left) and FB 11 (right), showing the two exterior doorways and first-floor windows in FB 10.3 (centre and right), and the widow in FB 10.2 (left end). The lean-to structure FB 10.1 is obscured by FB 10.1.

FB 10 is a stone rubble-built structure (**Plate 123**) comprising three distinct parts (**Plate 124**). FB 10.1 is single storey lean-to structure butting against the east-facing elevation of FB 10.2. There is an external doorway in the north-facing elevation with a stone lintel and threshold, and a timber internal frame and door. The south-facing elevation contains a centrally placed window with no frame. The original roof remains intact and comprises flagstone slabs.

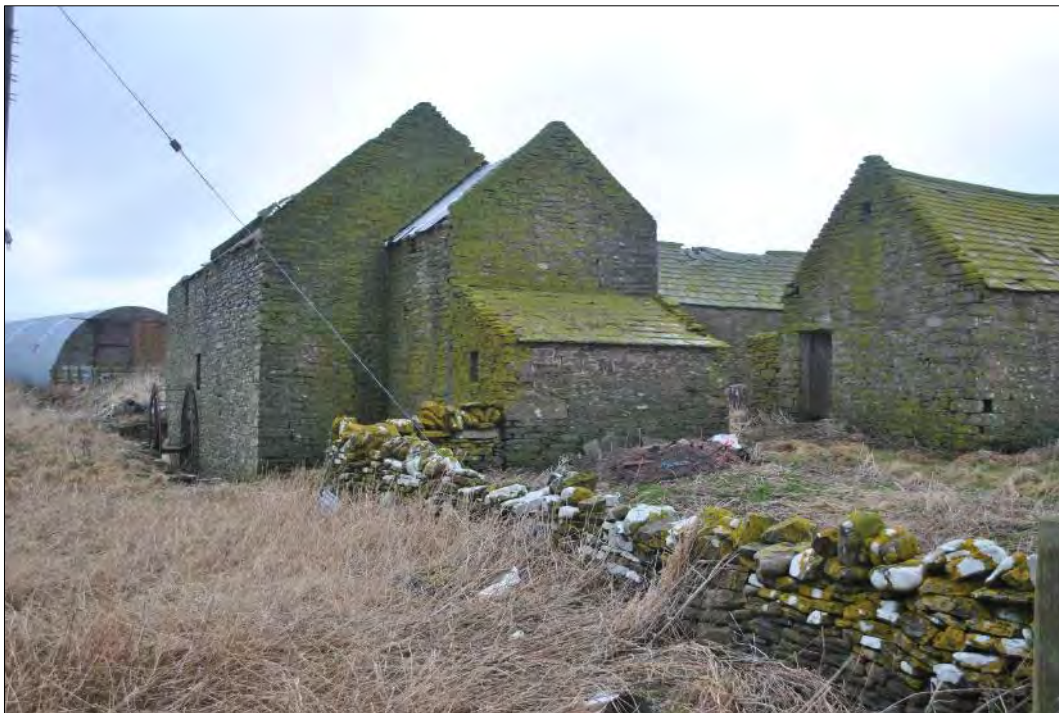
**Plate 124:** East-facing elevation of Building FB10 showing lean-to FB 10.1, the east gable of FB 10.2 immediately behind and the east gable of FB 10.3, the largest of the three structures. The mill-wheel is visible in the south elevation of FB 10.3 (left).
