## **The Industrial Heritage of the North Isles Orkney**

## **Research and Interpretation Project Data Structure Report**

February 2025

**Project No: 996**

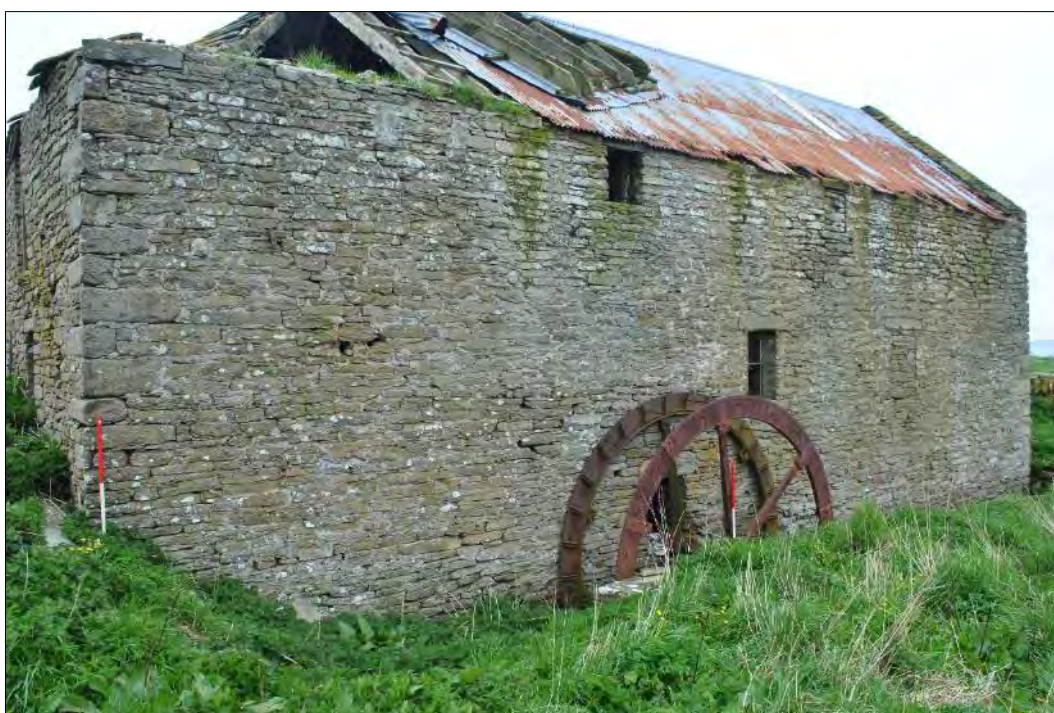
*Plate 125: South-facing elevation of FB 10.3 showing the three internal levels and the mill wheel.*

FB 10.3 is contemporary with FB 10.2 but stands taller and is keyed into the south end of FB 11. There are two external doorways in the north-facing elevation both with stone lintels and thresholds, and timber internal frames. There are also two windows at first floor level. These are identical to the window in FB 10.2 but are slightly larger and one has an internal timber shutter. There are two large windows at ground floor level in the south-facing elevation. Both have stone lintels and sills, and the right (east) window has been blocked with stone constituents. There are two further windows just below the eaves which match the form of those in the north-facing elevation. Again, the right window has been blocked. The main feature in the south-facing elevation is the water wheel (**Plate 125**) which is situated lower than the ground floor level of FB 10.3. The wheel, shroud plate, arms and axle are all cast iron but the buckets are all missing and so, presumably, were timber-built. The shaft passes into the interior of FB 10.3 through a large rectangular aperture, similar in size and form to the ground floor window. The wheel sits in a stone-lined wheel pit which also acts as the bearing support wall. Much of the pit is filled with debris and is overgrown, particularly at the west, and no pen trough was identified. The water supply comes from the Loch of Wasbister via a

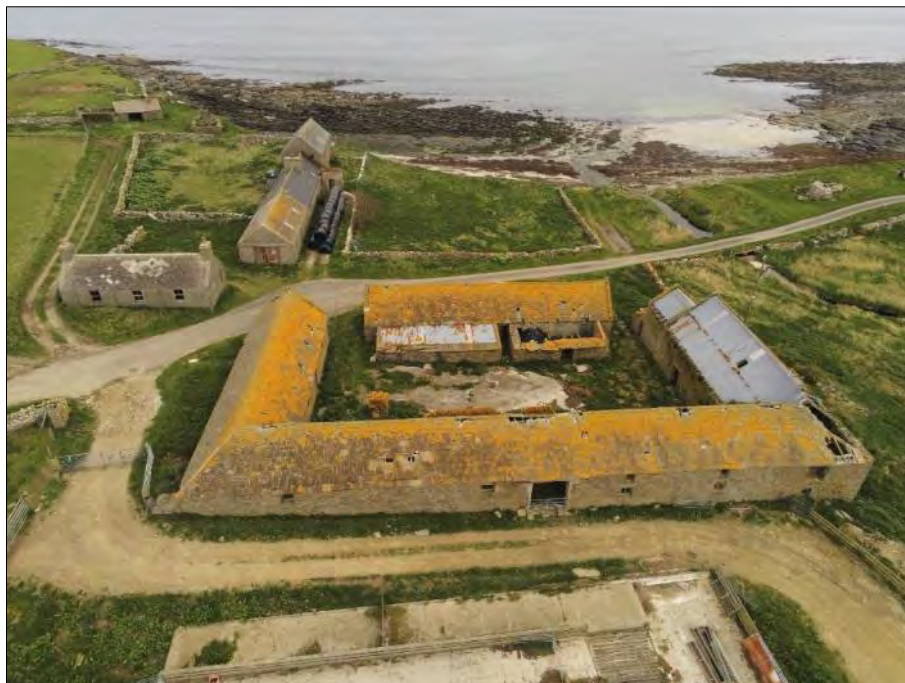
**Plate 126:** West-facing elevation of FB 11 illustrating how the sloping ground surface heightens the elevation and increasing the number of internal floor levels (© Robert Friel).

The west-facing elevation runs the full length of the west side of the range and encompasses the west ends of FB 10.3 and FB 12. The rising ground level towards the north end is more noticeable in this elevation (**Plate 126**) than in the east-facing elevation. There is a large, centrally-placed doorway with a steel and aluminium rail and housing for external sliding doors. The stonework around the doorway is heavily re-pointed with cement mortar indicating that the doorway has either been modified or is a later addition. To the right (south) of the doorway are two, evenly-spaced windows with large stone lintels, smaller stone sills and timber frames, which are probably original. The frames divide the windows into three panes (one upper, two lower). Directly above each are smaller windows with small stone lintels and sills. One has an internal frame of a single pane. These windows indicate the interior of the building has ground

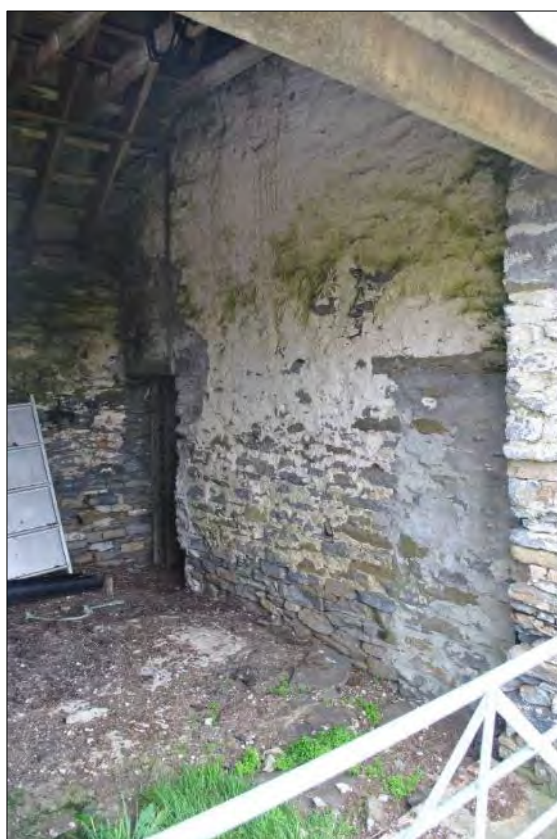
and first floor levels. This contrasts with the view of the interior through the doorway which shows a single, ground floor-level space within. The change in the interior layout is probably marked by the dividing wall immediately south of the large, central doorway (**Plate 127**). To the left (north) of the external doorway are two, evenly-spaced windows. These match the first floor-level of the windows to the south but their design and form is more similar to the southern windows at ground floor level. Internally, this portion of FB 11 has only a ground floor. The roof materials and construction are identical to that seen on the east side of the roof. There are two skylights, their location showing these illuminate first floor levels of FB 11. The south end of the west-facing elevation forms the west-facing elevation of FB 10.3 which is continuous with that of FB 11. A window, identical to that in the south-facing elevation of FB 10.3, is centrally-placed, at ground floor level. A large external doorway is directly above this at first floor level with a timber lintel, a stone threshold and an internal timber door. There is a vertical construction break running up to the height of the ground floor window lintel, approximately 1.3m from the south edge. This may be related to an annex on the west end of FB 10.3 shown on the early Ordnance Survey maps. Much of the lower part of this elevation and the adjacent ground surface is obscured by dumped spoil and heavy vegetation, however, and it was not possible to identify any further remains potentially associated with this annex.

**Plate 127:** View through doorway in the west-facing elevation of FB 11 with the internal wall marking the point where the building becomes a two storey-structure.

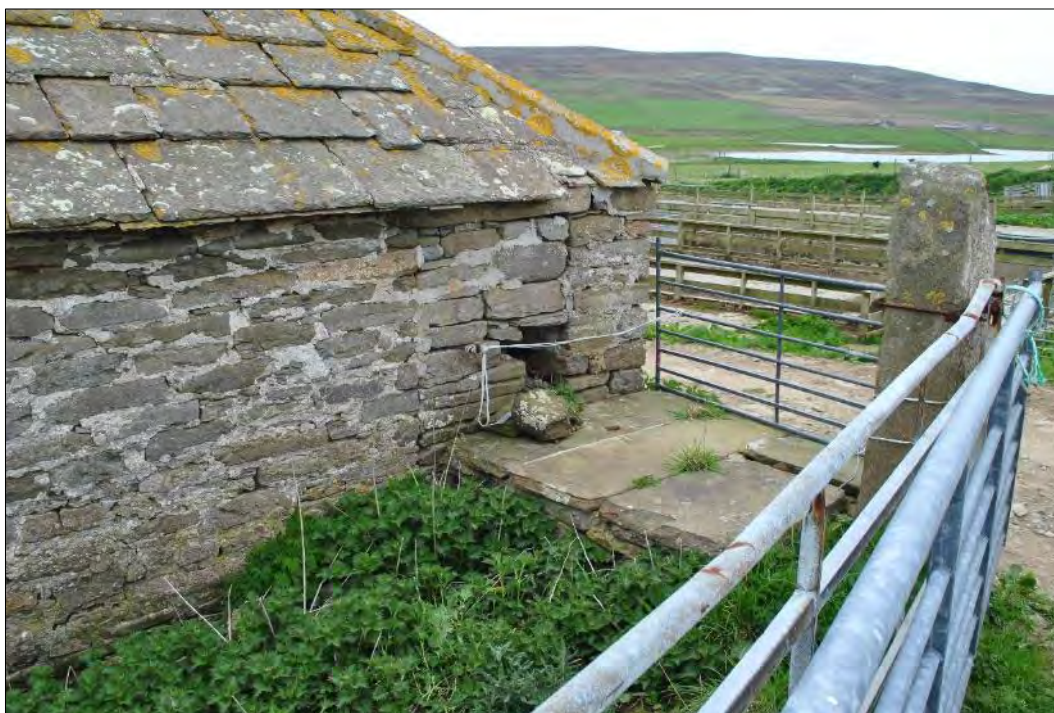
are no features in the north-facing elevation other than a blocked window close to the west end. The window matches the size and form of those in the south-facing elevation with the stone lintel lies just below the eaves but, because of the rising ground level and the subsequent reduction of the elevation height, the sill is only approximately 0.3m above the base of the elevation. Butting against the elevation, below the window, is a rectangular stone-built platform. This does not align directly with the window and the upper edge covers part of the lower portion of the window (**Plate 128**). It would be likely, therefore, that this platform was constructed following the blocking of the window rather than being related to any alternative use of the aperture.

*Plate 128: West end, north-facing elevation of FB 12 with the stone-built platform butting against the lower edge of a blocked window.*

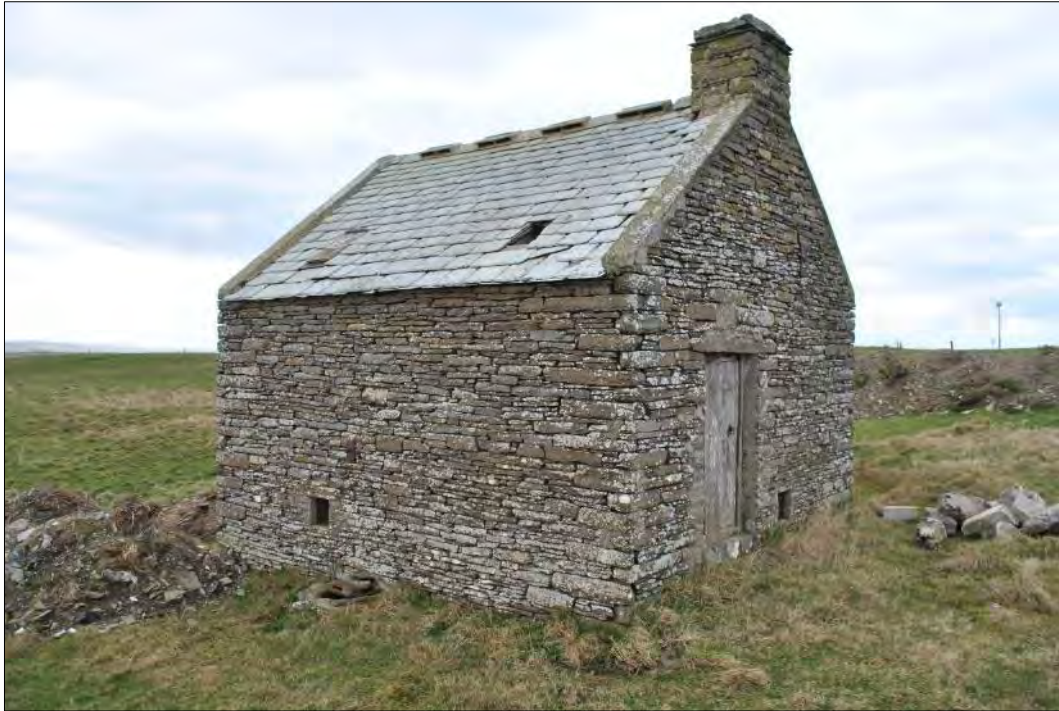
The former slaughterhouse at Cotbrae is located at NGR HY 50330 17522 in the centre of Shapinsay, standing to the south of the B 9058 highway, on the west side of Chapel Brae Road (**Plate 129**). The earliest known depiction of the building is on the Second Edition 25-inch Ordnance Survey map (Orkney CIII.1. 1902).

*Plate 129: General view of the slaughterhouse, looking northwest.*

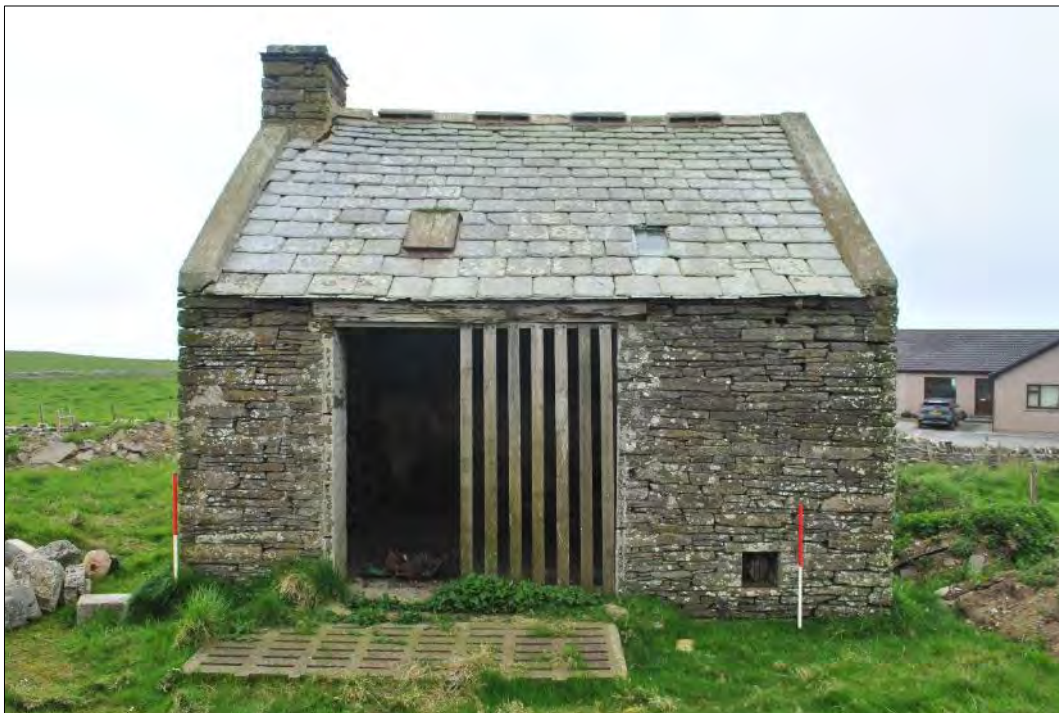
*Plate 130: North-facing elevation of the slaughterhouse showing large doorway and ventilation hole.*

There is a large external doorway in the north-facing elevation (**Plate 130**). This is 2.3m wide and is the full-height of the elevation with a timber lintel directly below the eaves. The doorway has been partially blocked by timber slats. There is an aperture (0.32m wide by 0.36m high) to the right (west) of the doorway, approximately 0.3m above the current ground surface. This has a stone lintel and sill, and an internal iron frame with seven vertical iron bars. The roof has

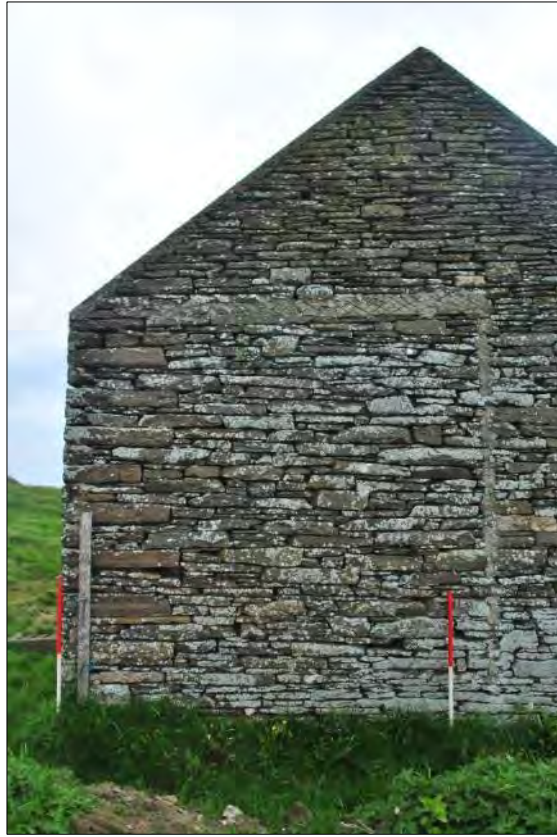
**Plate 131:** North side of the west-facing gable showing the L-shaped deposit of mortar.

The west-facing gable has an L-shaped skim of cement mortar which may be indicative on a lean-to structure having once butted against this elevation (**Plate 131**). The mortar runs horizontally at the height of the eaves and then runs vertically at a point 2.3m from the north corner. The horizontal mortar skim is noticeably wider than the vertical, and its surface has been scored with a series of intersecting diagonal lines throughout.

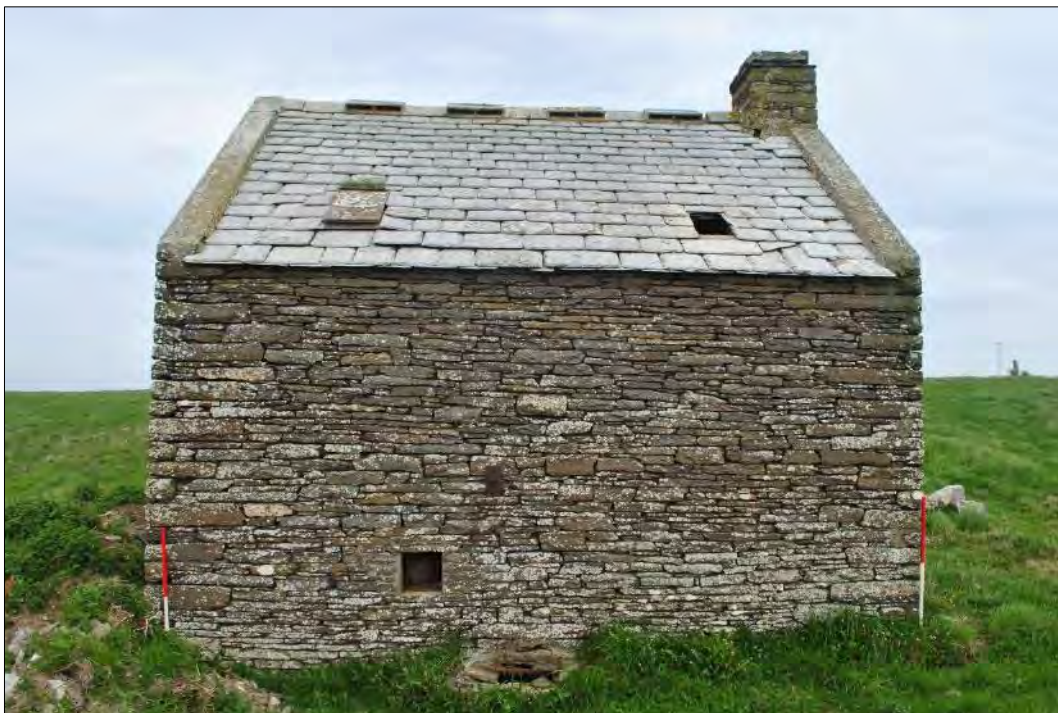
**Plate 132:** South-facing elevation of the slaughterhouse showing ventilation hole and drain head in the ground surface at the base of the elevation.

The south-facing elevation (**Plate 132**) has an aperture similar to that in the north-facing elevation (0.32m by 0.32m) located to the left (west) of the centreline and approximately 0.5m above the current ground level. Centrally-placed, butting against the base of the elevation is a stone rubble-built drain head with an iron drain cover (**Plate 133**). The roof also has two evenly-spaced skylights on this side. One has no additional features, the other has an iron frame and is covered by an external timber shutter.

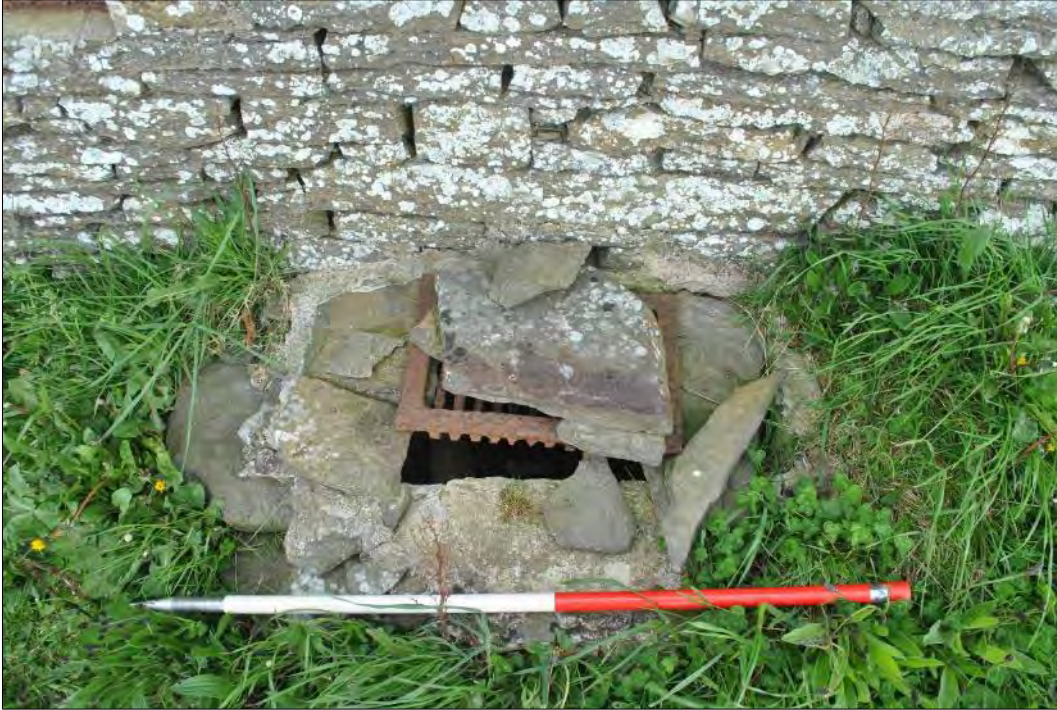
*Plate 133: Detail of the south-facing elevation showing the drain head.*

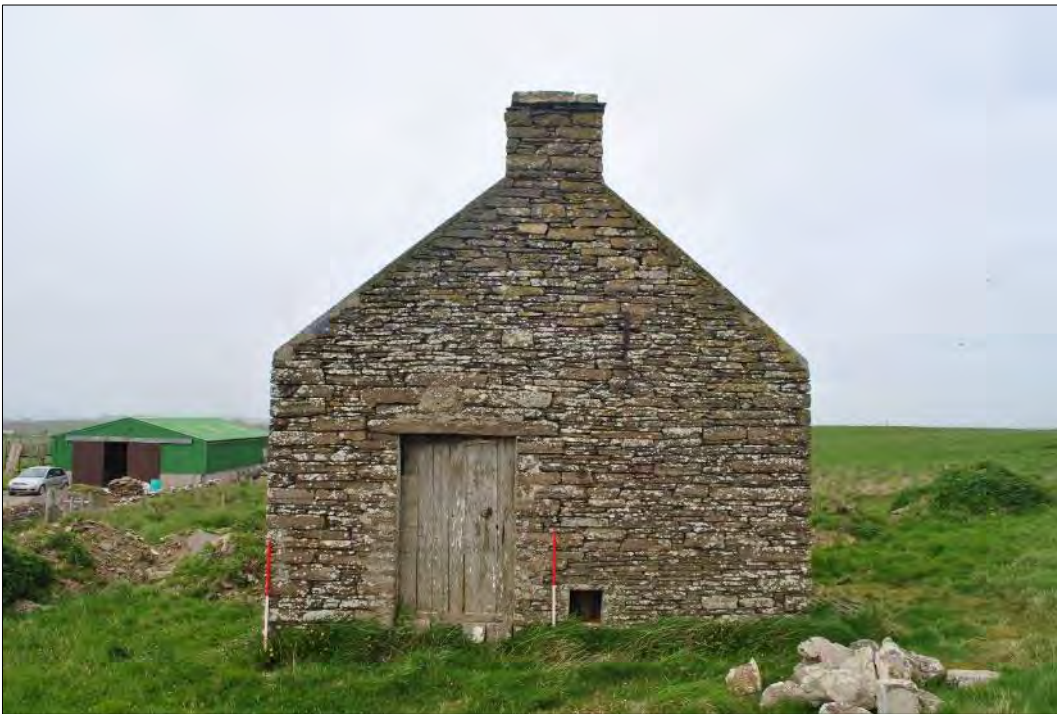
*Plate 134: East-facing gable of the slaughterhouse showing the doorway, ventilation and chimney.*

The east-facing gable (**Plate 134**) has an external doorway, 1.11m wide by 1.95m high, with a stone lintel and threshold. The doorway is left (south) of the elevation centre line and has an internal timber frame and door. To the right (north) is an aperture similar to that in the north-facing elevation (0.33m by 0.33m) located approximately 0.15m above the current ground level. The elevation also features a centrally-placed chimney stack, six stone courses-high.

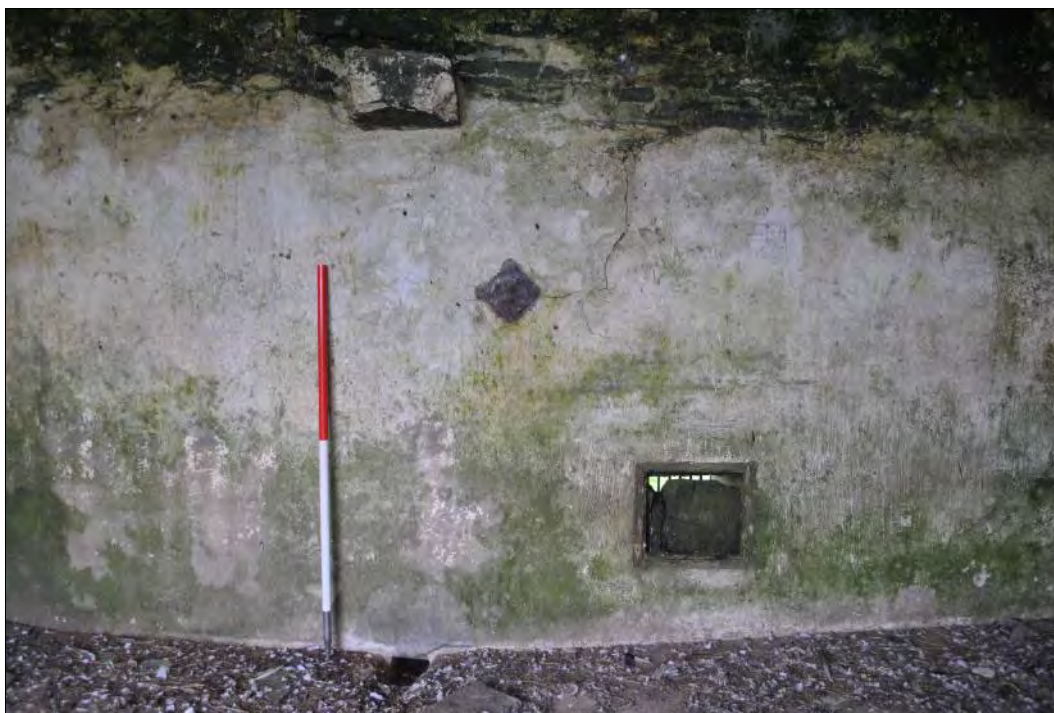
**Plate 135:** South elevation with surface drain at the foot of the wall and chamfered protruding stone directly above.

The interior elevations are all covered with a lime mortar render to a height of approximately 1.5m. There is a timber beam running the full length of the west elevation at this approximate height. Each end of this beam is inserted into the stonework of the adjacent elevations. The three apertures seen externally were all clearly visible in the internal elevations. No additional features were associated with these and it seems probable that these were for ventilation only. A surface drain was seen at the base of the south elevation (**Plate 135**) and this aligned with the drain head identified externally. Directly aligned above this, a large stone constituent protruded from the wall surface. Though damaged, it is clear that the stone surface had been chamfered. The function of this feature is not known and it is unclear if its positioning in relation to the surface drain is relevant.

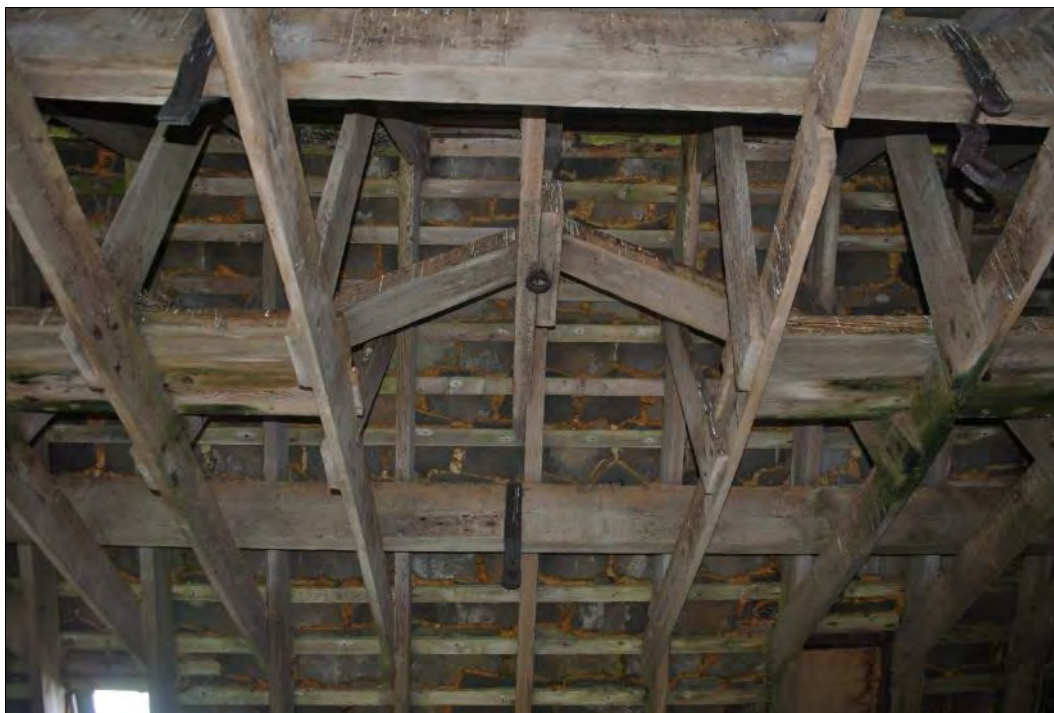
The interior fixture and fittings forming the roof are clearly visible. There are a total of ten roof trusses. The fifth truss from the west elevation has no tie-beam and has been modified to create an anchor point for an iron screwed into the lower face of the timbers (**Plate 136**). A number of the beams around this had iron bands fixed to them, one of which terminated in a hook. The precise function of these fittings could not be determined but it is likely that these were related to the hanging of carcasses.

*Plate 136: Detail of the roof showing the modified central truss with iron ring (centre) and three iron bands on the timbers around including one with a hook (top right).*

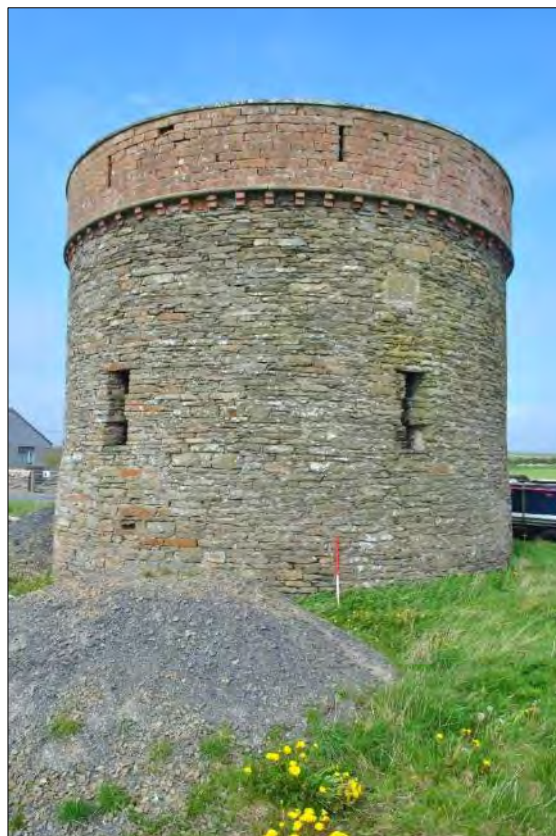
**Plate 138:** The gasometer, looking west, showing the red brick cap upon the stone rubble body.

The exterior of gas storage tower is a cylindrical structure predominately built of stone rubble but with a red brick crown (**Plate 138**) within which the structures that stored the coal gas would be housed. There is an external doorway facing west with a stone lintel. The doorway also has a stone lintel but this is partially obscured by a concrete step 0.3m high. There is a ring of six windows around the structure at the height of the door lintel. These are tall and narrow, resembling the loopholes seen in medieval fortifications. The join between the stone and red brick constituents is marked by a thin course of stone forming a half round moulding with red brick corbel below. The red brick cap also has six loopholes. The structure is designed to give the impression of being a turret in a system of fortifications.

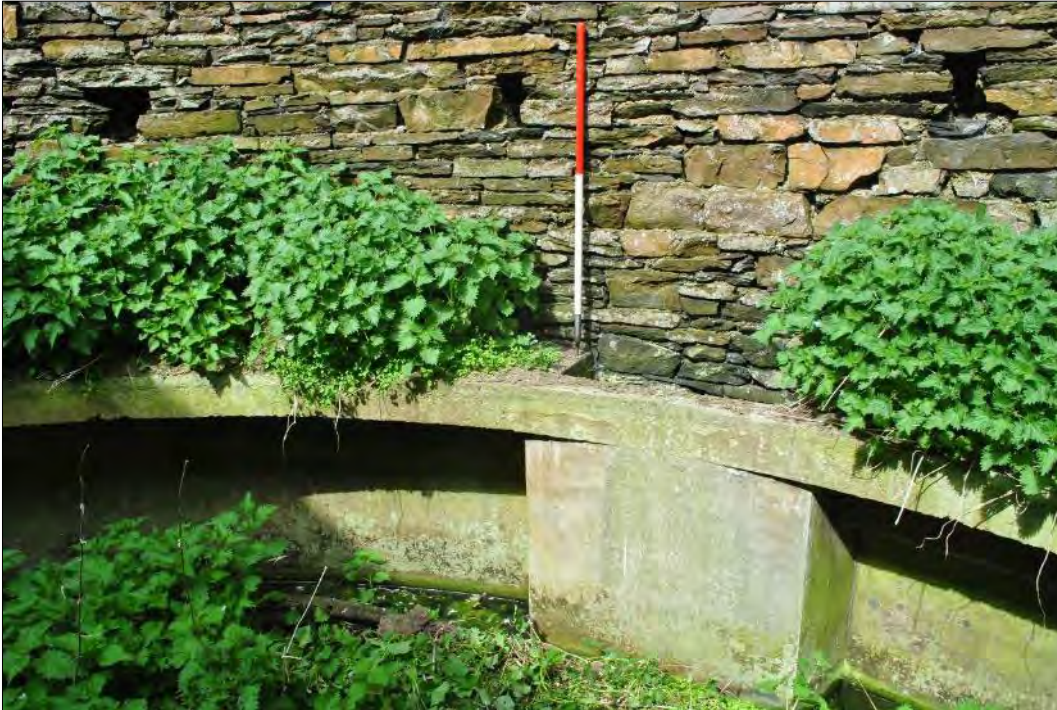
There was also a series of smaller apertures both at the height the lower loopholes and lower down in the elevation, at a level of approximately 0.75m above the concrete threshold in the doorway. Again, these may be related to the frame that held and guided the bell. The concrete threshold forms part of a cement concrete ring which runs round the full circumference of the tower interior (**Plate 142**). The ring sits on intermittent concrete blocks and a narrower, taller ring running behind the blocks and these all sit within a concrete groove. The inside edge of this is marked by a metal pipe, 0.1m in diameter, which runs round the full circumference of the concrete structures. The area defined by these sits lower than the exterior ground surface (see **Plate 141**). The concrete structures possibly anchored the open underside of the bell whilst also forming part of the water tank that provided the seal around the base of the gasometer.

**Plate 142:** The concrete ring running around the base of the of the interior wall. The metal ring which runs inside of this is visible in the nettles at the bottom of the picture.

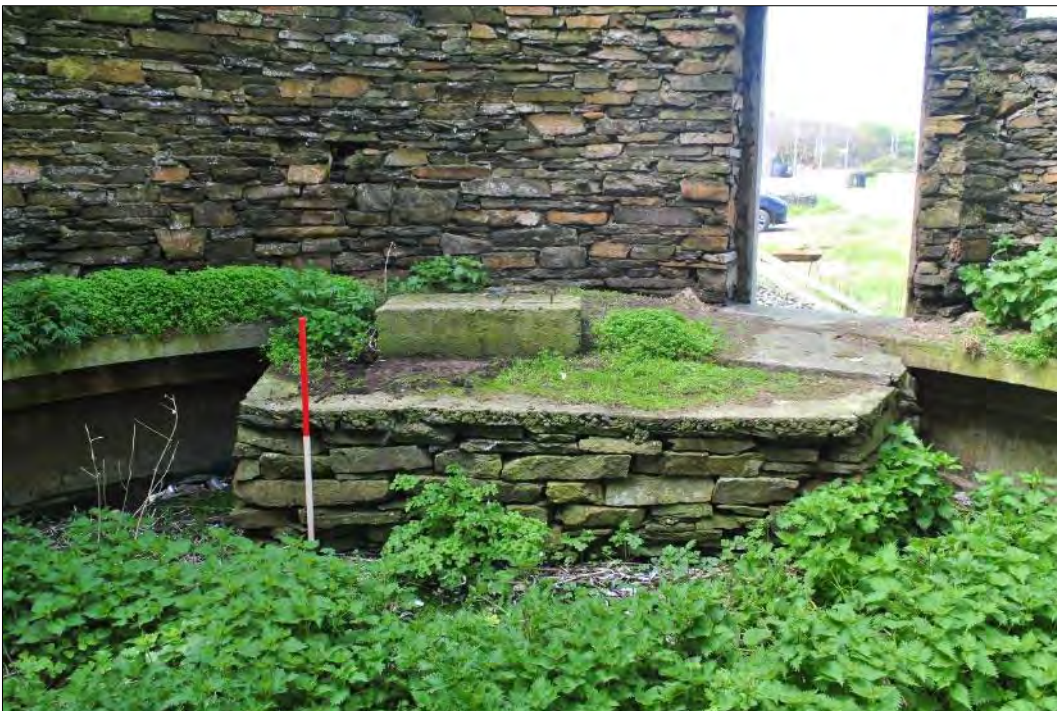
A stone-built, sub-rectangular structure butts against the concrete rings, close to the external doorway, 2.75m in length. The upper surface is covered in a layer of concreted pebbled stones

and mortar (**Plate 143**). Mounted on the structure is a concrete base, measuring 1m by 0.85m in plan, with four iron bolts protruding from the upper face towards the north end, and arranged in a square pattern. No possible function for these features could be determined.

**Plate 143:** The stone-built platform within the circumference of the concrete ring, with a concrete base on its upper surface.

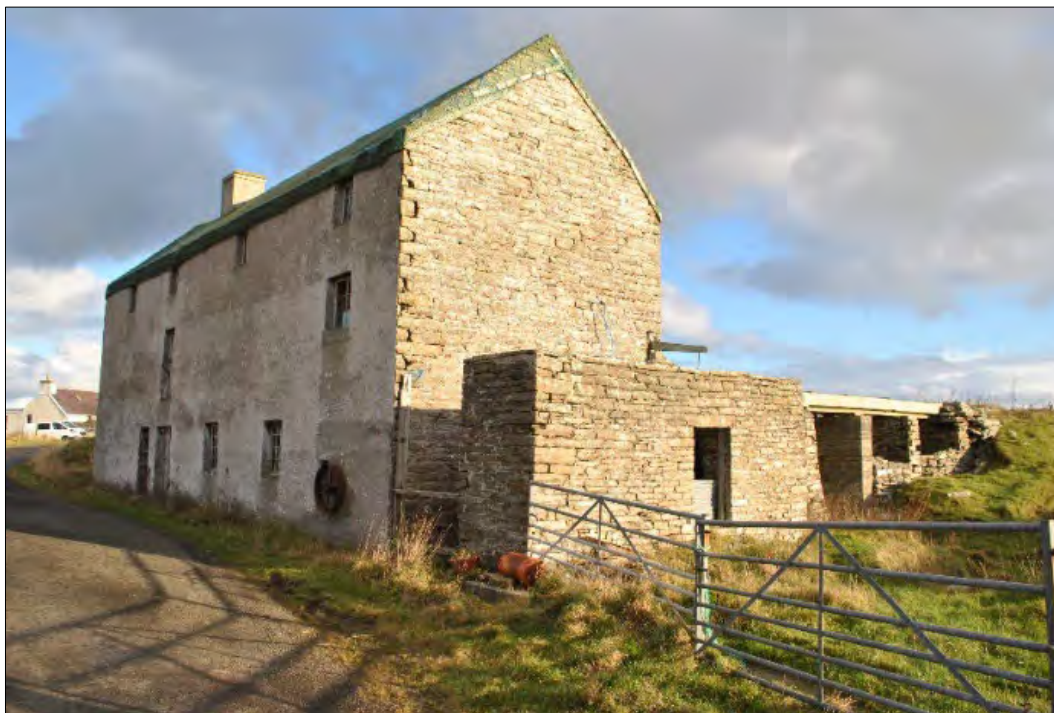
*Plate 144: View of Meikle Meal Mill, Stronsay, looking east, showing the harled front (northwest-facing) elevation and the roofless structure against the southwest gable housing the water wheel.*

The mill building is a three-storey building, stone rubble-built with harling on the front (northwest-facing) elevation. The northeast- and southwest-facing elevations are gabled with the waterwheel housed in a roofless structure against the southwest gable (**Plate 144**).

The water wheel house is a roofless, stone rubble built structure (see **Plate 144**). The rear (southeast) wall incorporates a section which is slightly lower and slightly thicker to act as a support structure for the trough. There is a large, rectangular aperture in the southwest wall (see **Plate 156**) with a stone floor beyond presumably to allow access to the wheel and the wheel pit. The front (northwest) elevation is almost entirely open. There are timber frames on both sides of the open elevation with two timber cross beams. It is unclear if these formed part of the original fabric of the structure or a later, additional safety feature. The water wheel is an overshot wheel, 5-feet wide and 10-feet in diameter. The wheel would have turned in an anti-clockwise when viewed from the exterior (southwest). The axle, arms, rim and sole plate are all cast iron, with the buckets being timber. The axle passes through the southwest gable of the mill with the exterior end being seated upon the masonry forming the southwest side of the wheel pit (**Plate 157**).

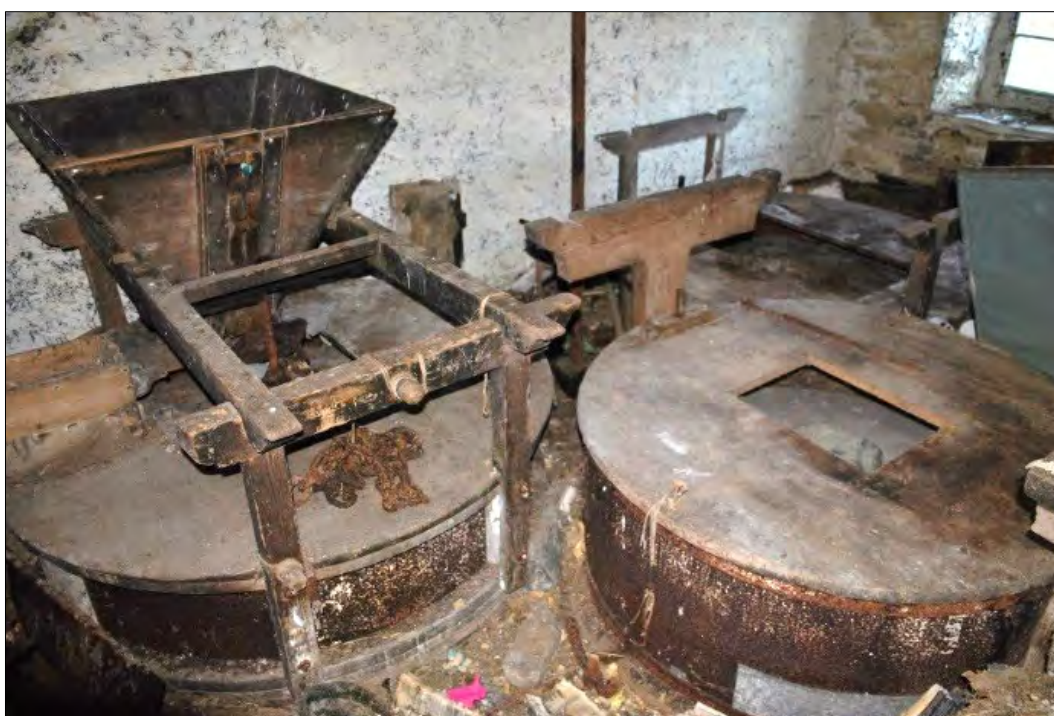
A timber-built staircase against the northwest elevation provides access to the first floor. The grinding of the grain was undertaken on the first floor and three pairs of grindstones remain within their casings at the southwest end of the room (**Plate 149**). Grain would be ground initially to separate the kernels from the husks before they were ground into meal. Different grindstones would be used for producing bere meal or producing animal feed. This floor would also have been used to store the meal bags awaiting collection by the farmers. These bags would have been lowered through the first floor-doorway in the northwest elevation (see **Plate 145**). The northeast end of the first floor comprised the stone rubble-built southwest wall of the corn-drying kiln. Other than the grinding stone and their casing, no other machinery or fittings associated with the working use of the mill were identified. As with the ground floor, much of the floor space is covered by rubbish and detritus.

**Plate 149:** Two of the three grindstone pairs within their casings on the first floor of the mill building.

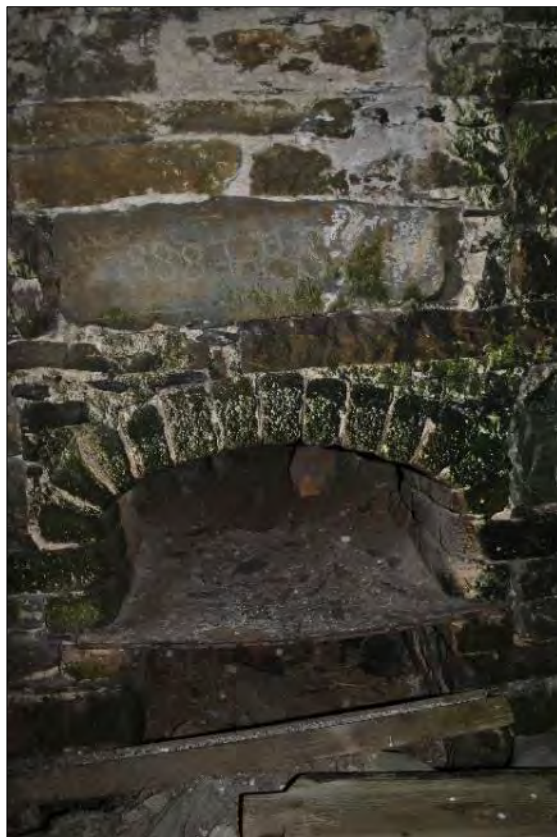
Only a single fire-charging hole was present in the southwest wall of the kiln. The aperture is formed by a dressed stone round-arch and incorporated a cast iron grate. A large stone block above the hole bore incised graffiti reading “888 + P S” (**Plate 153**).

**Plate 153:** Detail of the kiln charging hole showing the iron grate and the graffiti above.

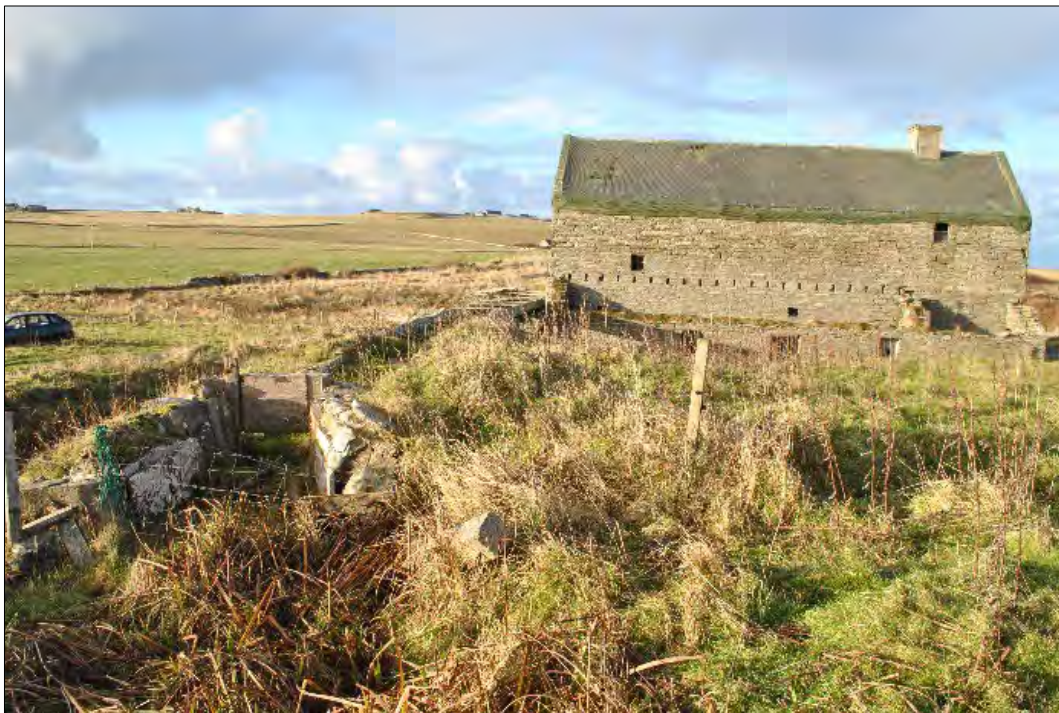
*Plate 155: General view, looking northwest, showing the mill (right) with the stone-lined head race (left) leading to the timber trough and roofless wheel house (centre).*

from mill pond was carried, firstly, along a stone-lined channel cut into an earthen embankment, and then, a timber-built trough into the roofless structure containing the water wheel (**Plate 155**). The timber trough was supported by four stone piers and a second sluice operated from within the mill controlled the flow of water and, as a result, the operations of the mill machinery. An overflow ditch ran from Mill Pond, to the southwest of the embankment and water wheel house, and under the roadway to rejoin Mill Burn close to the Brig.

The Mill Pond is currently heavily silted with very little standing water within, and the Mill Burn now flows along the line of the overflow ditch. The sluice gate between Mill Pond and the head race has been replaced by a single concrete slab. The head race channel and trough are completely dry with some encroachment by the surrounding vegetation. Three of the stone piers supporting the trough remain with one having been partially replaced by a pier comprising concrete blocks (**Plate 156**).

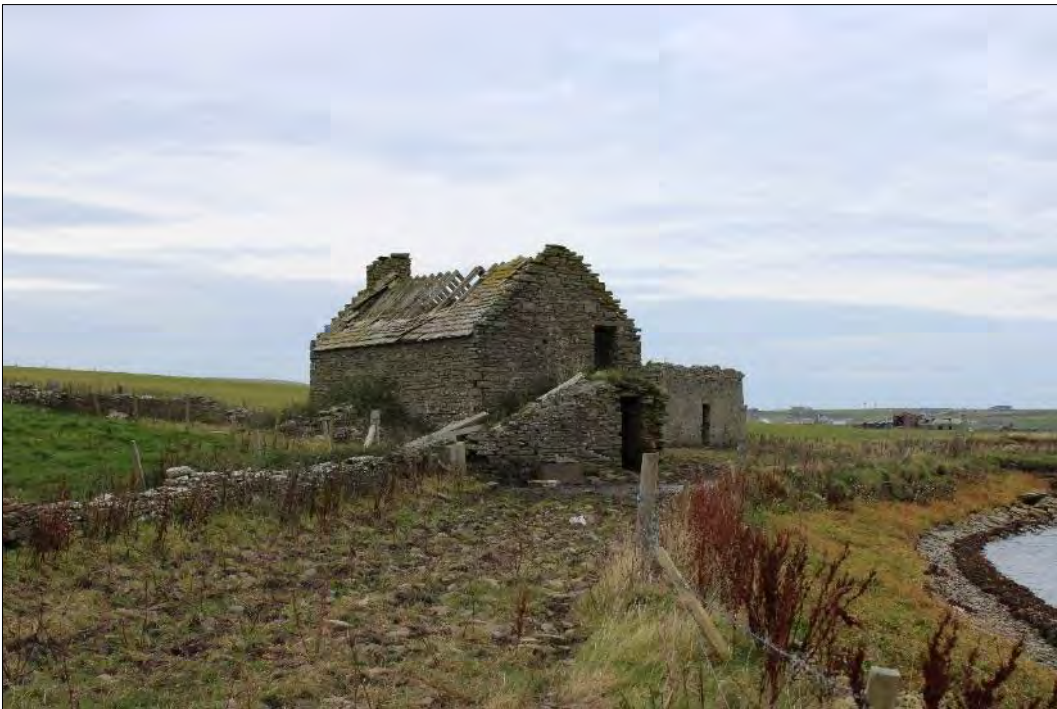
*Plate 158: General view of Cornhouse, looking west, with Broughton beyond (right background)*

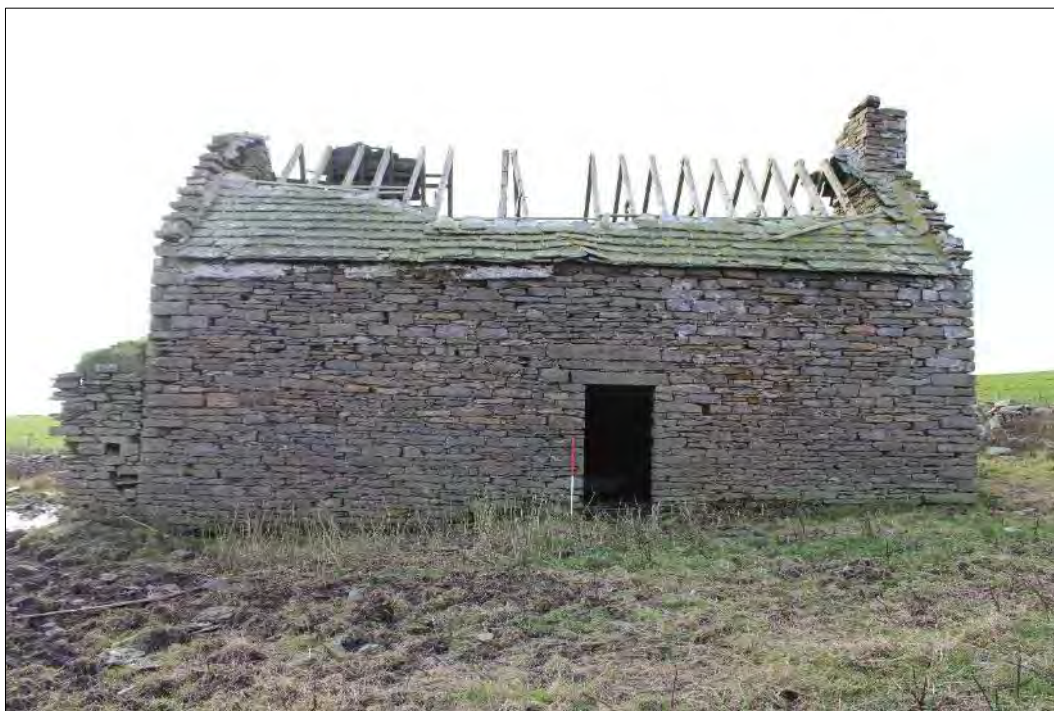
*Plate 159: North-facing elevation of Cornhouse*

This is a two-storey, stone rubble-built structure measuring 10m by 5m in plan. The walls are 0.6m to 0.7m thick, clay-bonded with alternate canted quoins. The Canmore entry records the roof as being intact when visited in 1998. Much of the flagstone roof has now collapsed, exposing the timber roof trusses.

The north-facing elevation (**Plate 159**) has an external doorway, slightly right (west) of the centre line, with a stone lintel and threshold. Internally the doorway has a timber lintel and each side has a deep, full-height recess indicating the doorway probably had a substantial frame (**Plate 160**).

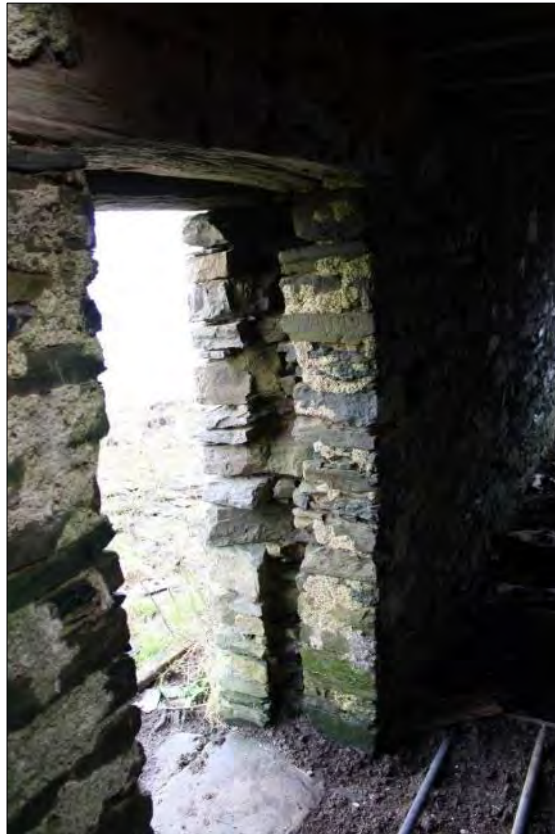
**Plate 160:** Detail of external doorway in north-facing elevation with a wall scar showing the former position of the door frame.

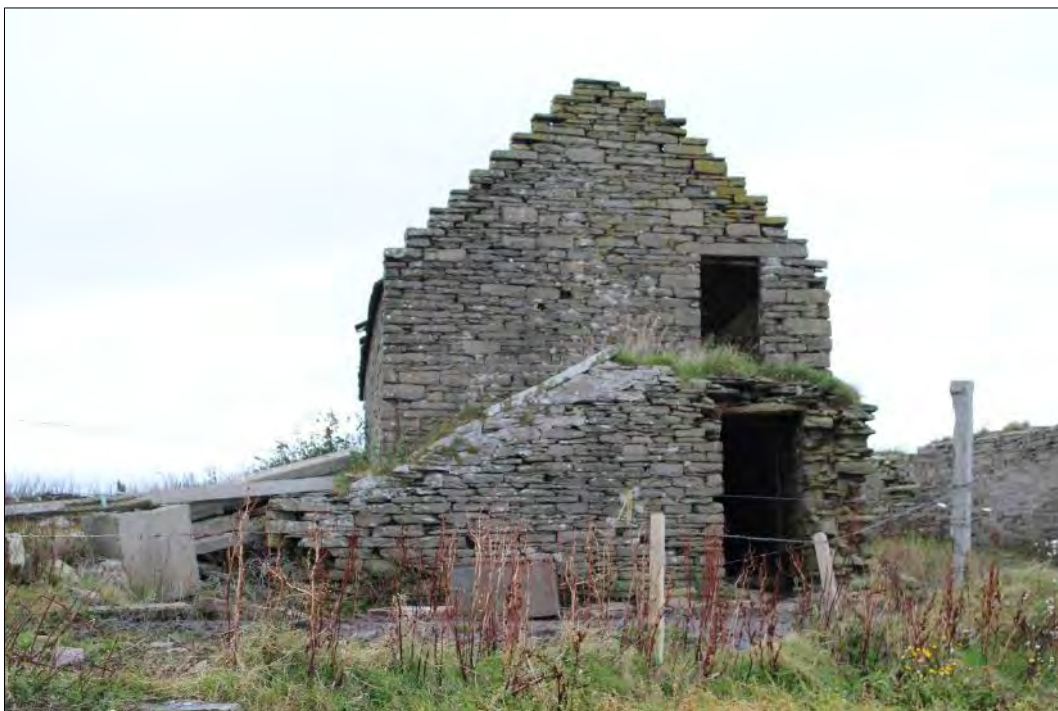
**Plate 161:** East-facing gable showing external stairs and doorway at ground- and first-floor levels.

The east-facing gable is crow-stepped with external stone rubble-built stairs leading to a first floor external doorway (**Plate 161**). The doorway is located close to the north edge of the gable and its stone lintel also forms part of the crow-stepping. Directly below this doorway is a ground floor accessed via a passage running below the stairs and the top platform. The stairs were seen to comprise a wall running parallel to the gable with the steps bridging the gap between this and a slightly protruding section of the gable (**Plate 162**). The east-west wall at the north end, supporting the top platform, butted against the east-facing gable and was not bonded to it.

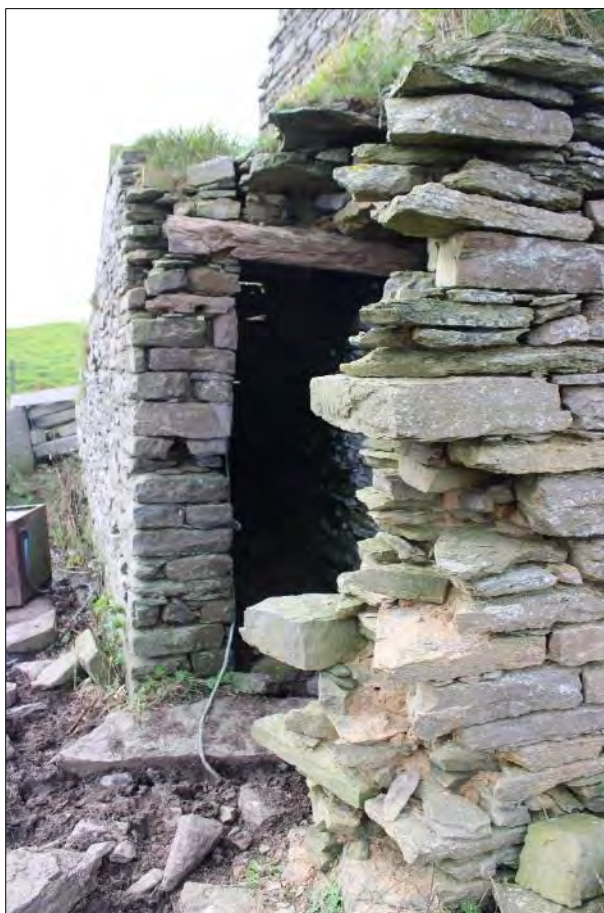
**Plate 162:** Detail of the staircase butting against the east gable showing the space below the stairs which is accessible from the passage leading to the external doorway.

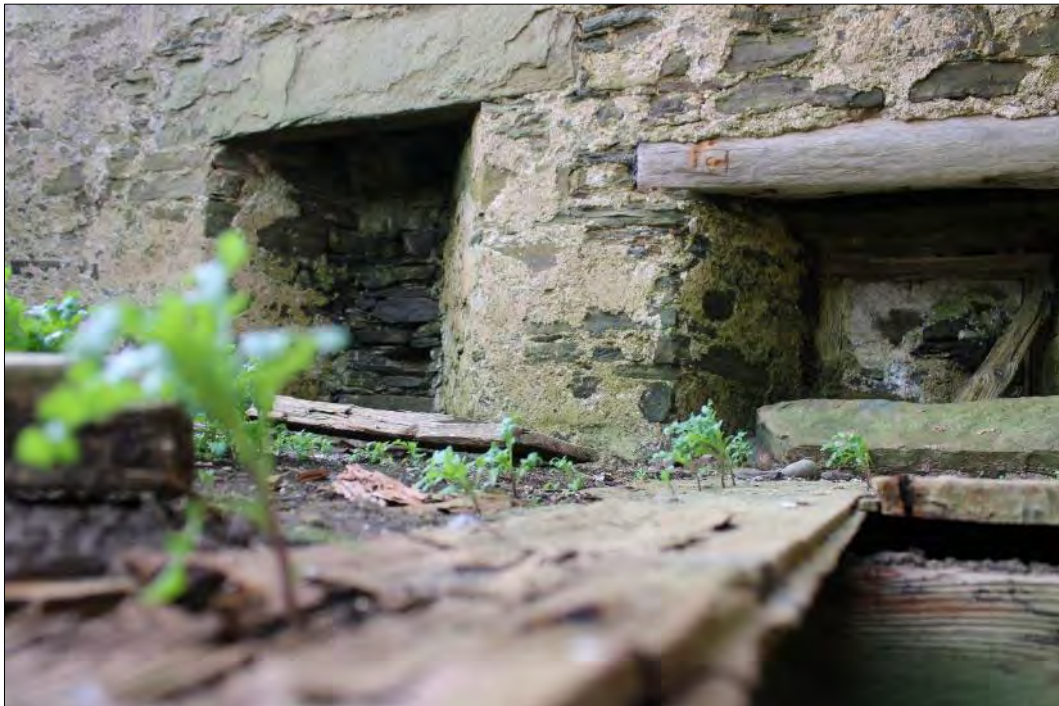
It was not possible or safe to access the first floor and the interior at this level could only be examined through the floor where the timbers were absent. A fireplace was identified in the west elevation (**Plate 164**). This had a large single stone as a lintel and the surrounding wall surface were covered with the same lime mortar render which appeared to have survived to a greater degree than at the ground floor level. To the right (north) of the fireplace, the window

**Plate 164:** Detail of west elevation, first floor with fireplace (left) and blocked window (right).
