## **The Industrial Heritage of the North Isles Orkney**

## **Research and Interpretation Project Data Structure Report**

February 2025

**Project No: 996**

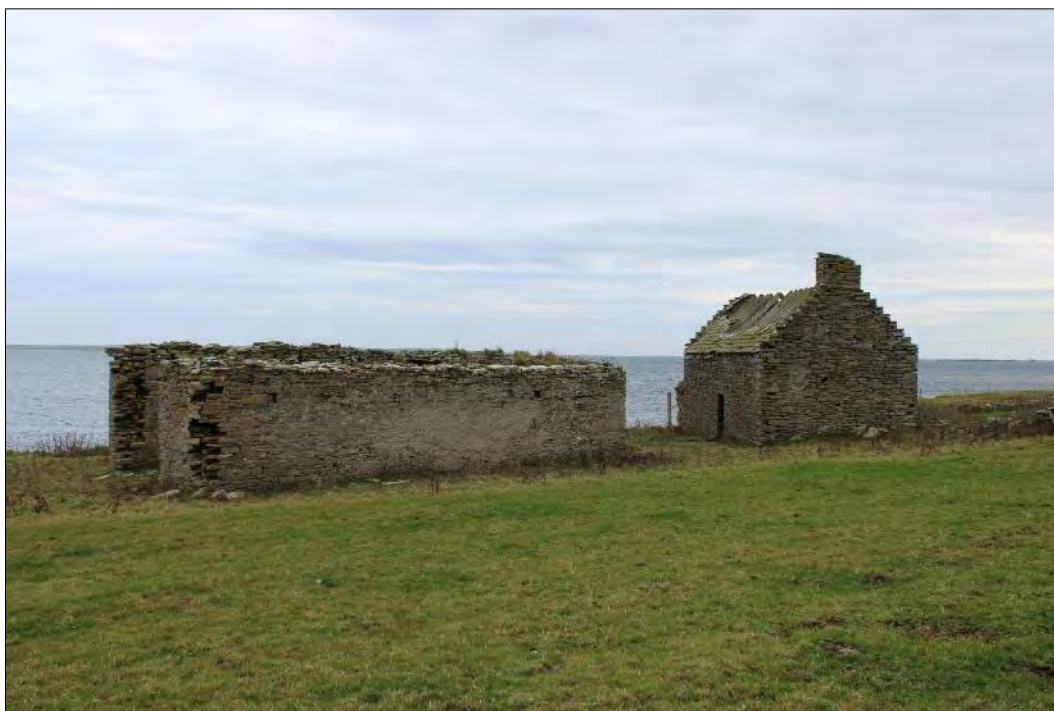
This is a two-storey, stone rubble-built structure measuring 12m by 5m in plan (**Plate 165**). Much of the walling at the first floor level is absent and nothing of the roof survives.

**Plate 165:** General view looking west towards the north building and the cornhouse.

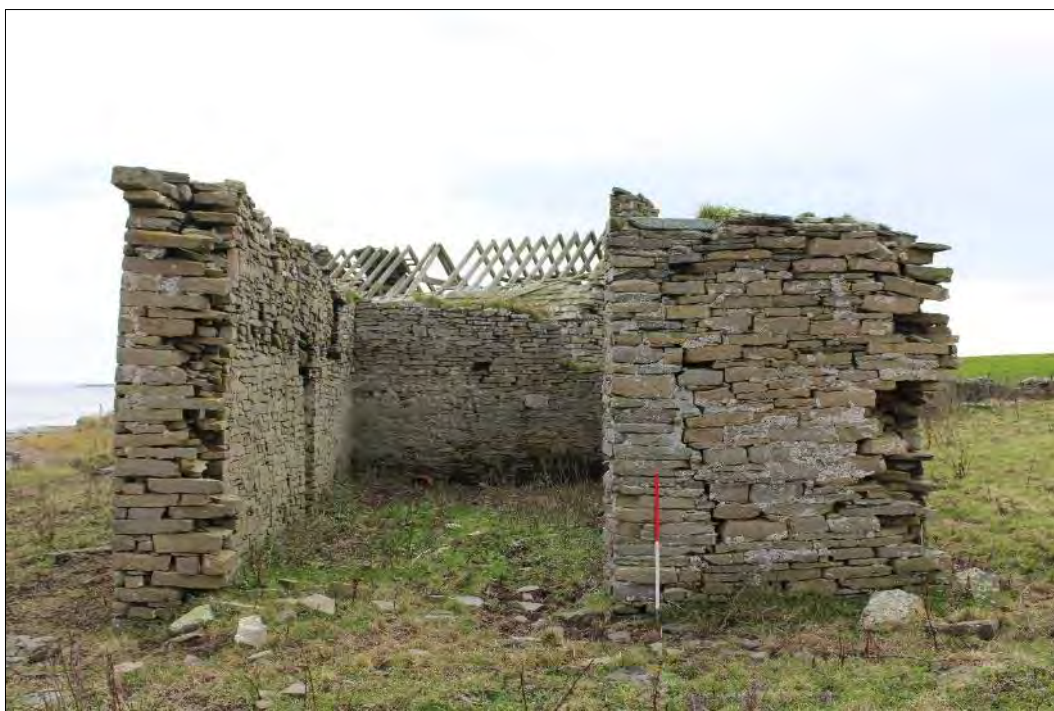
**Plate 166:** Northwest-facing elevation with large exterior doorway.

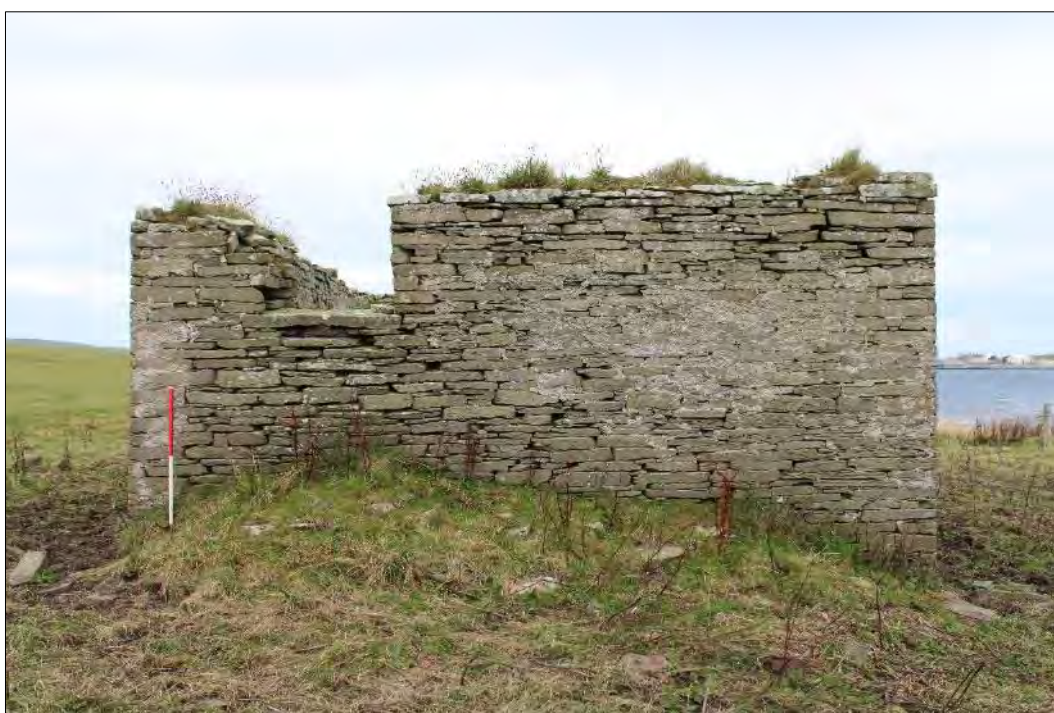
The southwest-facing elevation is plain other than the slots for the first floor support timber being visible in the stonework. Some of the stone constituents forming the west corner are missing. The southeast-facing elevation has a first floor external doorway close to the west edge (**Plate 167**). This has a stone threshold and survives to approximately half its original height. There is no direct evidence for the external stairs but there is a pronounced rise in the ground level below the doorway with a significant number of earth-fast stones within which may be rubble from the demolished stairs.

**Plate 167:** Southwest-facing elevation with truncated first-floor doorway.

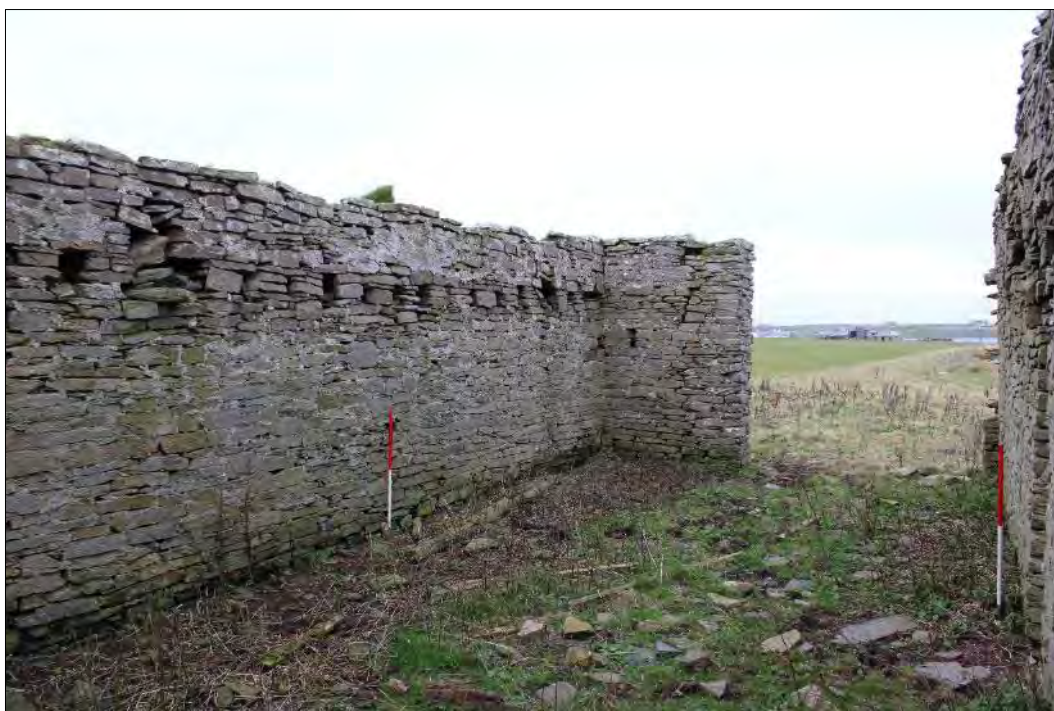
Internally the floor surface is completely obscured by soil, stone debris and scrub vegetation. The only features identified in the internal elevations were the beam slots for the first floor. Twenty-four were visible at a height of approximately 2m, running the full-length of the northeast and southwest elevations (**Plate 168**). The presence of the first floor beam across the northwest end of the building further strengthens the conclusion that the opening at that end of the building is a much later modification.

**Plate 168:** Interior looking north showing the slots for the first floor joists slightly below the truncated wall head.

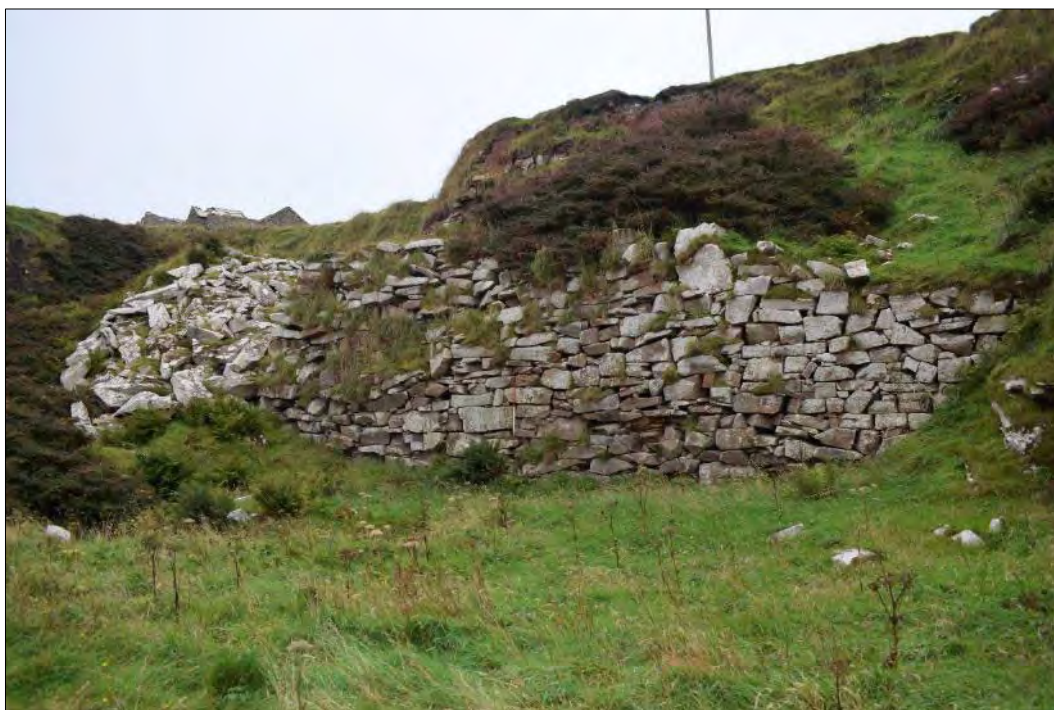
**Plate 170:** View from the centre of Fersness Quarry, looking towards the southwest corner, showing a pile of stone debris alongside one of the retaining walls (**Feature 20**) constructed within the quarry.

Much of the earlier quarry faces at the north end are obscured by the tipping of spoil and stone debris from the later workings. There is also a similar spoil and debris pile at the southwest corner of the quarry cutting (**Plate 170**). Throughout the quarry workings, tooling and cutting marks were identified on the exposed work faces (**Plate 171**). A total of five retaining walls, all constructed of stone from the quarry itself, were identified within the quarry cutting. Three of these (Feature 15, 17 and 19) were along the east side, with the remaining two (Feature 20 and 21) on the west side (see **Plate 170**). Four of these are located within the workings excavated after 1881 in an area where the rising coastal slope means the quarry face heightens significantly. The most northerly retaining wall, Feature 15, lies much closer to the shoreline in an area that is shown without a working face on the early Ordnance Survey

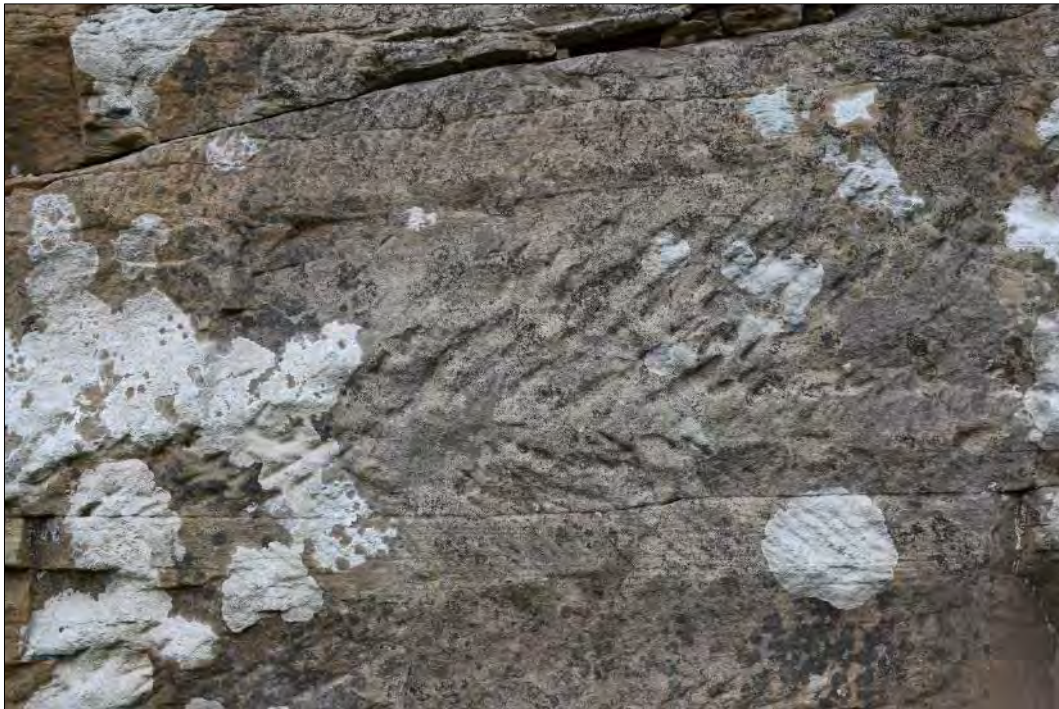
**Plate 171:** An example of the tooling marks visible on the working faces.

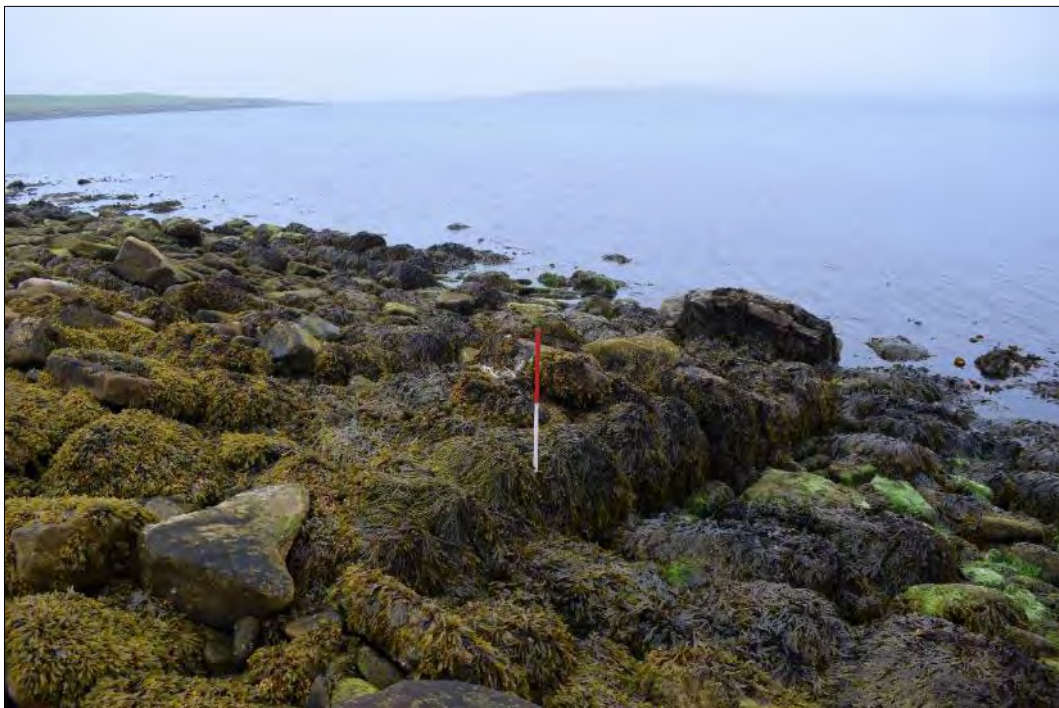
**Plate 172:** The beach at Fersness Quarry, looking north, showing the remains of the east-facing elevation of the former pier with an additional, distended fragment at the water's edge.

A pier was located on the shoreline at the mouth of the quarry cutting to allow the loading and transport of quarried stone. This is shown on both the First Edition (1881) and the Second Edition 25-inch Ordnance Survey map (Orkney LXXXVI.10 1902) with the Second Edition showing a crane located on the end of the pier. The structure was heavily damaged during the storm of 1953 and it is not shown on subsequent mapping. Examination of the rocky foreshore identified fragments of dressed stone with mortar and concrete adhering to the surfaces. Close to the water's edge, *in-situ* facing stones (Feature 23), interpreted as the east- and west-facing elevations of the pier, were identified. These extended for a length of approximately 6-7m with a maximum preserved height of approximately 1m (**Plate 172**).

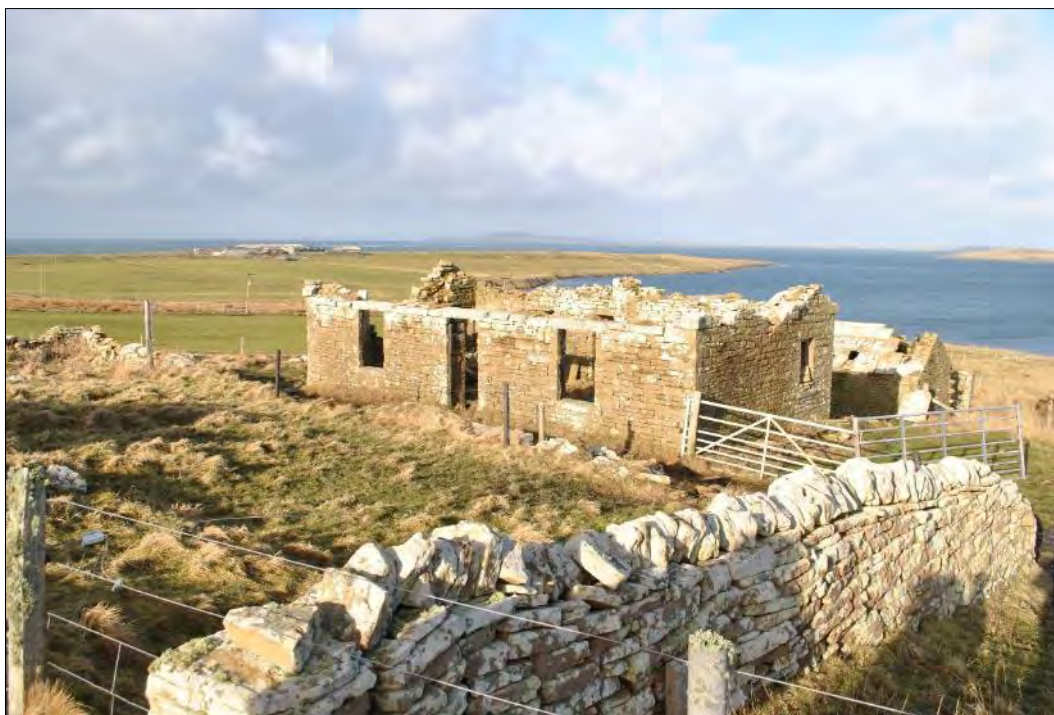
**Plate 173:** General view of Quarryhouse looking northwest from Westside Road. This view shows the main domestic building (Building 1), now roofless, with a later outbuilding (Building 6) behind.

The east-west arm (Building 1) of the L-shaped building formed the main domestic structure in the farmstead (see **Plate 173**). The domestic structure is built of dressed stone blocks, laid in irregular course with stone lintels and sills throughout, and large quoins in each of the corners. The quality of the building reflects its location alongside the quarry and access to the necessary skills and stone-cutting tools to construct a domestic structure of a significantly higher quality than other vernacular, domestic buildings in Eday. There is a centrally-placed external doorway in the south-facing elevation, flanked by large windows. Both the west- and east-facing gables feature a slightly smaller window located towards the south end of the gable. Both gables have suffered extensive collapse above the level of the eaves but the shape and dressing of the surviving quoins in the uppermost courses show that the roof was double-pitched. The north-facing elevation contains two windows of the same height of those in the gables but narrower. One is centrally-placed, the second is located halfway between the first window and the left (east) end of the elevation. The west end of the elevation is obscured by the north-south arm of the L-shaped building complex.

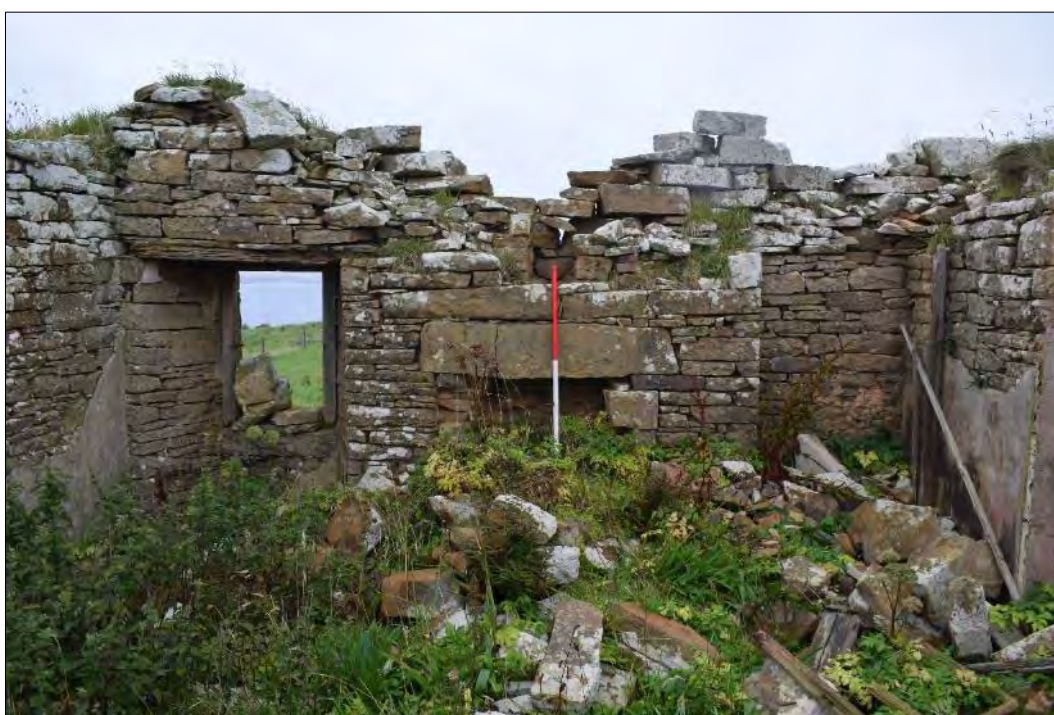
**Plate 174:** East elevation, Building 1 at Quarryhouse with centrally-placed fireplace, storage cupboard (right) and external window.

Stone constituents from the collapse of the gables and the roof littered the interior of Building 1. Fragments of wall plaster covering the wall faces are visible on all four interior elevations. There are centrally-placed fireplaces in both the east (**Plate 174**) and west elevations though that in the west elevation has collapsed and is discernible only just above floor level. Both fireplaces have an external window to the south and a storage space on their north side. The remains of plaster within the storage space in the west elevation shows that these spaces originally contained shelves. There is a third, significantly smaller fireplace in the north elevation, immediately to the right (east) of the central window. All, the windows are set in recess within the interior elevations that are wider than the window apertures themselves (see **Plate 174**) with the exception of the central window in the north elevation. There is an internal doorway in the north elevation located halfway between the central window and the west end of the elevation, providing access to Building 2.

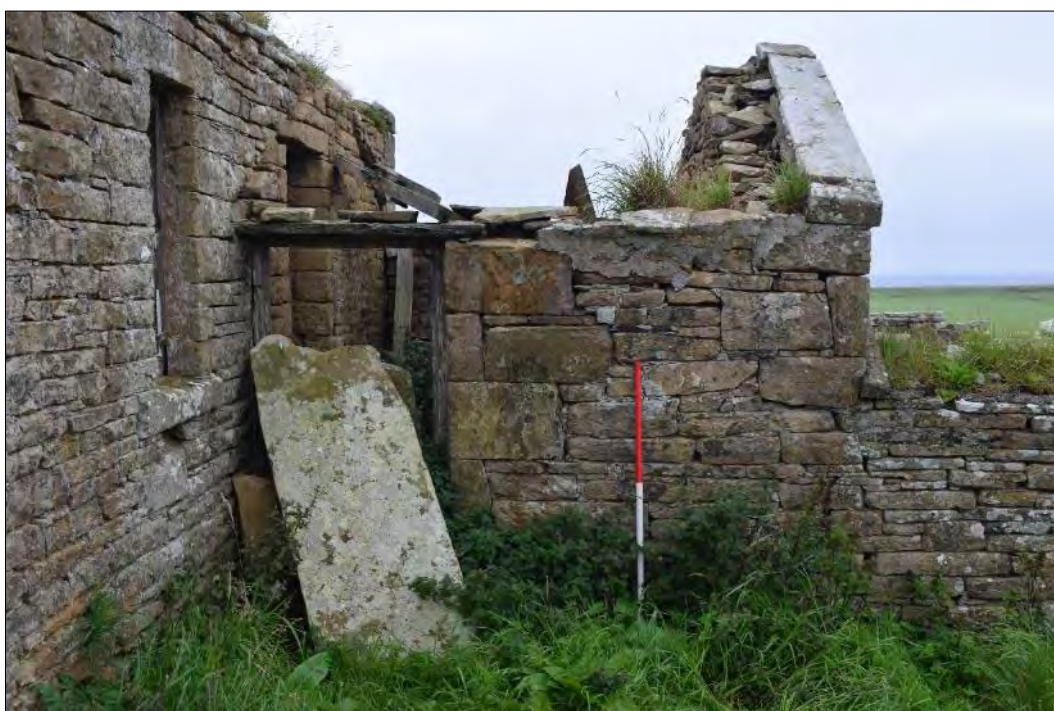
*Plate 175: East-facing elevation of Building 2 at Quarryhouse showing external doorway and the exposed constituents of the north gable. The wall scar for the double pitched roof of Building 2 can be seen in the north-facing elevation of Building 1 (left) above the doorway of Building 2.*

Building 2 is the southernmost element of the north-south arm of the Quarryhouse building complex. The stonework of Building 2 clearly butts against the north-facing elevation of Building 1 and a wall scar matching the double-pitched roof of Building 2 can be seen cut into the stonework of Building 1 (**Plate 175**). There is an external doorway in the east-facing elevation, sitting in the apex of the L-shape of the building complex so that the south edge of this doorway is formed by the north-facing elevation of Building 1. There is a window in the west-facing elevation which is currently partially blocked by a piece of hardboard with a rectangular hole cut through it. Unlike the windows of Building 1, this window has a two-stone lintel though the sill is a single stone. The north gable also acts as the south gable of Building 3 and the stonework of these two structures appears to be continuous. Only one interior feature was identified in Building 2. A large storage cupboard with a single stone slab is set in the north elevation at the west end against the west elevation. The interior of Building 2 is littered with collapsed stone constituents and roof timbers.

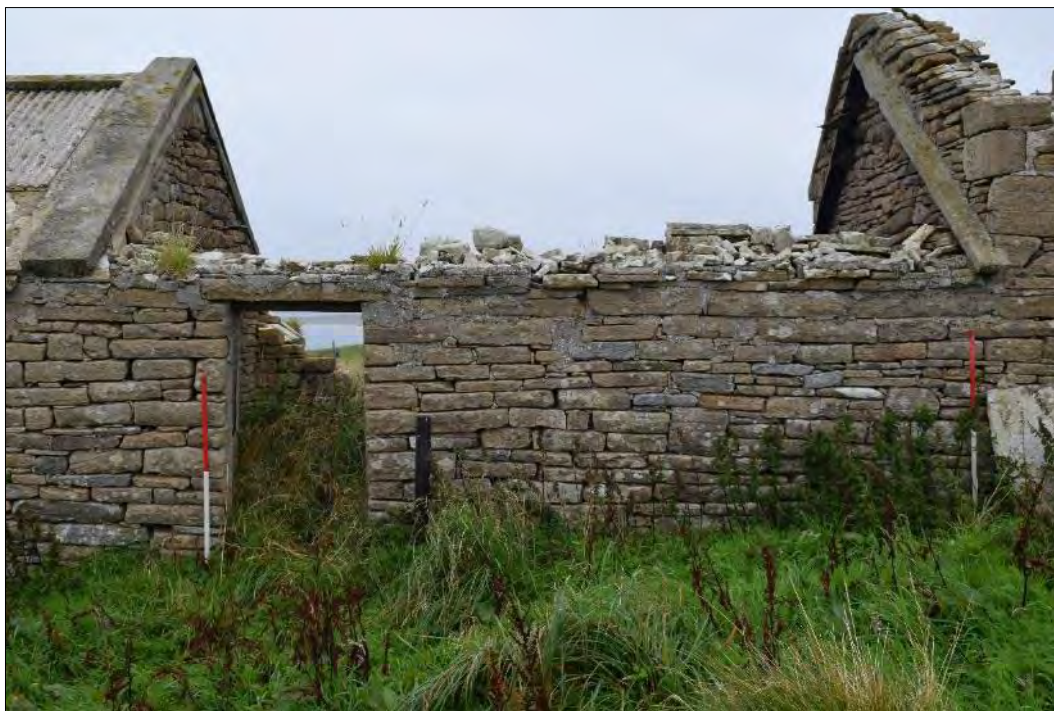
Building 3 is directly north of Building 2 and the mortar adhering to the shared gable between these two buildings show that the roofline of Building 3 was set lower than that of Building 2. This was considered to be a result of the downward sloping ground surface. The line of this mortar and the shape of the north gable show that the roof of Building 3 was double-pitched (**Plate 176**). Building 3 has two external doorways, directly opposite each other in the east- and west-facing elevations. The interior floorspace is covered by scrub vegetation.

**Plate 176:** West-facing elevation of Building 3 showing the line of the roof on the shared gable with Building 2 (right) and the external doorway.

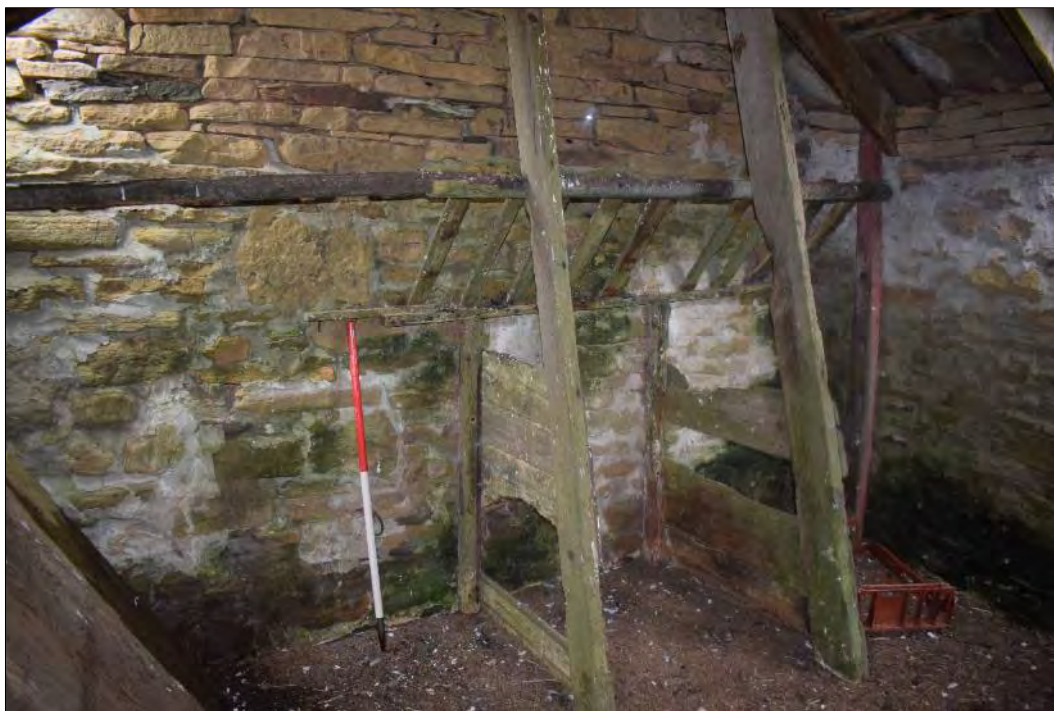
Building 4 is directly north of Building 3. The stonework is continuous between the two structures and they are continuously shown as a single structure on the Ordnance Survey mapping. The external doorway is located at the north end of the east-facing elevation, has a single stone lintel and an internal timber frame. The height of this doorway was noticeably lower than those seen in the other buildings. There is a large drain aperture in the north-facing elevation, approximately 0.75m above the external ground surface. Internally, this aperture was only approximately 0.25m above the floor. The south-facing gable is a shared dividing wall with Building 3 and a series of timber-built animal stalls against the south elevation. Two survive *in-situ* (**Plate 177**) but it was clear that there were originally four stalls. Building 4 is the only structure within the L-shaped complex with an intact roof. The original roof comprised flagstone roofing slabs with a small, square-cut skylight in both the east and west sides. The upper half of the roof on both sides has been replaced by corrugated, cement sheets.

**Plate 177:** South elevation of Building 4, Quarryhouse, with two, in-situ timber-built animal stalls.

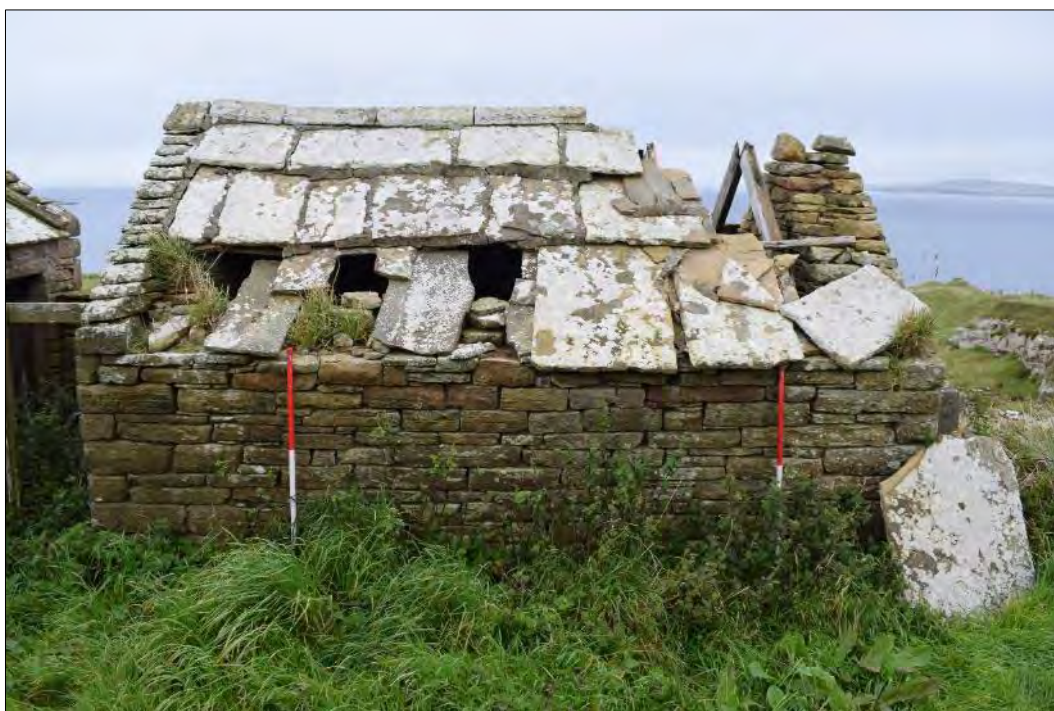
**Plate 178:** South-facing elevation of Building 6 showing partially collapsed roof.

Building 6 is a rectangular, stone rubble-bult outbuilding. There is an external doorway in the west-facing gable directly opposite the doorway of Building 4. The doorway has a single stone lintel the north end of which lies directly on the top of the north wall of Structure 5 and is, therefore, lower than that of the lintel in Building 4. There are no other external features. The roof is largely intact, with a minor collapse at the east end, and small, square-cut skylight in both the north and south sides. The roof comprises flagstone roofing slabs with a flagstone

ridge and timber roof trusses (**Plate 178**). Internal features comprised a drain in the north elevation and a timber frame against the east elevation with iron fixings for securing cattle.

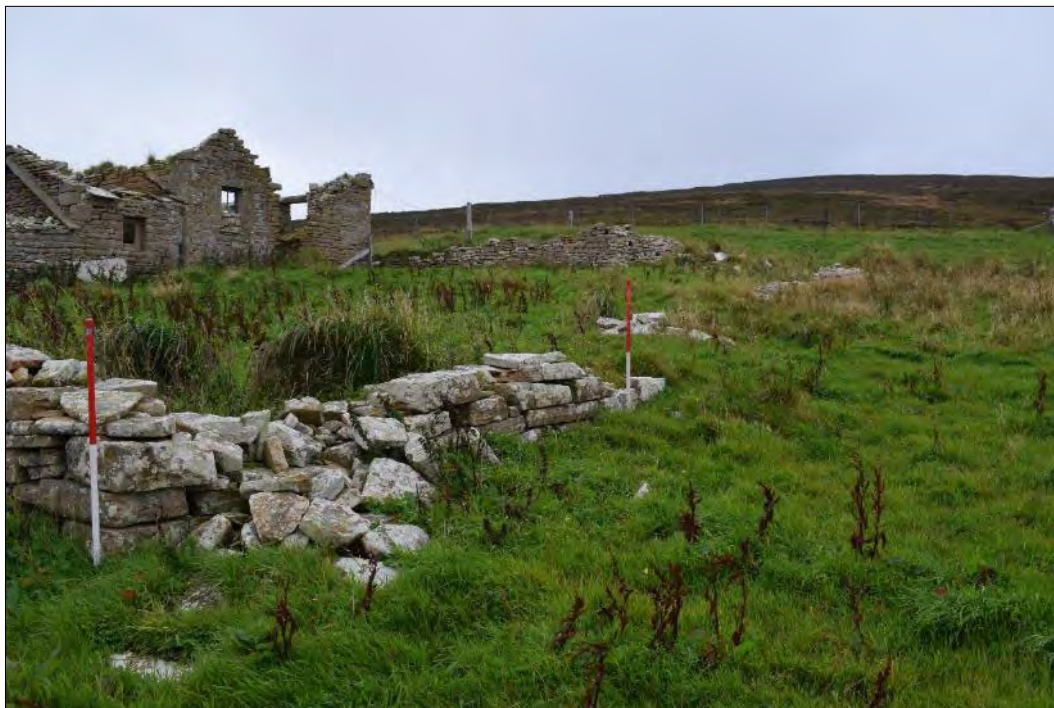
*Plate 179: General view, looking southeast, towards the northwest corner of the enclosure wall (Structure 8) showing the curvi-linear form of the north-south wall at its north end – a relict form preserving the line of the roofed, boat-shaped structure which originally stood at this corner of the enclosure.*

Structure 8 comprised the dry-stone walling forming the enclosure around the west, south and southeast edges of the L-shaped building complex. This are first depicted on the Second Edition Ordnance Survey map and their shape in plan remains essentially unchanged on the current mapping. The only significant change is the roofed, boat-shaped structure seen on the First Edition map which is incorporated into the enclosure wall. Late twentieth-century mapping shows this has lost both its roof and east by the line of its east wall remains preserved in the enclosure. This was identified during the fieldwork (**Plate 179**) and it was noted that the ground level within the curvi-linear section was higher than the surrounding ground which may indicate a former growing plot.

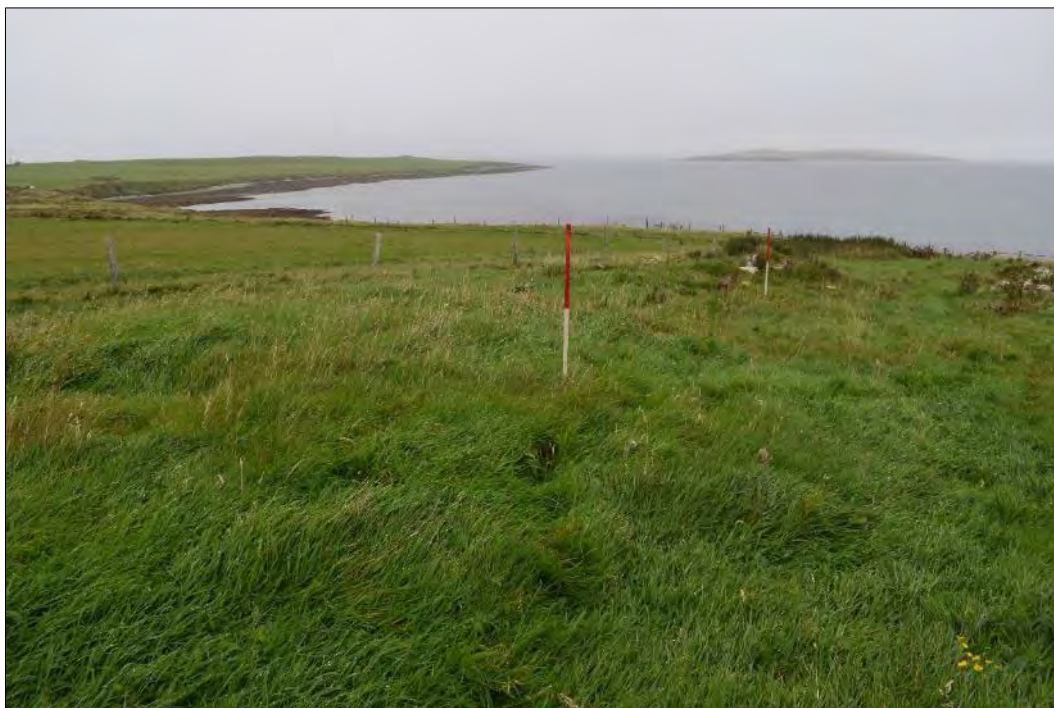
**Plate 180:** General view, looking northwest, showing the house platform (Building 11) with the remains of the enclosure wall beyond (right background)

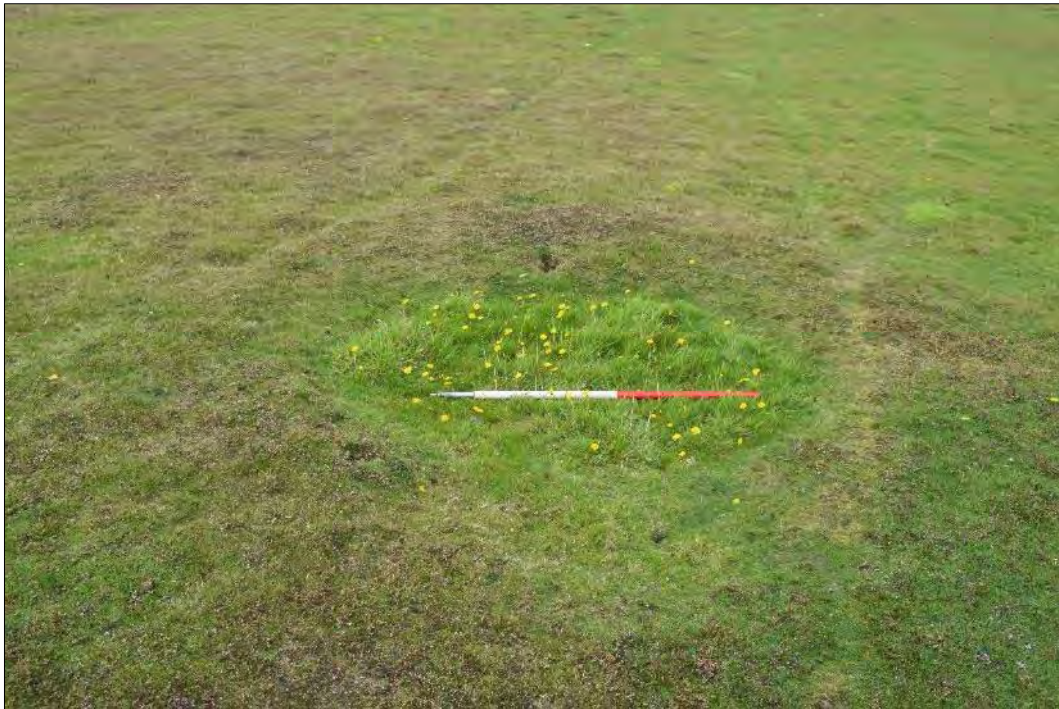
**Plate 181:** Feature 57, looking north.

The kelp pits were seen as circular depressions within a generally flat ground surface, often more abundant or varied flora (**Plate 181**). The 48 kelp pits regarded as ‘Definite’ were classified on the basis of stone constituents being present. The stone lining of the pits was occasionally visible within the features (**Plate 182**). During the survey it was noted that the kelp pits were occasionally set out in lines, often parallel to the shoreline, or at an oblique angle (see **Figure 15**). This was particularly evident at the small cluster of kelp pits near Trola Vatn. The area between Trola Vatn and Loch of Sjaivar was almost completely devoid of kelp pits, and it was observed during the walkover survey that this area was noticeably more waterlogged than other areas to the east of the metalled highway. The highest concentration of kelp pit was found in the area between Loch of Sjaivar and Dennis Loch, with the pits often laid in lines or large clusters around the extant walled enclosures. There was a small cluster to the south of Dennis Loch but none to the east where the Old Beacon is located.

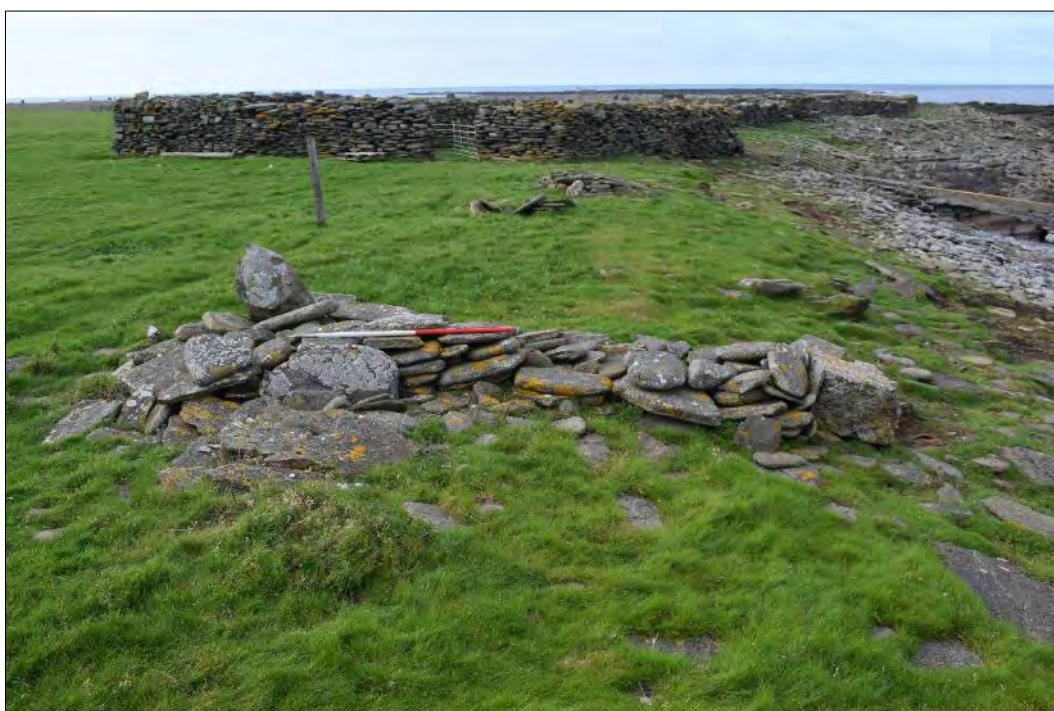
*Plate 183: Feature 75, looking north, with Feature 74 in the background.*

Only three tangle dykes were identified. These formed a group above the coastal section at Versa Geo. These measured between 3.4m and 4.3m in length, all with a width of 1m and were preserved to an average height of 0.35m. Two of the dykes, Feature 74 and 76, were orientated parallel to the shore and one, Feature 75, perpendicular to it. Stone coursing was visible in all three examples (**Plate 183**).

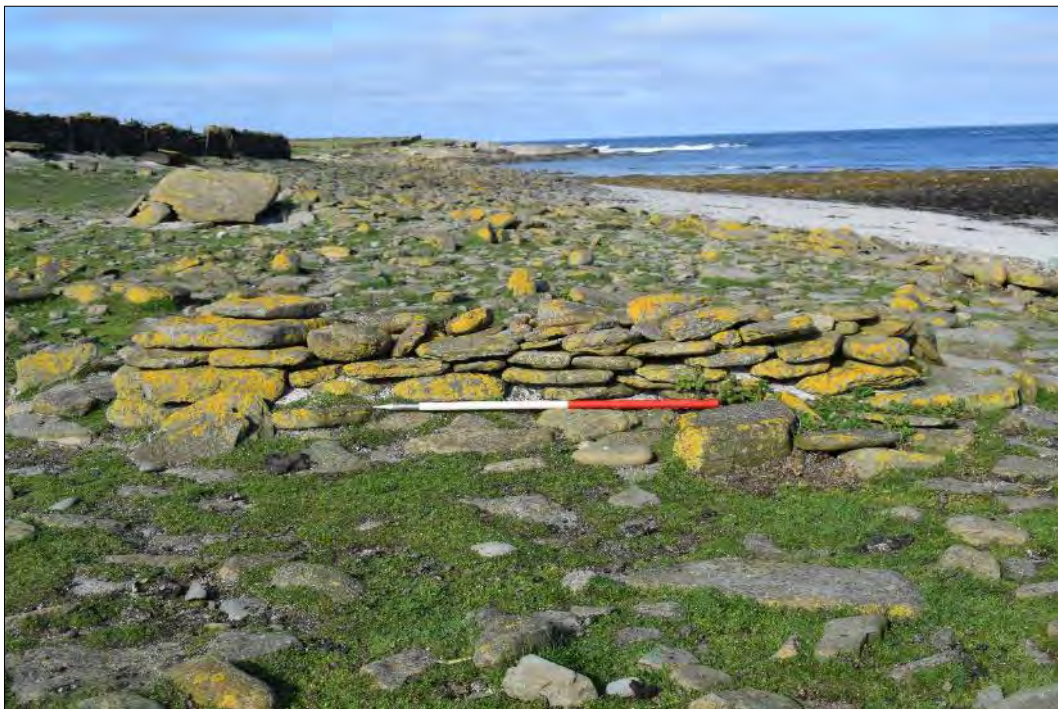
**Plate 185:** East-facing elevation of Feature 08.

The tangle dykes varied in length from 2.78m to 6.67m, with an average length of 4.97m. These were generally 1m in width with a height varying from 0.18m to 0.73. The variation in length and height can generally be attributed to truncation through erosion, stone robbing and the movement of sand altering ground levels and partially obscuring the structures. The dykes were preserved as linear stone-built features (**Plate 184**) within which distinct courses could be identified (**Plate 185**).

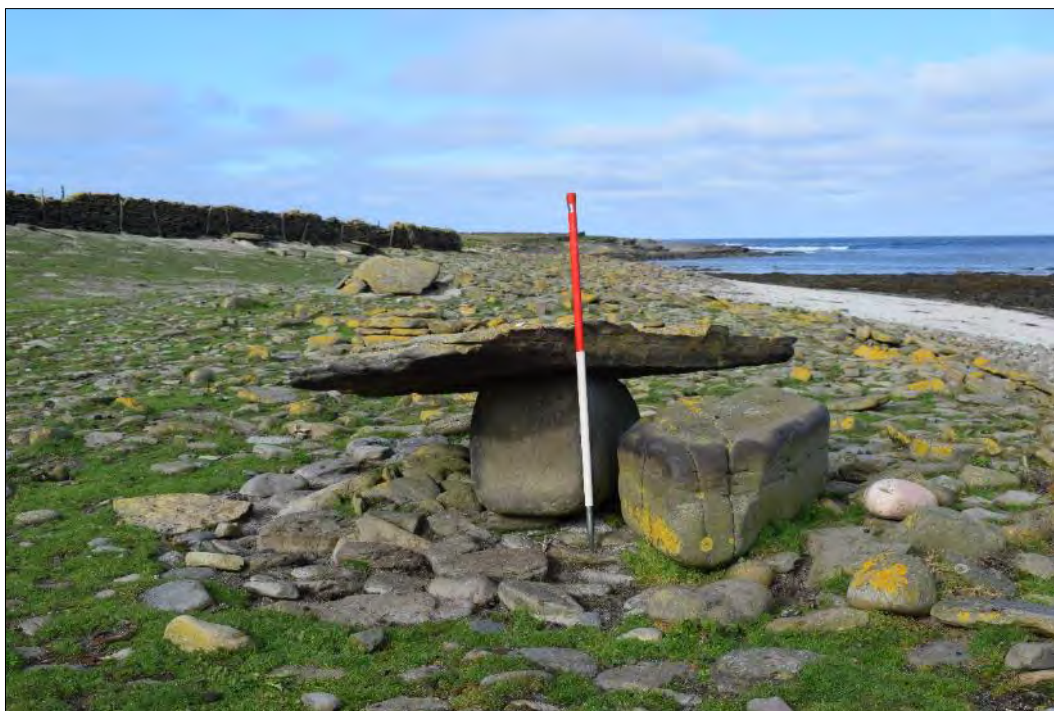
**Plate 186:** Feature 07, looking west.

There were four features interpreted as tangle drying-platforms. These comprised a large, pebbled stone slab supported by smaller beach stones (**Plate 186**). These slabs varied in length from 0.64m to 2.59m. The smallest of these, Feature 12, was an example which had been dismantled and it was unclear if the largest remaining constituent was the top slab or a supporting stone.

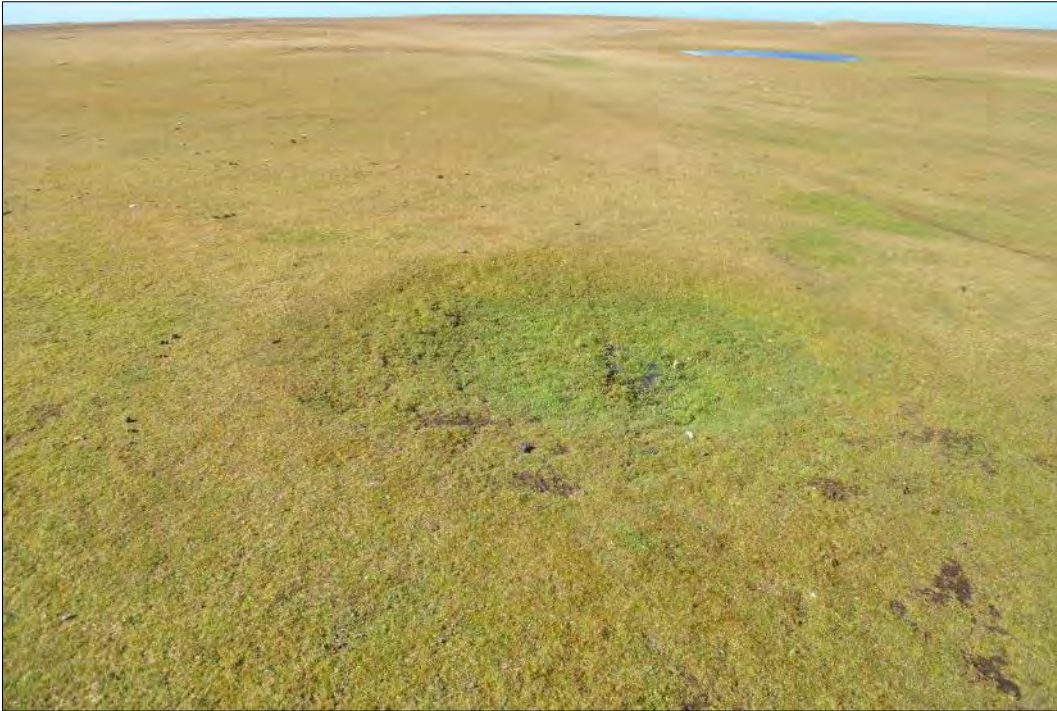
A total of five kelp pits were identified to the south of the disused quarry at Tor Ness. The location of the kelp pits is shown in **Figure 16** and the data summarised in **Table 9**. The pits varied from 1.8m to 2.5m in diameter, with an average preserved depth of 0.17m. Four of the kelp pits were graded as 'Definite' or 'Probable'. The pits were seen as a circular depression in the fairly flat landscape (**Plate 187**). It is possible that the number of kelp pits in this area was originally higher with examples lying closer to the shore being subsequently lost to the quarry workings.

*Plate 187: Kelp pit identified during the Project Launch site visit at Tor Ness, looking southwest.*

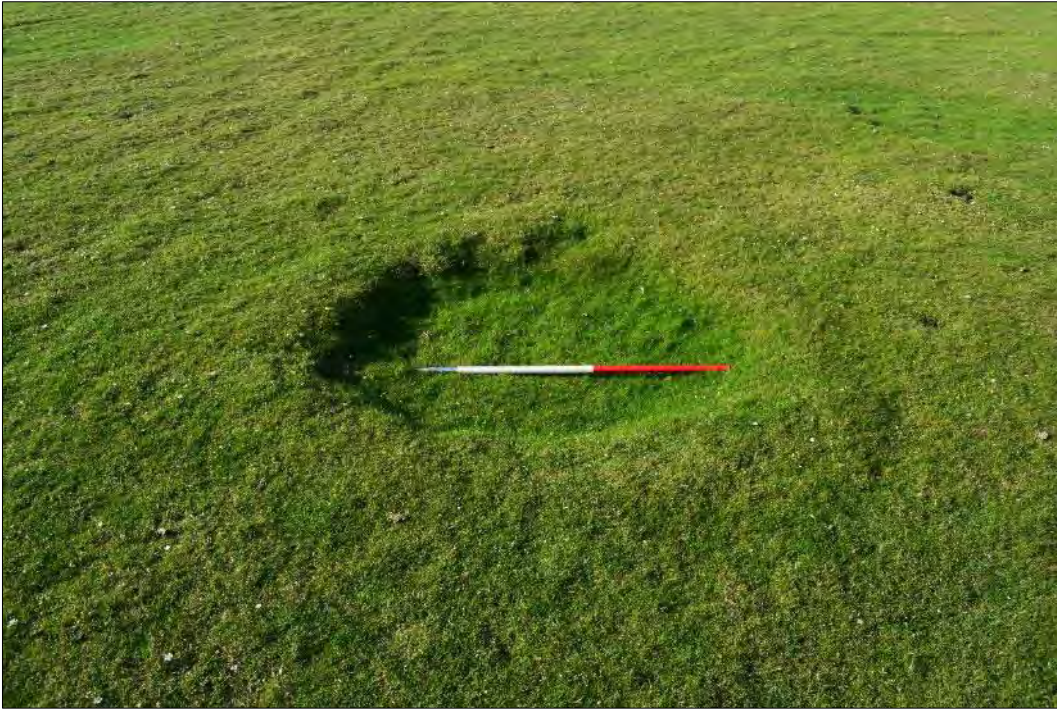
*Plate 188: Feature 178, looking northwest.*

The kelp pits were seen as circular depressions within a generally flat ground surface, often more abundant or varied flora (**Plate 188**). The 48 kelp pits regarded as 'Definite' were classified on the basis of stone constituents being present. The stone lining of the pits was occasionally visible within the features (**Plate 189**). During the survey it was noted that the kelp pits were occasionally set out in lines parallel to the shoreline (see **Figure 17**). This was particularly evident to the north of, and immediately south of, the ware slip (see below). The largest cluster, and greater spread, of kelp pit was in the area around the ware slip which was also associated with a number of openings in the sheep-dyke. This was probably the preferred area for burning the kelp as it was closest to the point where the material was being brought up from the beach and where there was easy egress to the trackway.

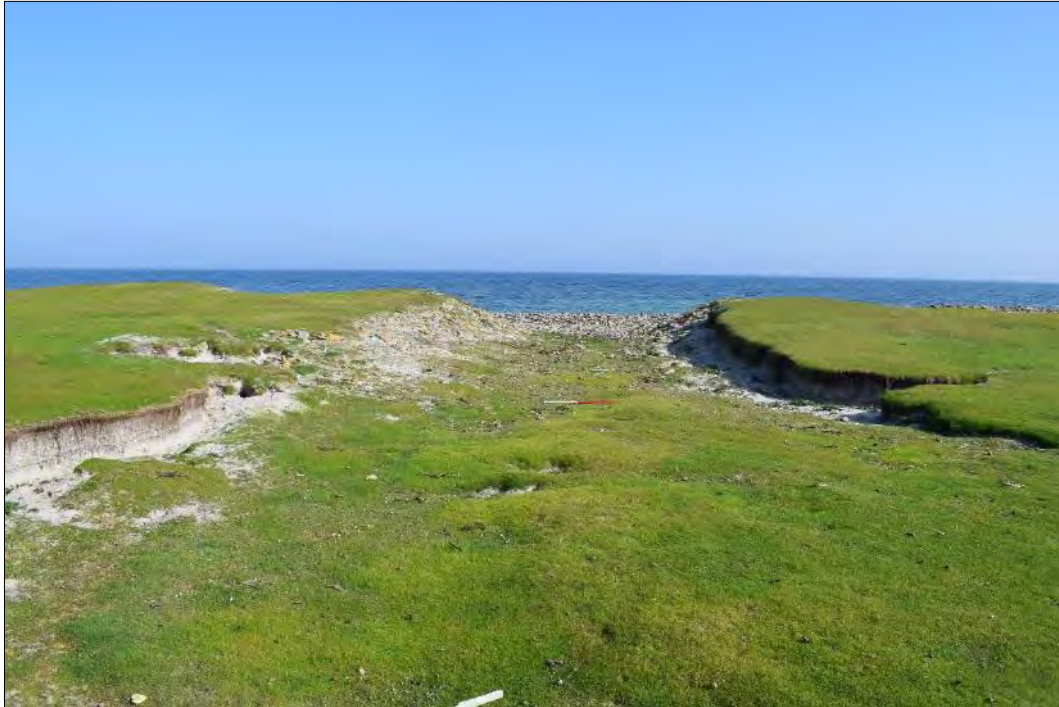
*Plate 190: Ware slip, Feature 128, looking northeast.*

A ware slip is a cutting through the sand and pebbled stone forming the coastal section to allow the gathered kelp to be dragged from the beach, up to the area of the kelp pits. One of these, Feature 128, was identified in the surveyed area (**Plate 190**). The cutting measured

26m in length and was approximately 8.2 wide. There was evidence for collapse along the edges of the cutting, particularly the south edge, as a result of erosion.

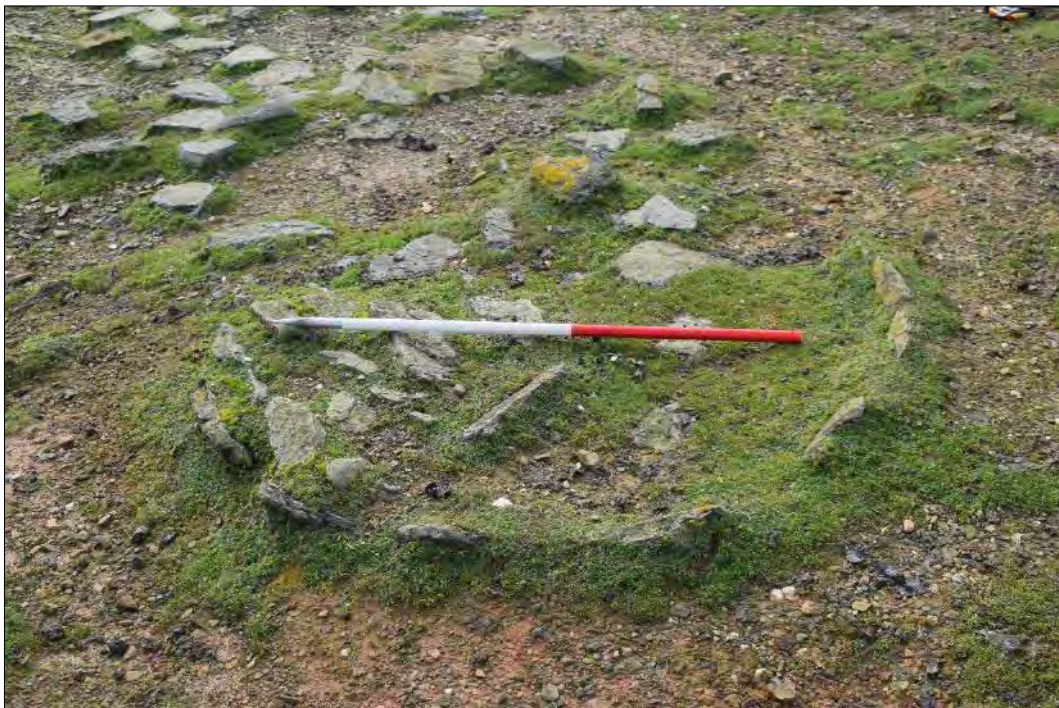
*Plate 191: Feature 92, looking south.*

A total of five kelp pits were identified in the survey area. These varied from 1.55m to 1.8m in diameter, with an average size of 1.63m. The pits had an average preserved depth of 0.10m. All the pits were classified as ‘Definite’, though much of their earthworks had eroded, the stonework was clearly visible, earth-fast and *in-situ* (**Plate 191**).
