## **The Industrial Heritage of the North Isles Orkney**

## **Research and Interpretation Project Data Structure Report**

February 2025

**Project No: 996**

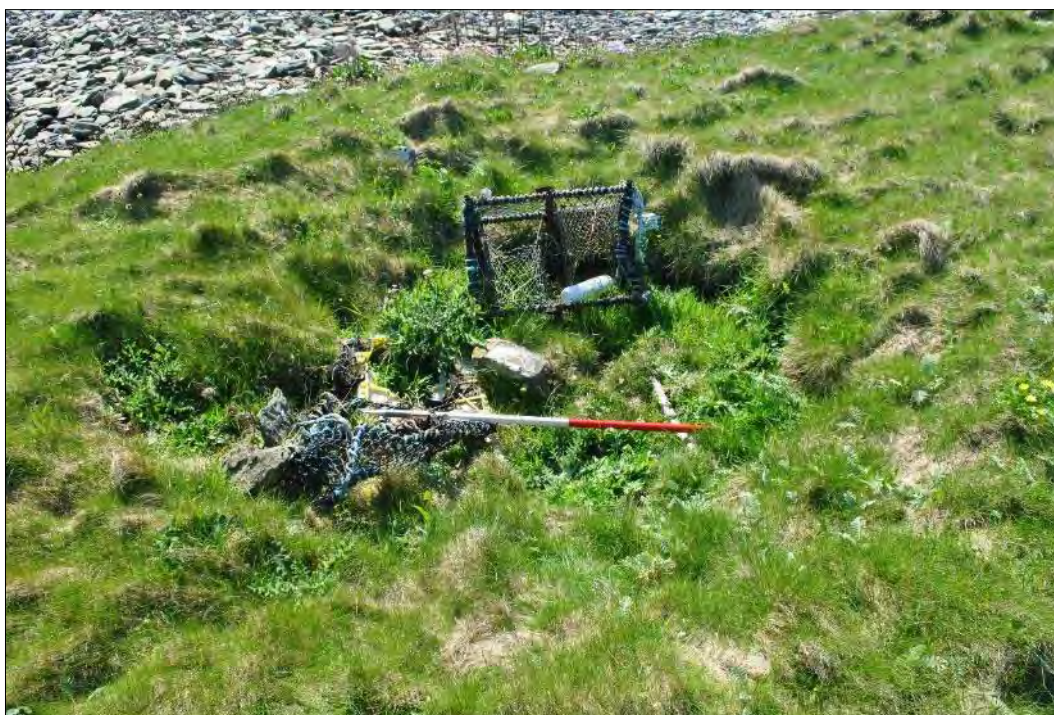
*Plate 192: Feature 09, looking southeast*

The seven kelp pits varied from 0.9m to 3.0m in diameter. Only one pit, Feature 09, was classified as 'Probable' (**Plate 192**). The kelp pits were seen as circular depressions in an uneven landscape. Feature 08, though still included in the data, is probably more likely to be an intrusive excavation rather than a kelp pit.

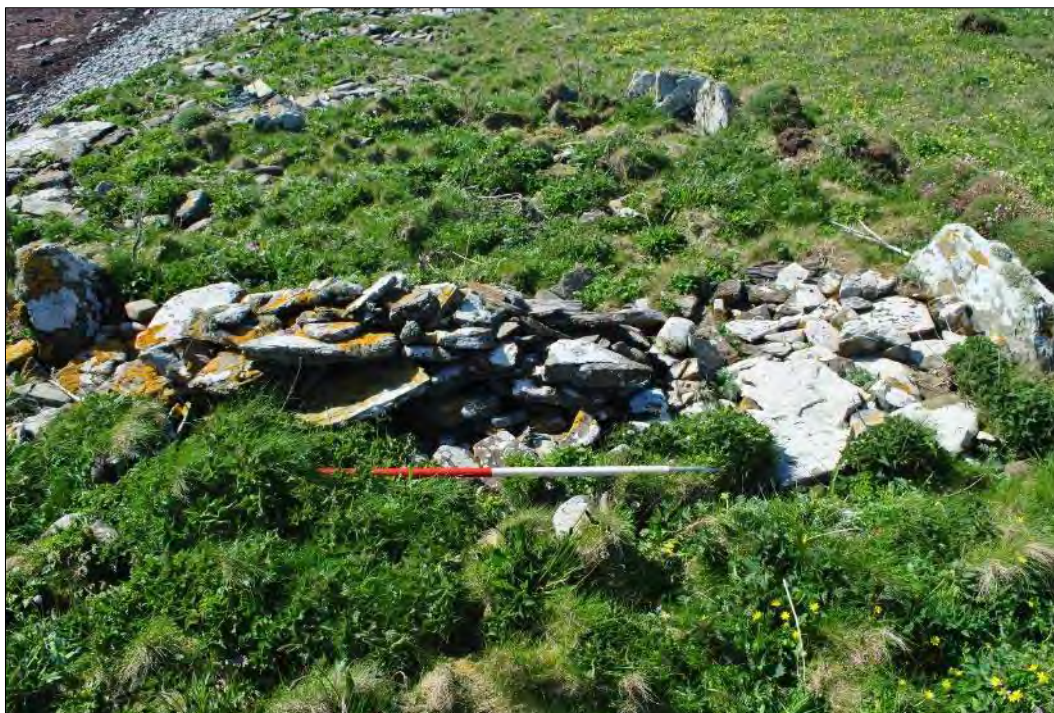
*Plate 193: Feature 01, looking southeast*

3.4m to 7.8m with an average width of 0.9m. The dykes bounded the edge of the storm beach and often the seaward end could not be clearly defined within the debris. The dykes were seen as distinct linear features extending from the storm beach with two examples, Feature 1 and 4, containing orthostats. The two examples classified as 'Probable' were less obscured by stone debris (**Plate 193**).

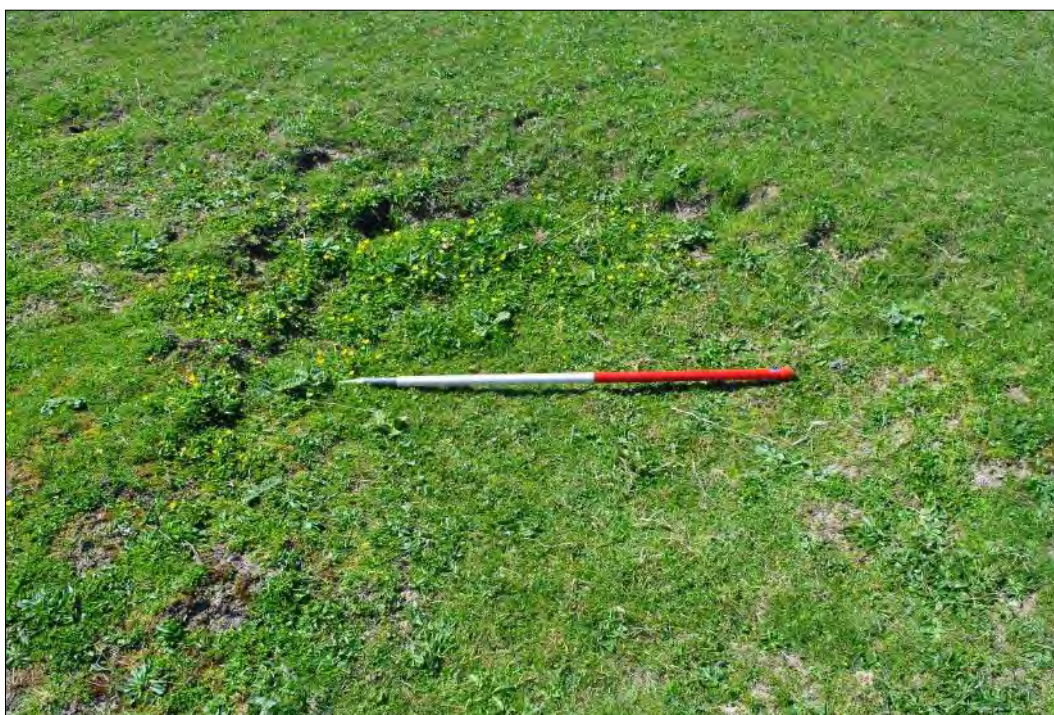
*Plate 194: Feature 31, looking southwest.*

The kelp pits varied from 0.8m to 2.7m in diameter. Though the ground surface sloped down towards the coastal section throughout the site, the incline was fairly gentle and even and, therefore, the kelp pits were fairly well defined as circular depressions in the ground surface. The stone lining was not identified in any of the examples, however, and the majority have been classified as 'Possible'. The three examples classified as 'Probable' were recorded as such on the basis of a clear, circular edge defined by a break in the grass covering (**Plate 194**).

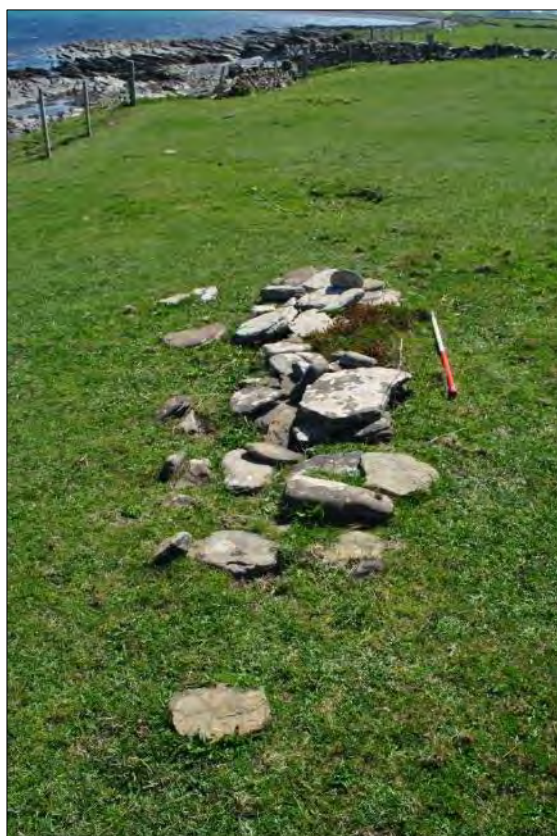
**Plate 195:** Feature 29, looking southeast

The three structures identified as tangle dykes were distributed fairly evenly across the site, intermingled with the kelp pits. All three were oriented parallel to the coastal section. The dykes varied in length from 2.9m to 6.1m with an average width of 0.9m. None of the tangle dykes were preserved as upstanding structures, all three being discrete linear features of earth-fast stones (**Plate 195**).

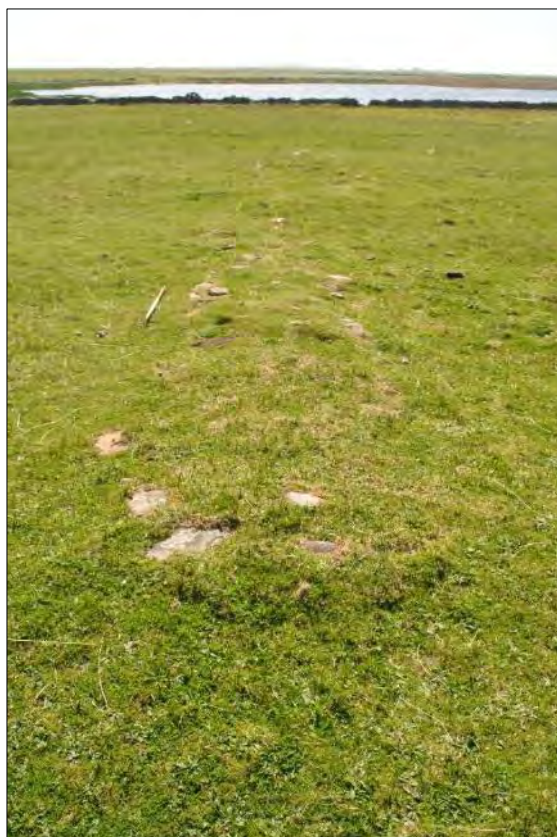
*Plate 196: Feature 01, looking south.*

The survey undertaken in May 2024 identified a total of six kelp working features: three tangle dykes; and three kelp pits. All of these were classified as ‘Possible’. The tangle dykes were seen as low linear earthworks containing earth-fast stones (**Plate 196**) in an area essentially devoid of stone material visible in the grass covering and topsoil. The tangle dykes formed a single group, parallel to each other and perpendicular to the coastal section, though this was located approximately 70m to the north. This distance from the shore was greater than that for tangle dykes recorded at other sites. The tangle dykes varied in length from 7.6m and 8.4m with an average width of 1.18m. The slightly larger size if these dykes compared to examples

at other sites in probably due the features appearing as earthworks. The collapse of stone material from the dykes has been covered by wind-blown sand creating a feature which encapsulates both the *in-situ* constituents and the spread of debris around the original structure.

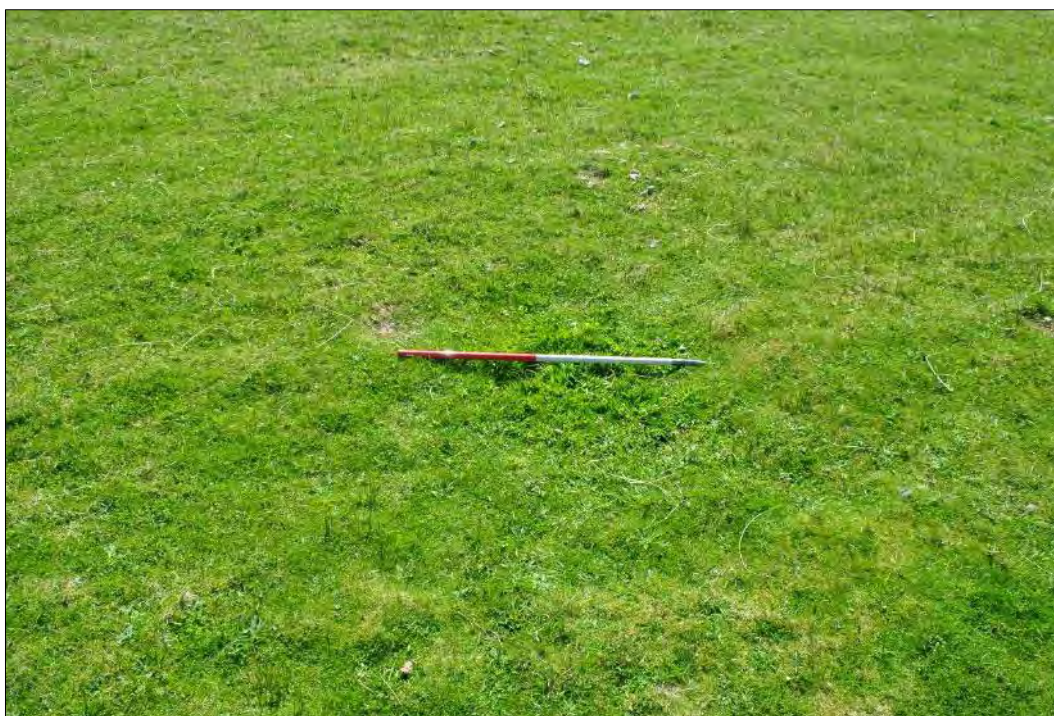
**Plate 197:** Feature 05, looking south.

The kelp pits varied from 1.85m to 2.9m in diameter and were visible as circular depressions in the fairly even ground surface. The pits were devoid of the variation in vegetation cover seen in other examples and there was no evidence for a stone lining (**Plate 197**).

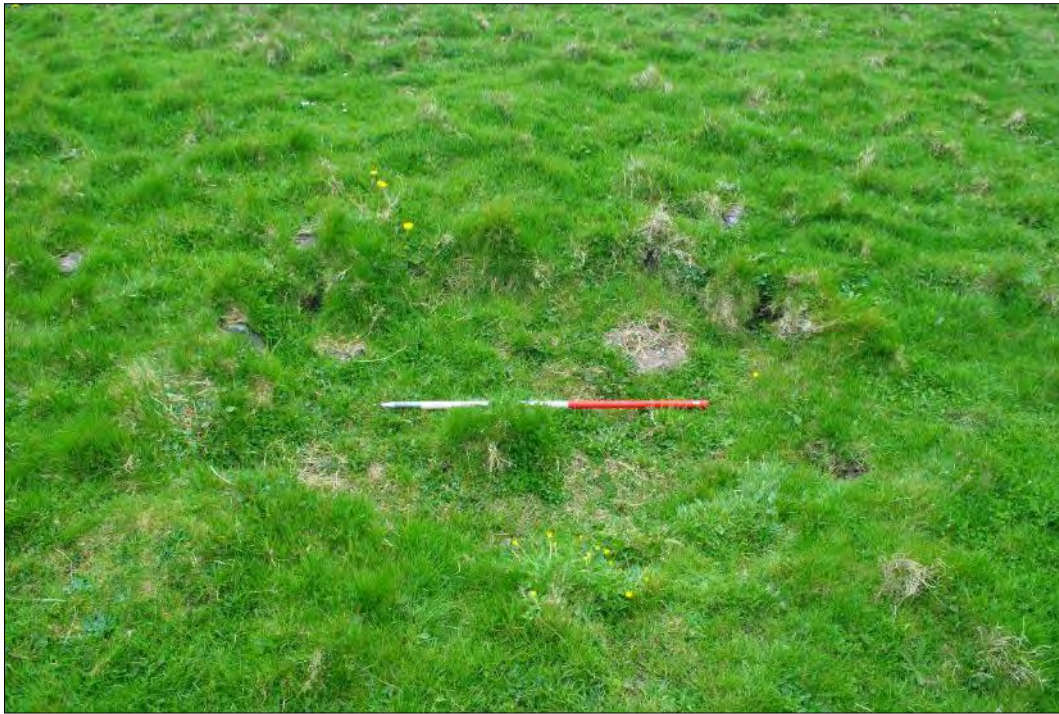
**Plate 198:** Kelp pit (Feature 41), looking west.

The kelp pits were seen as circular depressions within a generally flat ground surface. None of the identified pits bore visible signs of any stone lining but those considered as ‘Definite’ or ‘Probable’ usually exhibited a clear, sunken edge (**Plate 198**).

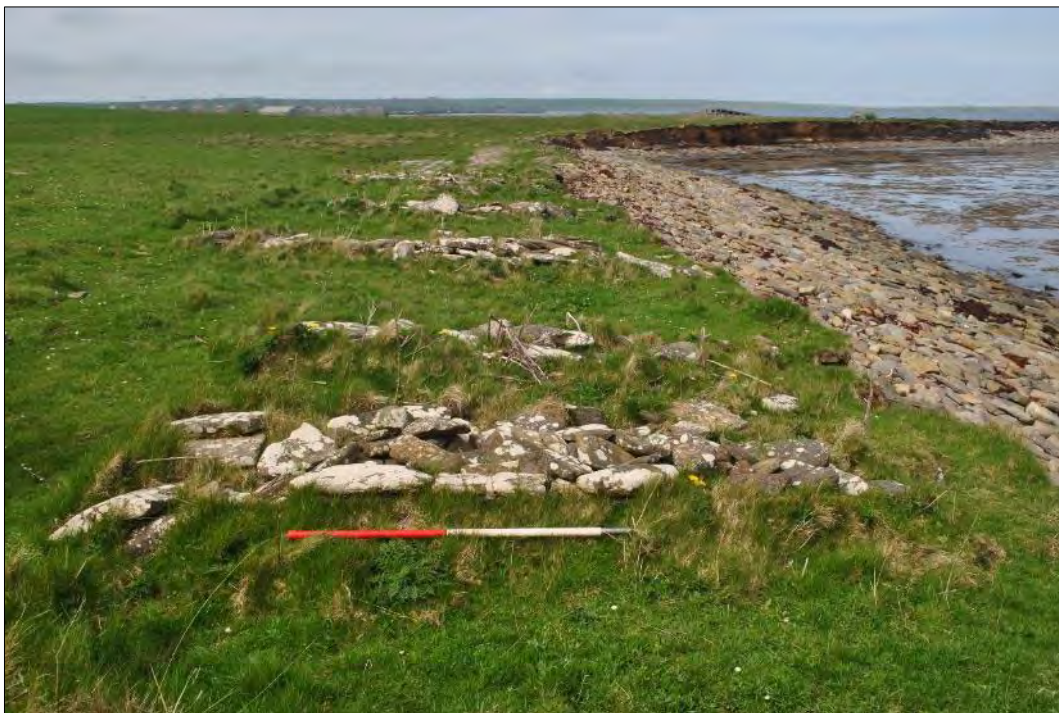
**Plate 199:** Tangle dyke (Feature 19), looking west with further tangle dykes (Features 14 to 18) in the background.

The tangle dykes varied in length from 1.10m to 8.25m, with an average length of 3.82m. They had an average width of 1.2m in width with a height varying from 0.12m to 0.55. The variation in length and height can generally be attributed to truncation through erosion and the storm beach partially obscuring the structures. The dykes were preserved as linear stone-built features (**Plate 199**) within which distinct courses could occasionally be identified.

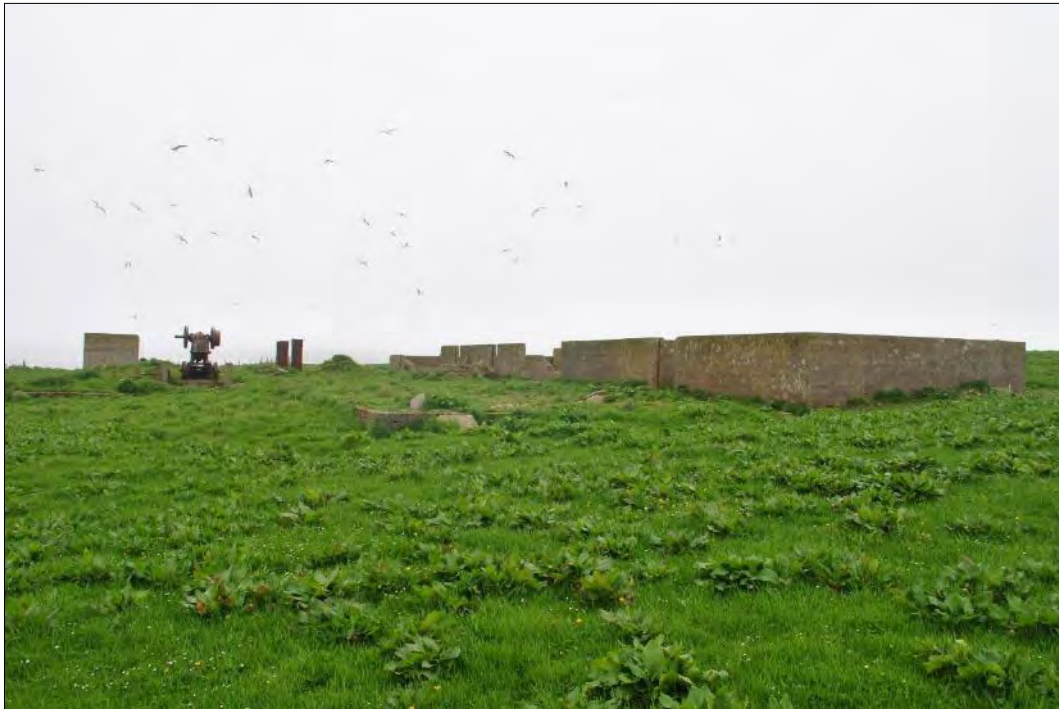
The remains of the former fish-gut processing plant are located on the on the north shore of the Point of Cumley, to the south Whitehall Village, at NGR HY 65525 27679. The remains comprise raised, concrete surfaces, upstanding ironwork structures and concrete walling (**Plate 200**).

**Plate 200:** General view of the Stronsay fish-gut processing plant, looking southeast, with concrete walling (right), iron features (left of centre) and a tank (extreme left). The machinery on the left is a stone crusher and is a much-later addition, unrelated to the activities of the plant.

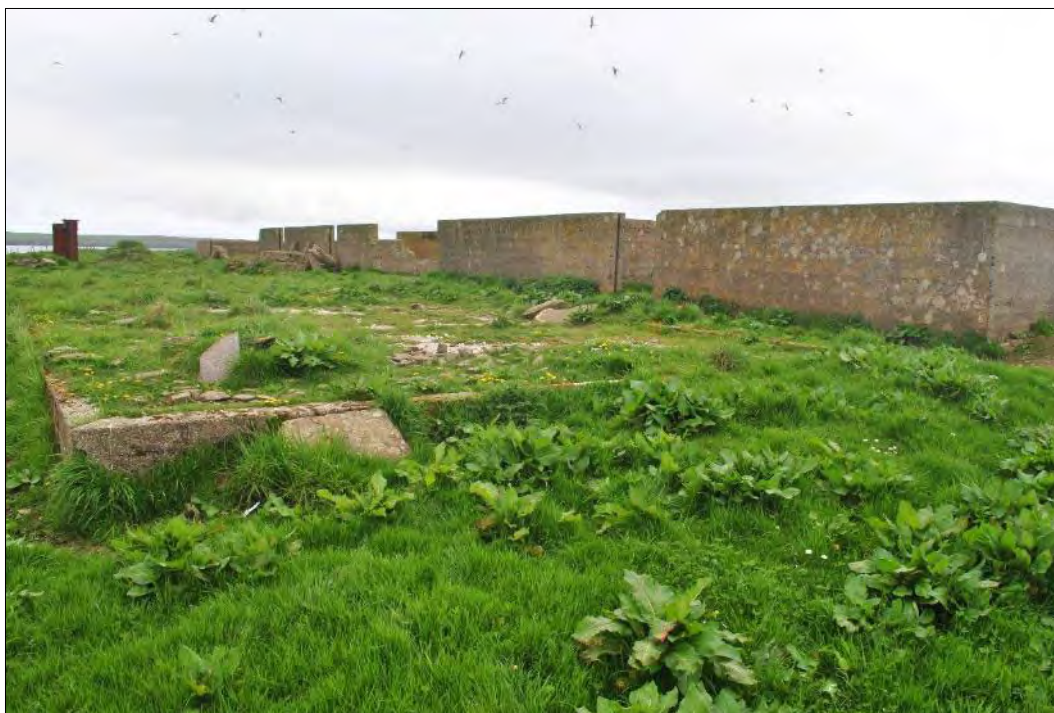
*Plate 201: A closer view of the plant showing the walling and the opening providing access to the internal areas. The northwest edge of raised concrete platform is visible in the foreground.*

The raised concrete platform measures approximately 45m by 18m, and a maximum height of 0.8m above the surrounding ground level (**Plate 201**). The platform is an uneven L-shape in plan and forms the footprint of the site to the northeast of the range formed by the concrete walling. There are a number of low, concrete buttresses around the external edge of the platform (**Plate 202**) along with a number of features across its surface. These include a concrete tank located close to its northeast edge, measuring 2.9m by 2.3m, and a series of upright iron structures. All of these are constructed of elements resembling girders or joists, I-shaped in cross-section. One of these has a cross-beam to form a square archway with the remainder being a line of three single elements in close proximity (**Plate 203**). The remaining surface features comprise concrete machine bases with iron fixing rods; square-cut apertures in rectangular patterns; and a small inspection pit.

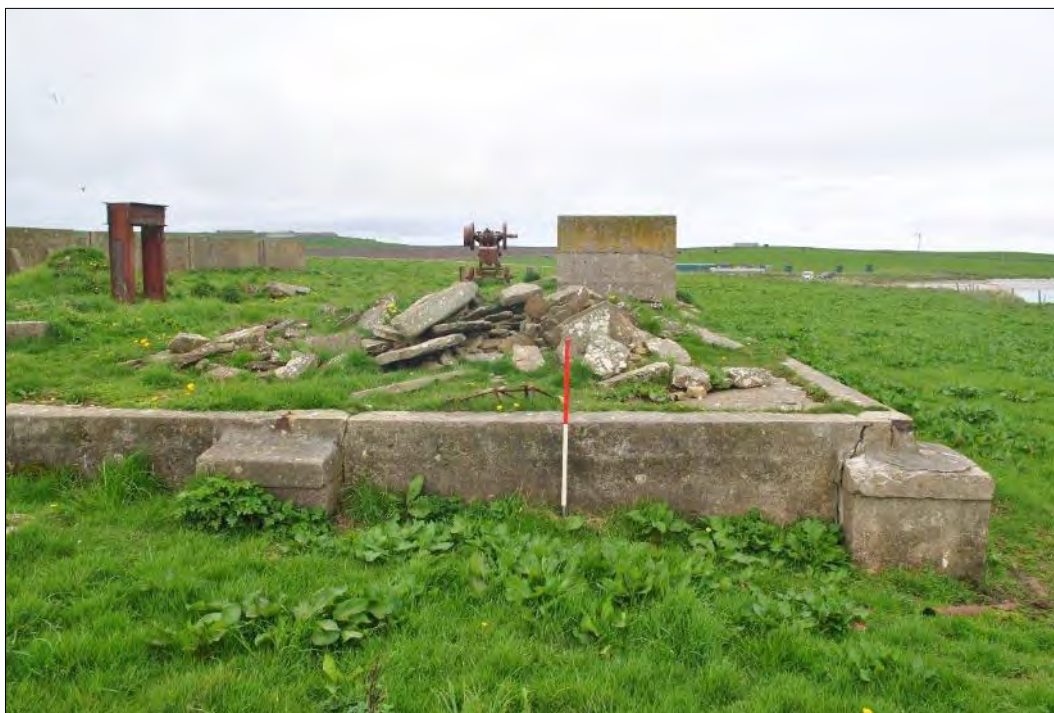
*Plate 202: The northeast corner of the concrete platform, looking northwest, with the tank in the background and the iron girder-arch to the southwest (left). The photograph also shows two of the low buttresses which are interspaced around the open sides of the platform. These two examples can also be identified on a photograph of the plant dating from the late 1930s.*

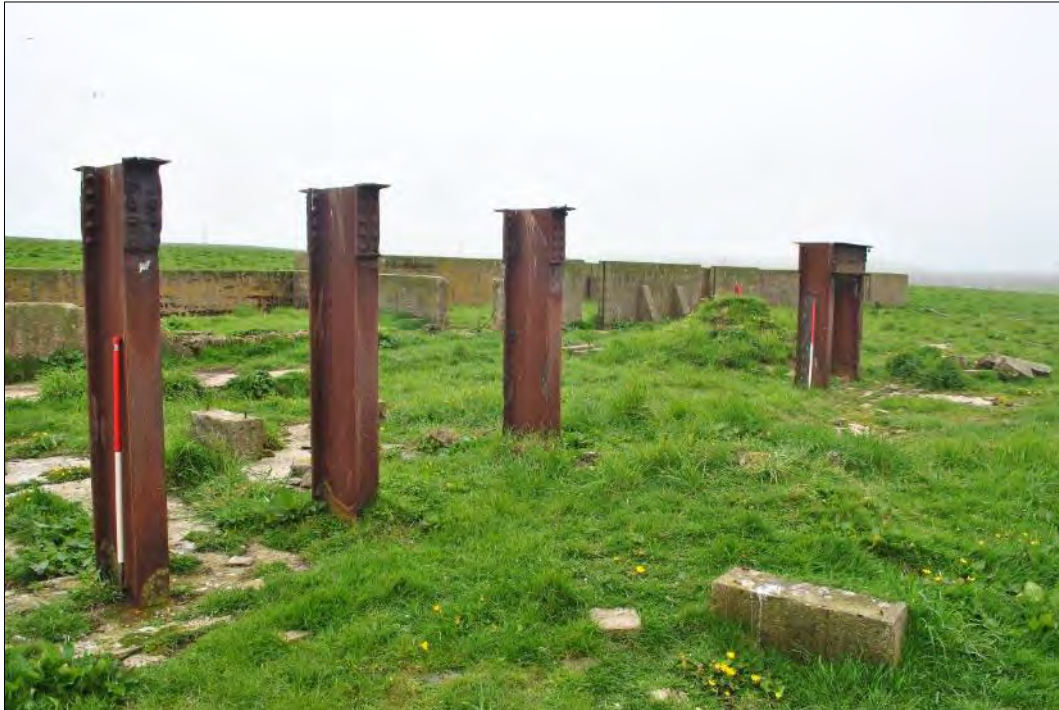
**Plate 203:** Detail view of the upright iron structures within the interior of the northeast building, looking west. In the right foreground is an example of a concrete machine-base with iron securing rods. Another example is visible between the two iron girders on the left.

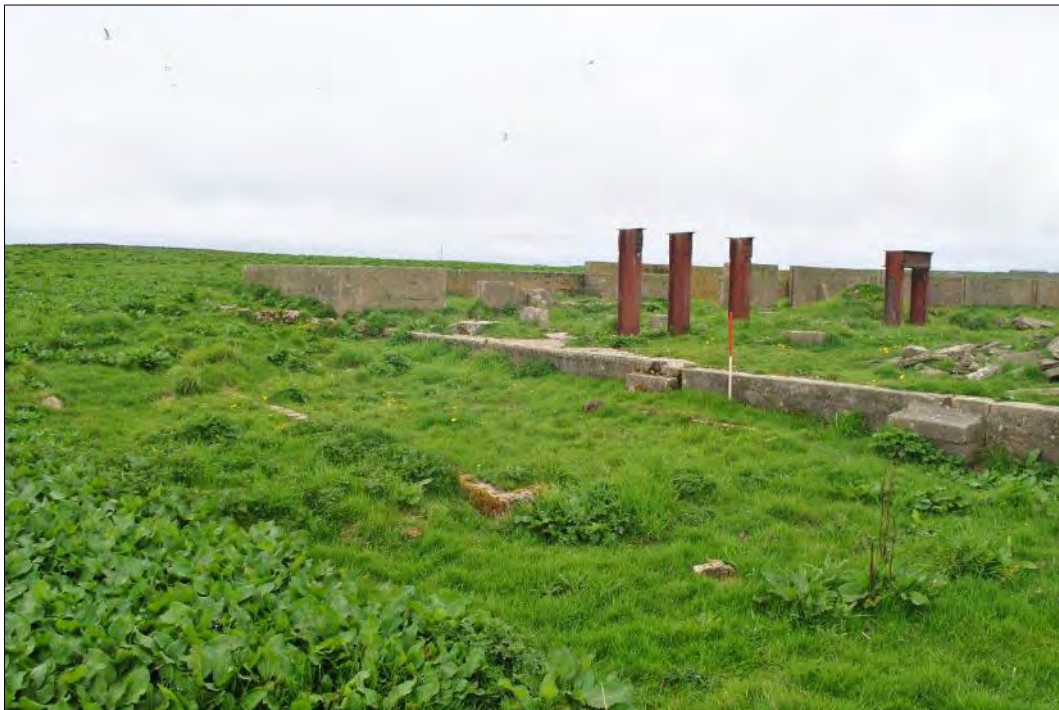
**Plate 204:** General view of the southeast edge of the plant showing the open-ended concrete structure outwith the raised platform area and the earth-fast concrete blocks partially obscured by vegetation.

A number of features related to the plant were identified outwith the concrete platform and the walled areas. The majority of these were located immediately to the southeast of the platform area and comprised a discrete area of earth-fast concrete blocks to the southwest of a rectangular concrete structure open at its northeast end (**Plate 204**). There is also a concrete, open-topped water tank located on the coastal edge approximately 450m south of the plant, below the farm at Hunton. This was fed all year round by freshwater springs in the area, and the water piped to the factory. Local knowledge asserts that, even though the tank is below the level of the plant, the system was gravity-fed and no pump was used to move water from the tank to the works. It is possible that there may have been a deep sump at the factory into which the water siphoned.
